**SACRAMENTO MUNICIPAL UTILITY DISTRICT
UPPER AMERICAN RIVER PROJECT
(FERC Project No. 2101)**

**PACIFIC GAS AND ELECTRIC COMPANY
CHILI BAR PROJECT
(FERC Project No. 2155)**

**RIPARIAN VEGETATION AND WETLANDS
TECHNICAL REPORT**

OCTOBER 2004

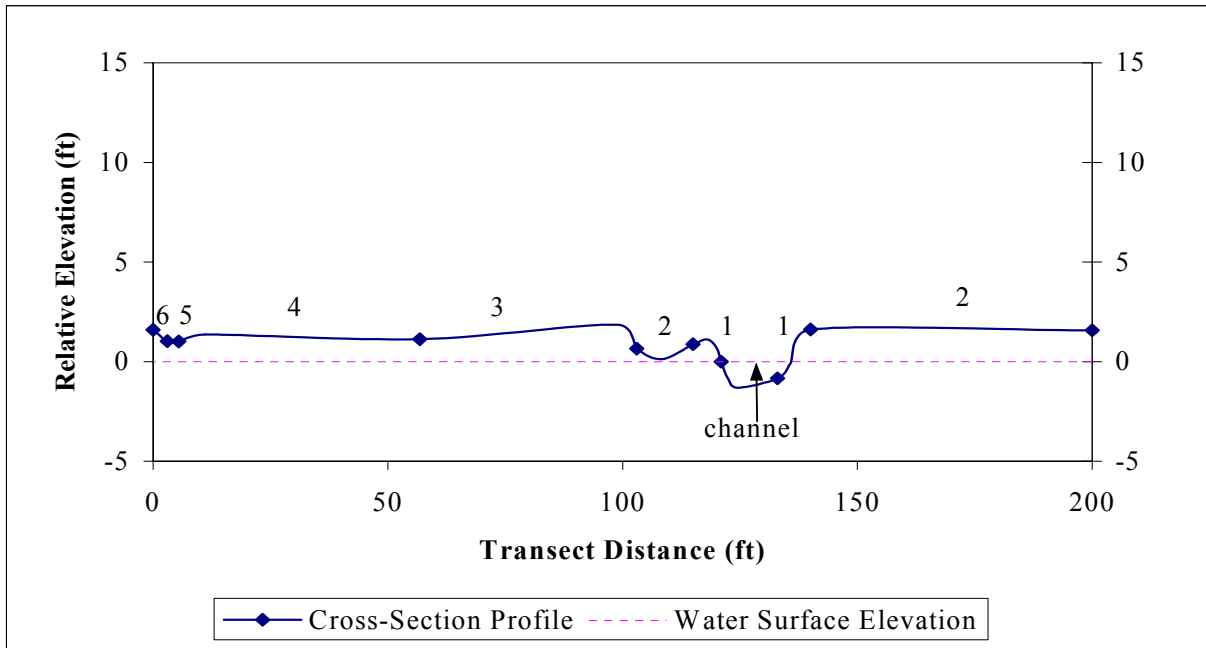
Figure 4.1.4-8. Loon Lake Dam Reach Site 3: Transect 2. Transect is shown so that the right bank headpin is equal to a distance of 0.0 ft.

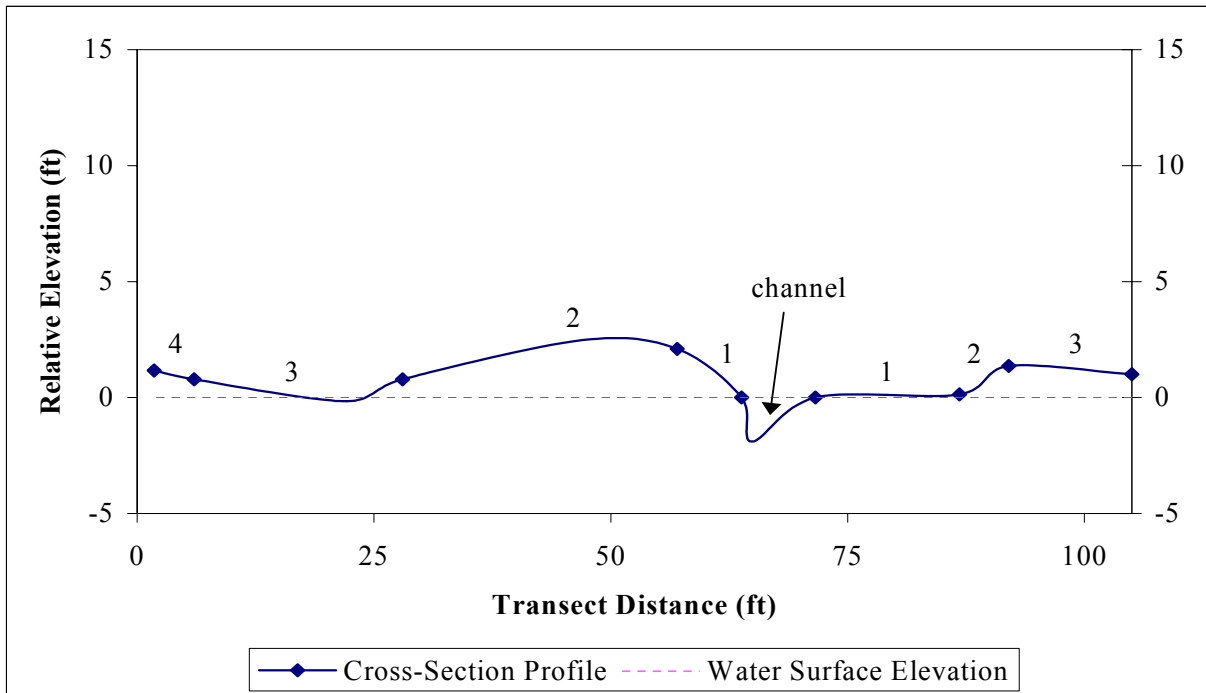
Figure 4.1.4-9. Loon Lake Dam Reach Site 3: Transect 3. Transect is shown so that the right bank headpin is equal to a distance of 105.0 ft. Water surface elevation extended beyond channel for diagrammatic purposes only.

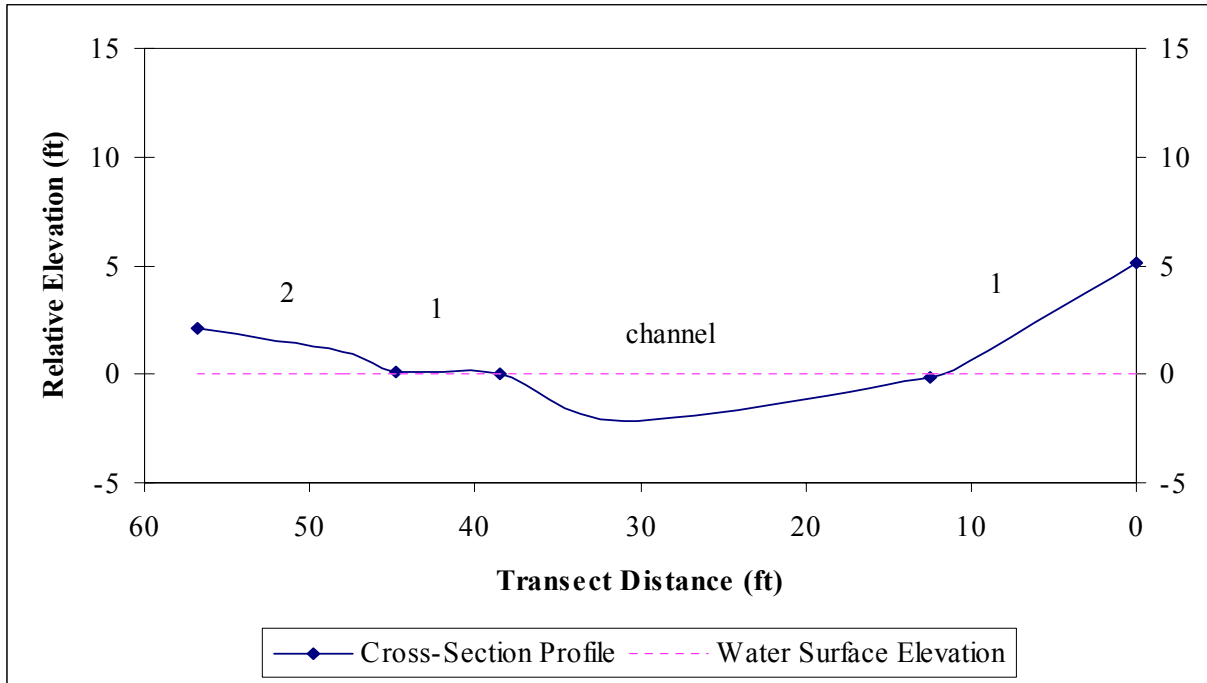
Figure 4.1.5-2. Gerle Creek Dam Reach: Transect 2. Transect is shown so that the right bank headpin is equal to a distance of 102.7 ft.

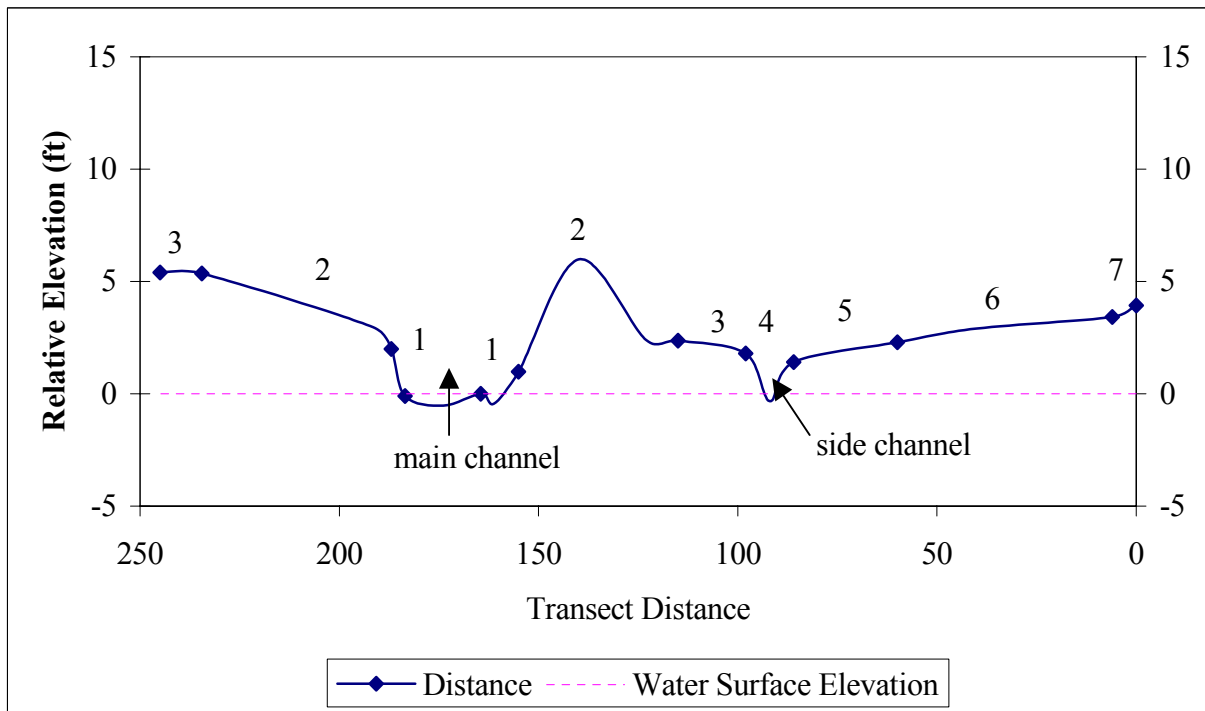
Figure 4.1.7-1. Ice House Dam Reach Site 1: Transect 1. Transect is shown so that the right bank headpin is equal to a distance of 0.0 ft. Water surface elevation extended beyond channel for diagrammatic purposes only.

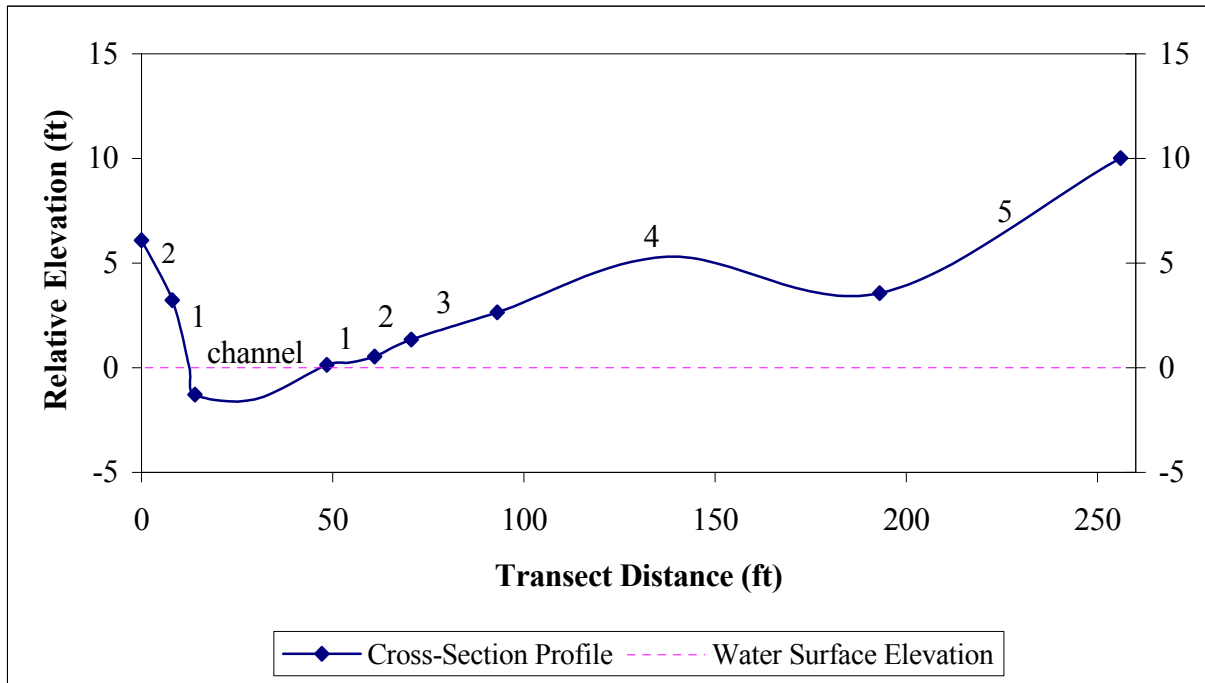
Figure 4.1.7-2. Ice House Dam Reach Site 1: Transect 2. Transect is shown so that the right bank headpin is equal to a distance of 316.0 ft.

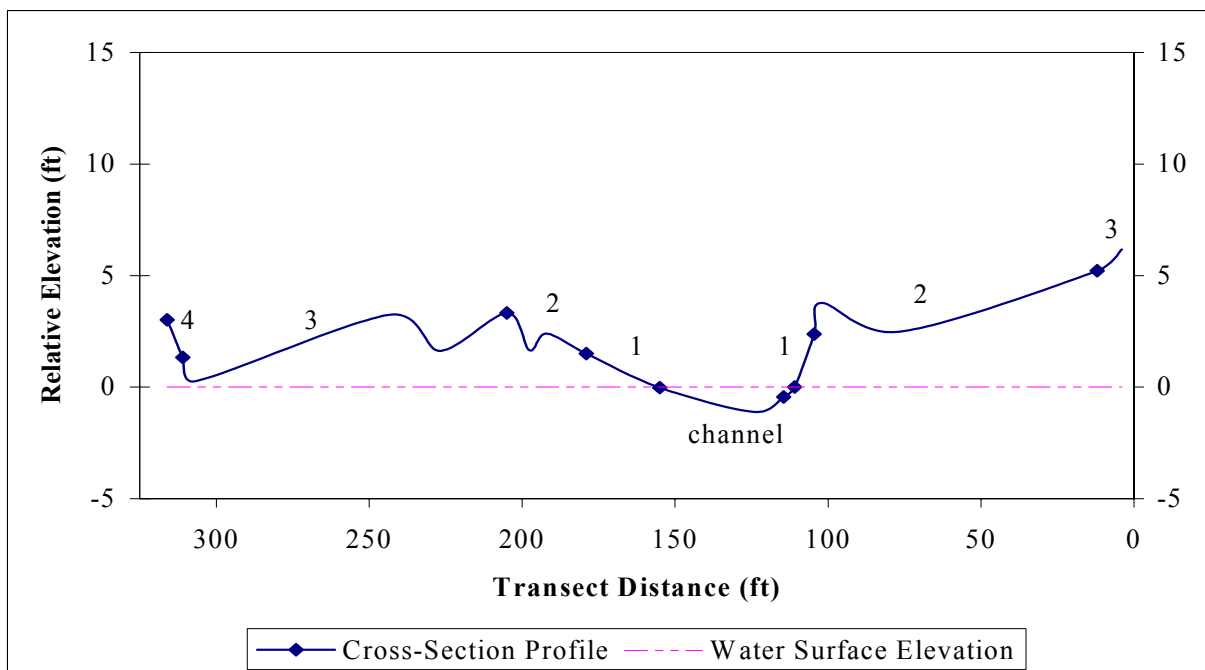
Figure 4.1.7-3. Ice House Dam Reach Site 1: Transect 3. Transect is shown so that the right bank headpin is equal to a distance of 251.0 ft. Water surface elevation extended beyond channel for diagrammatic purposes only.

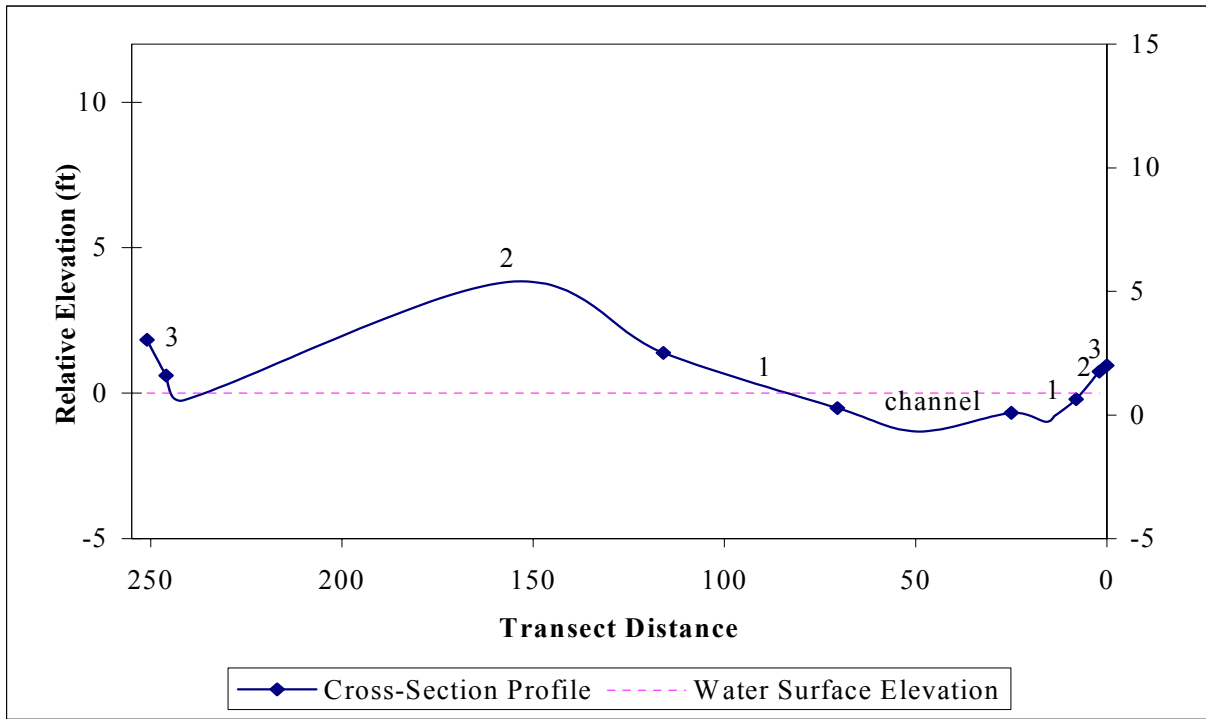
Figure 4.1.7-4. Ice House Dam Reach Site 2: Transect 1. Transect is shown so that the right bank headpin is equal to a distance of 302 ft.

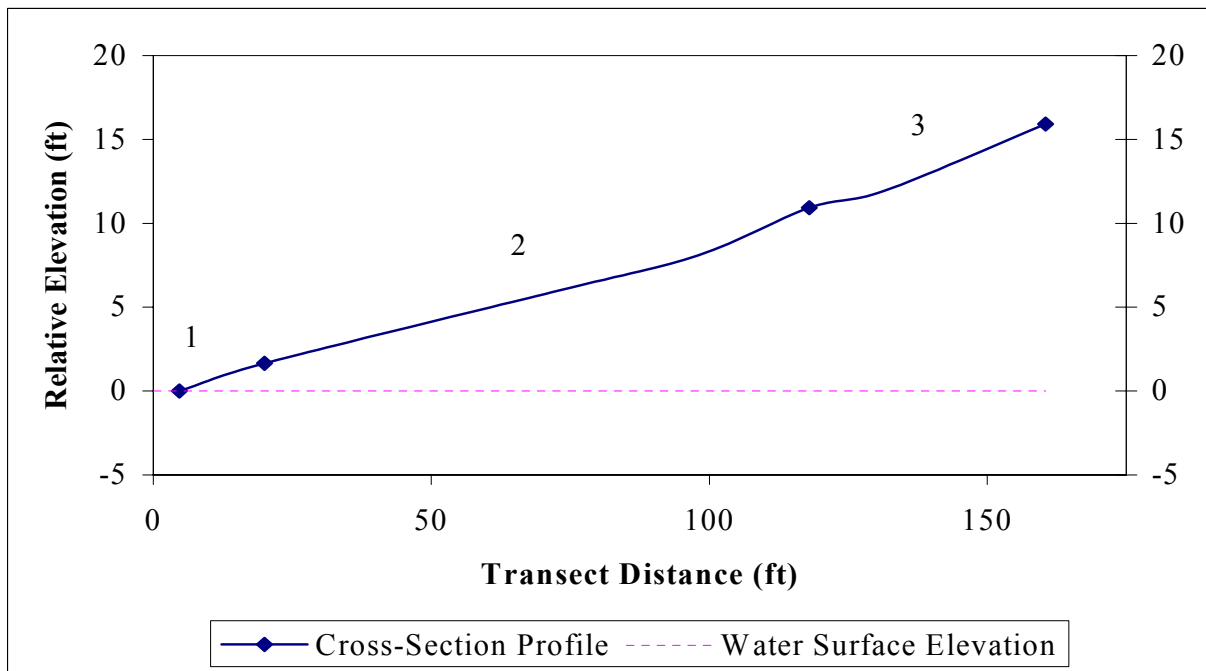
Figure 4.1.12-3. Slab Creek Dam Reach Site 1: Transect 3. Transect is shown so that the right bank headpin is equal to a distance of 155.0 ft. Water surface elevation extended beyond channel for diagrammatic purposes only.

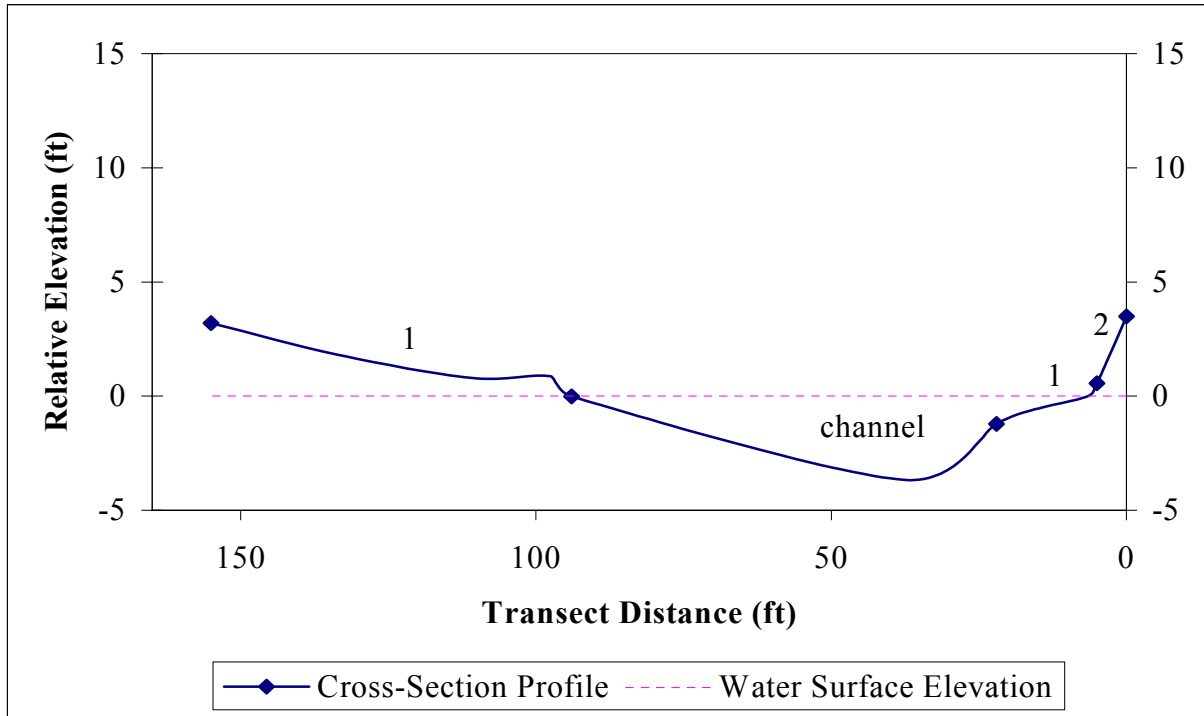
Figure 4.1.12-4. Slab Creek Dam Reach Site 2: Transect 1. Transect is shown so that the right bank headpin is equal to a distance of 0.0 ft.

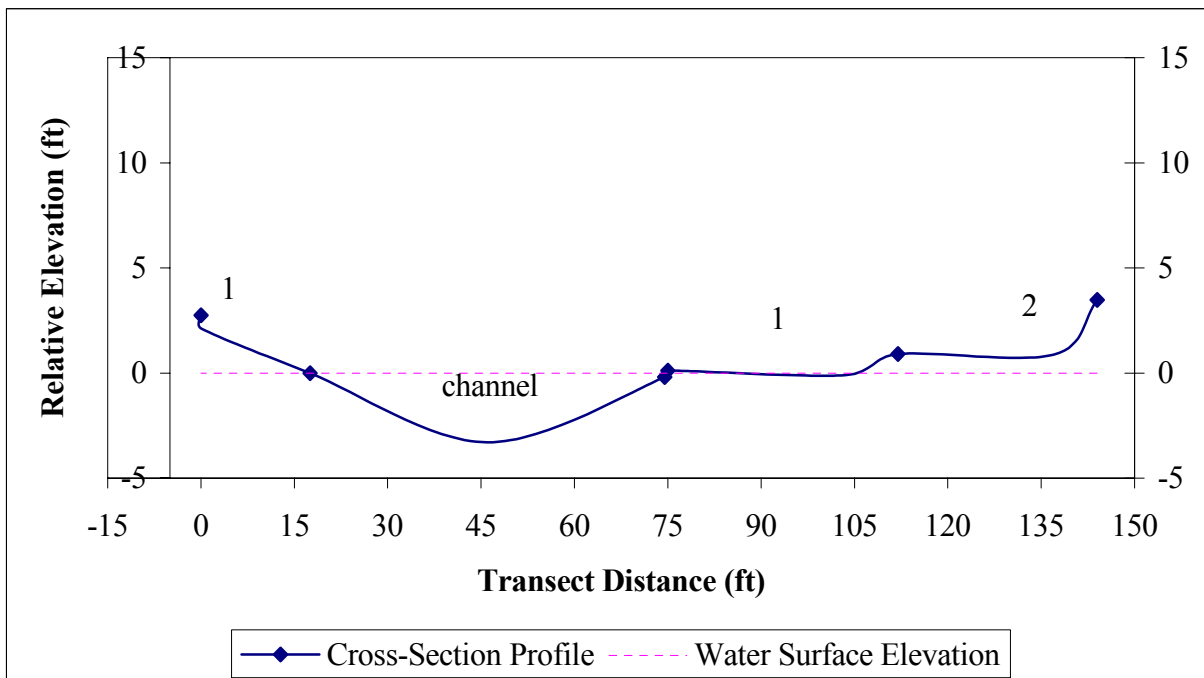
Figure 4.1.12-5. Slab Creek Dam Reach Site 2: Transect 2. Transect is shown so that the right bank headpin is equal to a distance of 0.0 ft. Water surface elevation extended beyond channel for diagrammatic purposes only.

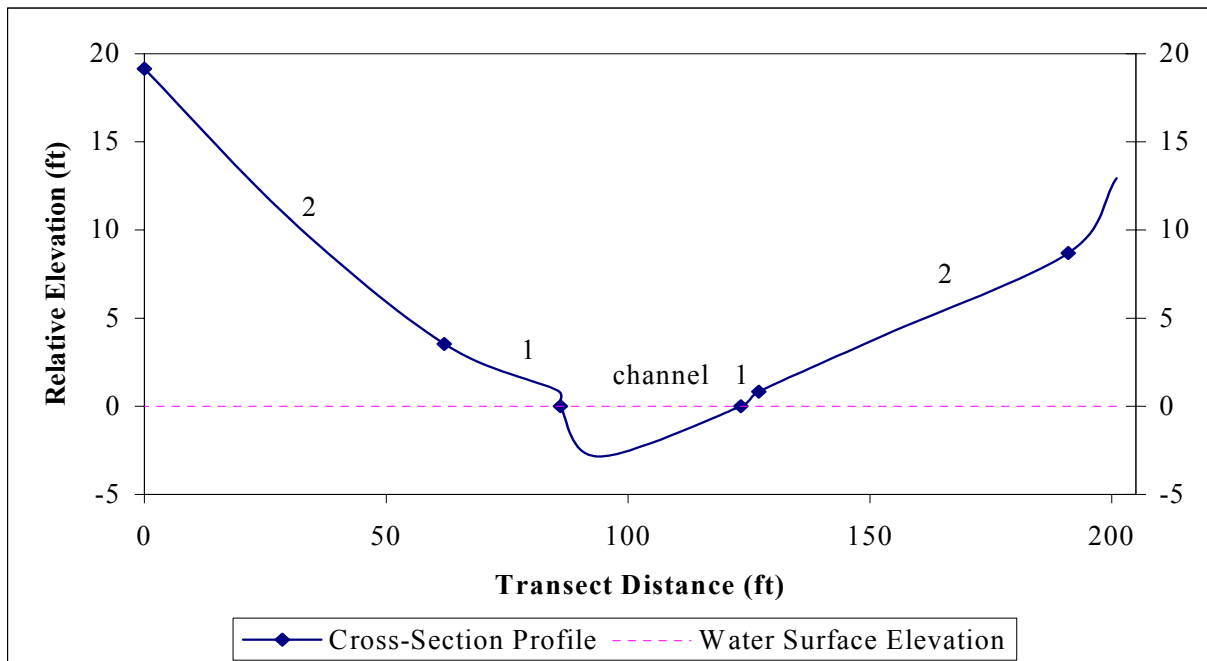
Figure 4.1.12-6. Slab Creek Dam Reach Site 3: Transect 3. Transect is shown so that the right bank headpin is equal to a distance of 0.0 ft.

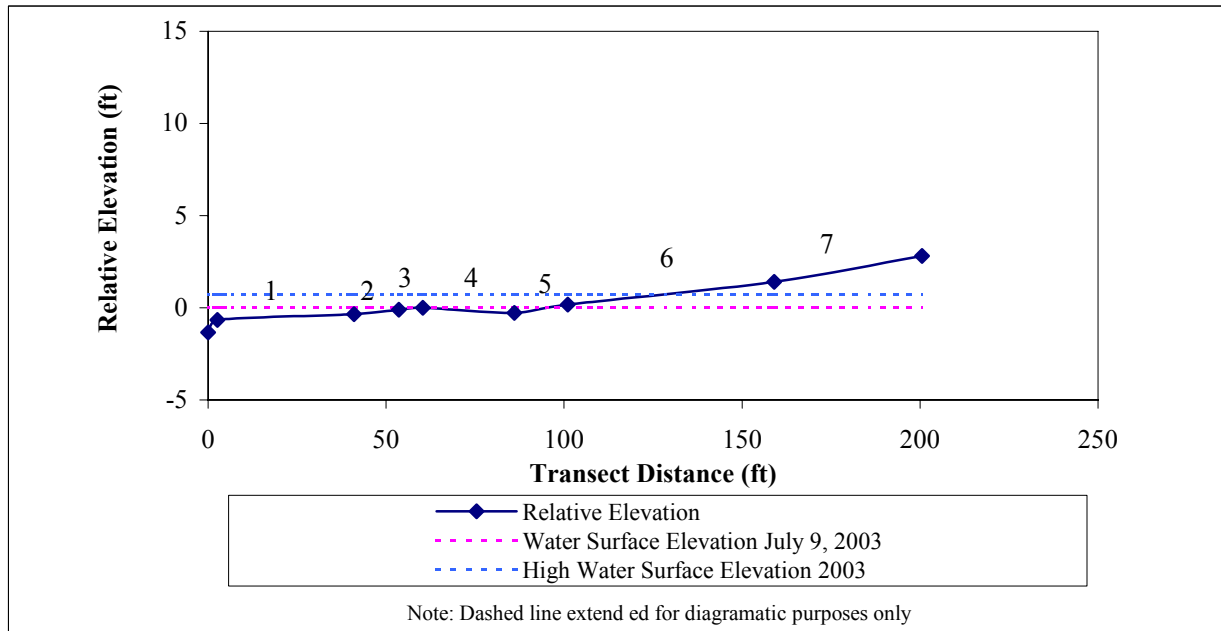
Figure 4.2.1-4. Loon Lake Reservoir Wetland Site 2: Transect 1. Y axis 0 at -1.0 ft water depth.

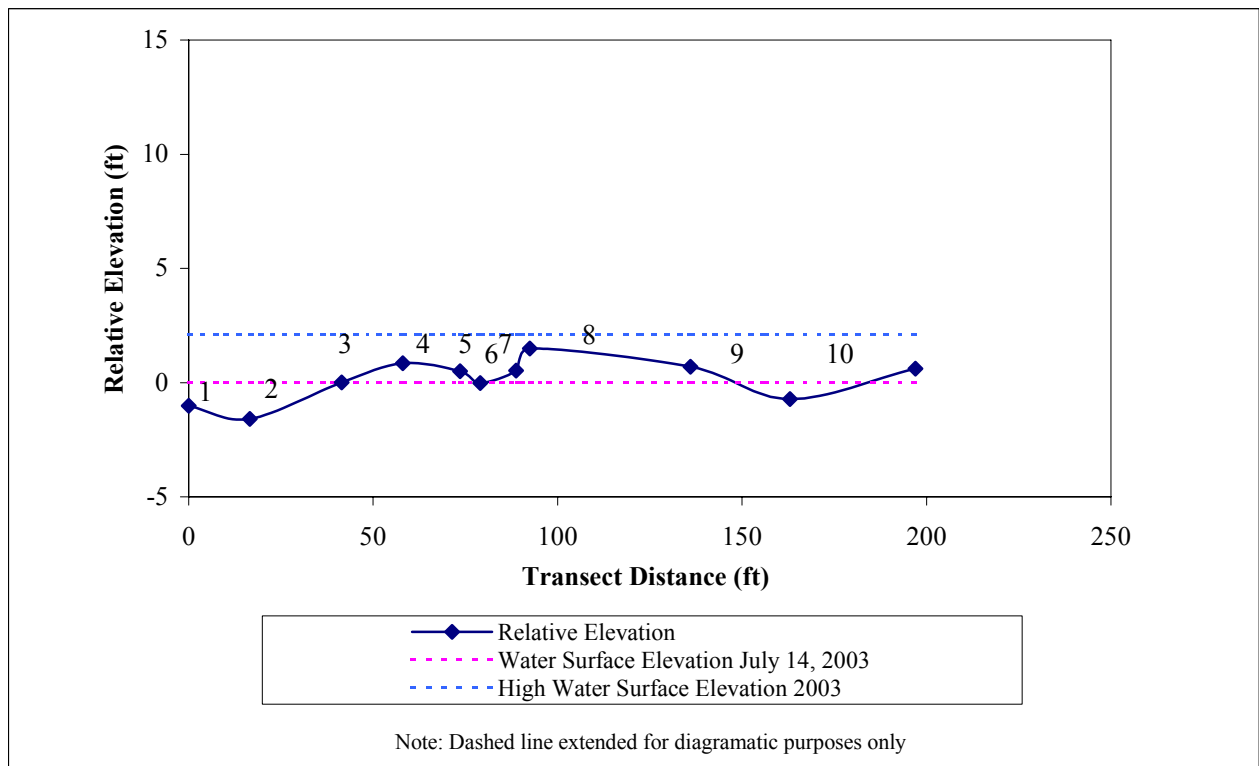
Figure 4.2.1-5. Loon Lake Reservoir Wetland Site 2: Transect 2. Y axis 0 at -1.0 ft water depth.

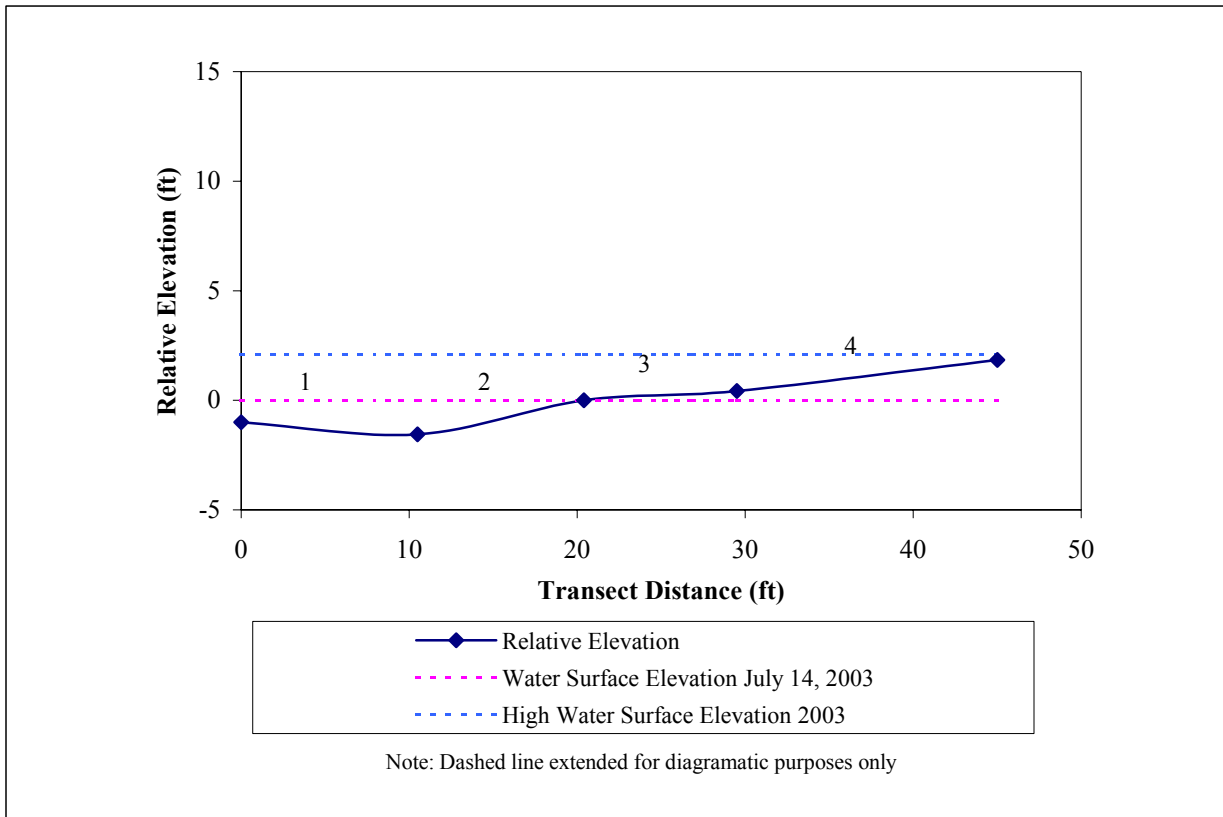
Figure 4.2.1-6. Loon Lake Reservoir Wetland Site 4. Y axis 0 at -0.4 ft water depth.

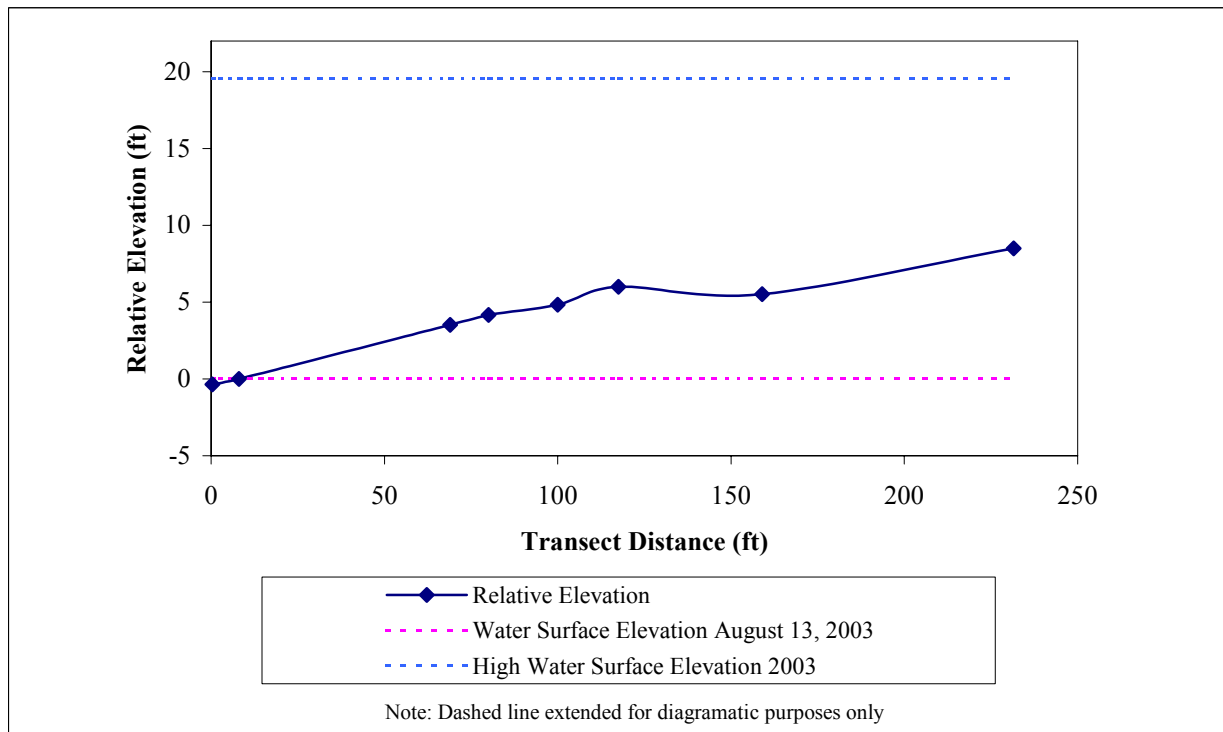
Figure 4.2.2-3. Gerle Creek Reservoir Wetland Site 1. Y axis 0 at -1.3 ft water depth.

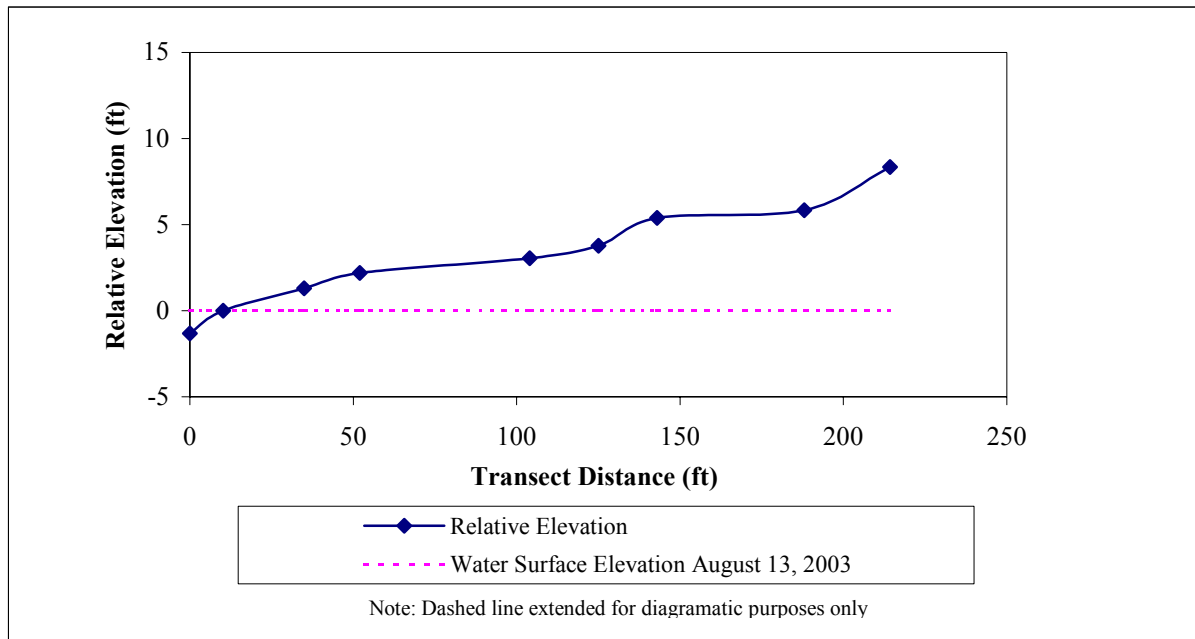
Figure 4.2.2-4. Gerle Creek Wetland Site 2. Y axis 0 at 0 ft water depth.

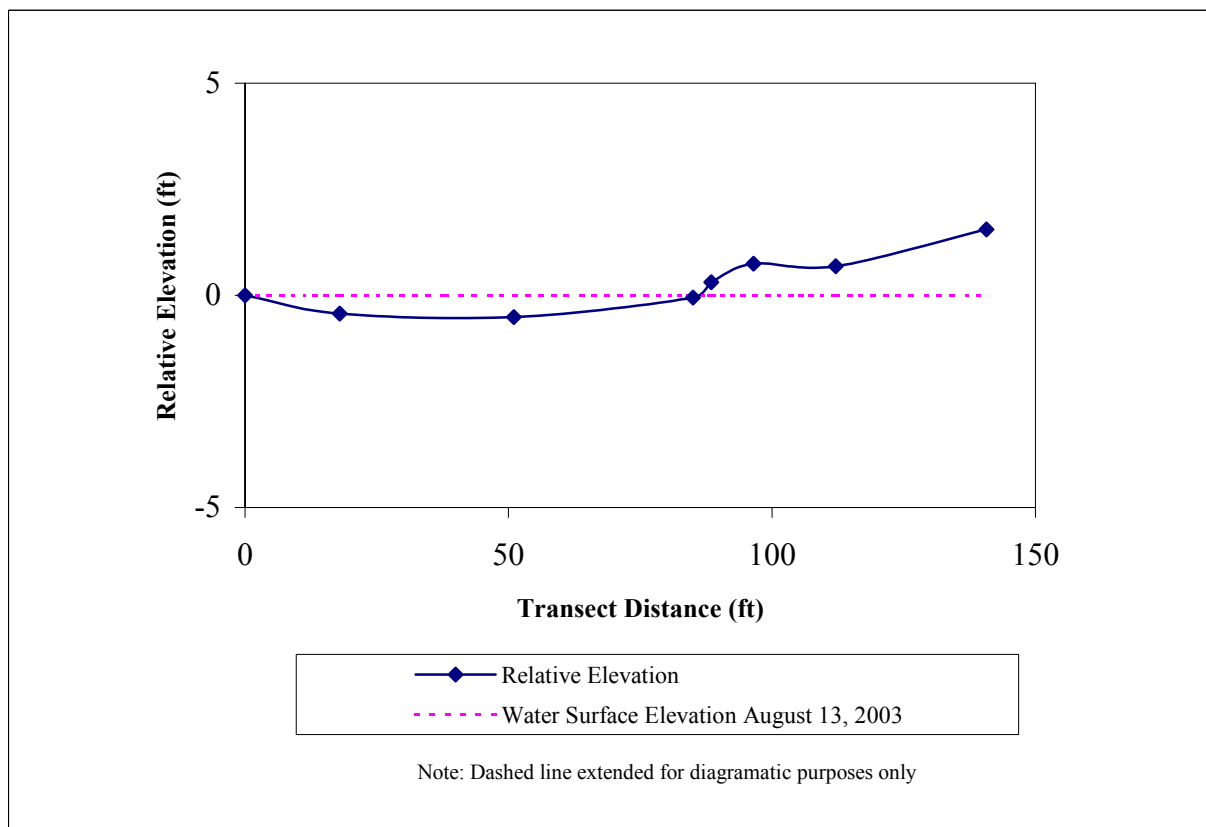
Figure 4.2.4-3. Union Valley Reservoir Wetland Site 1. Y axis 0 at 0.0 ft water depth.

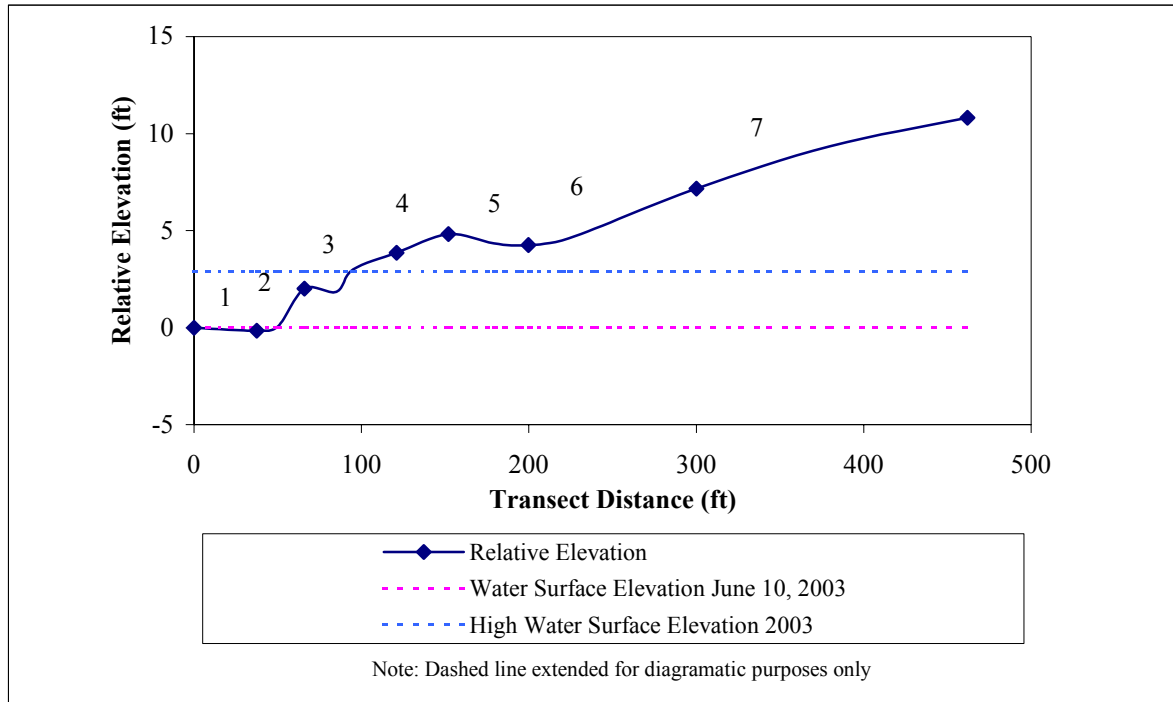
Figure 4.2.4-4. Union Valley Reservoir Wetland Site 2. Y axis 0 at 0 ft water depth.

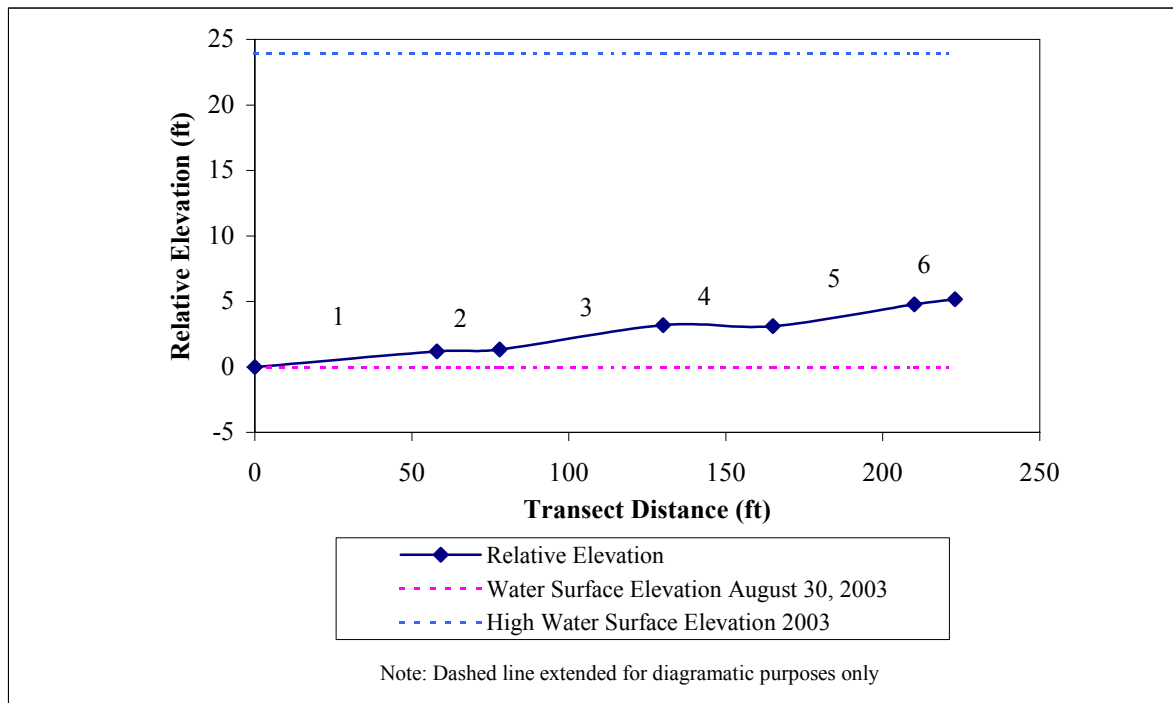
Figure 4.2.4-5. Union Valley Reservoir Wetland Site 3. Y axis 0 at 0 ft water depth.

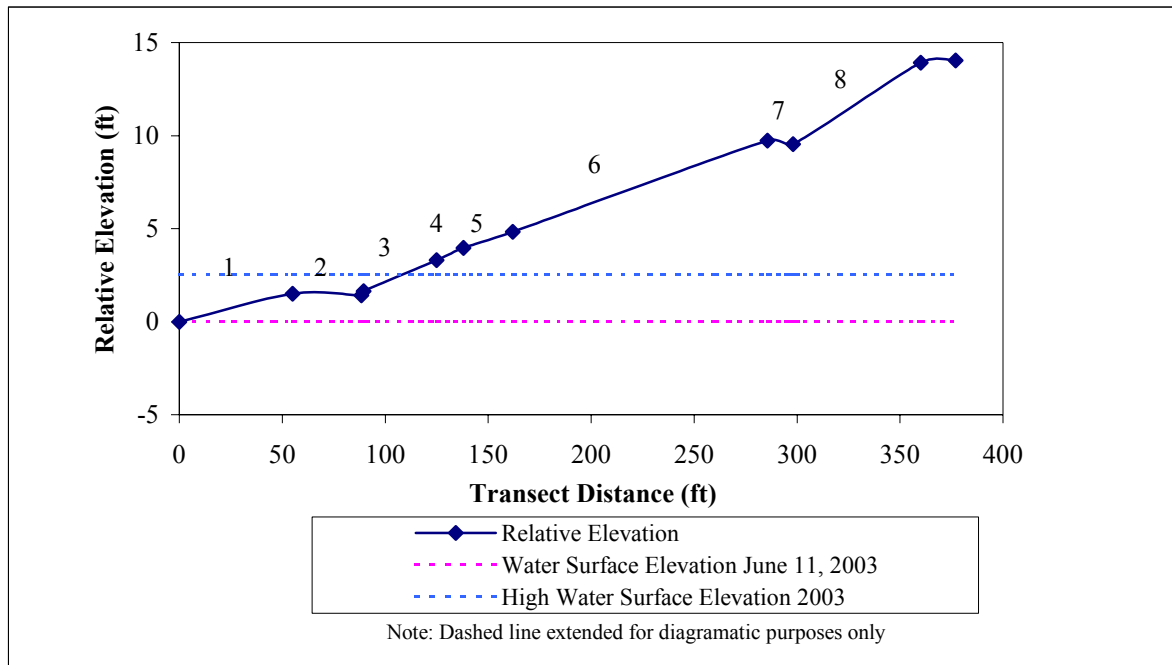
Figure 4.2.4-6. Union Valley Reservoir Wetland Site 4. Y axis 0 at 0 ft water depth.

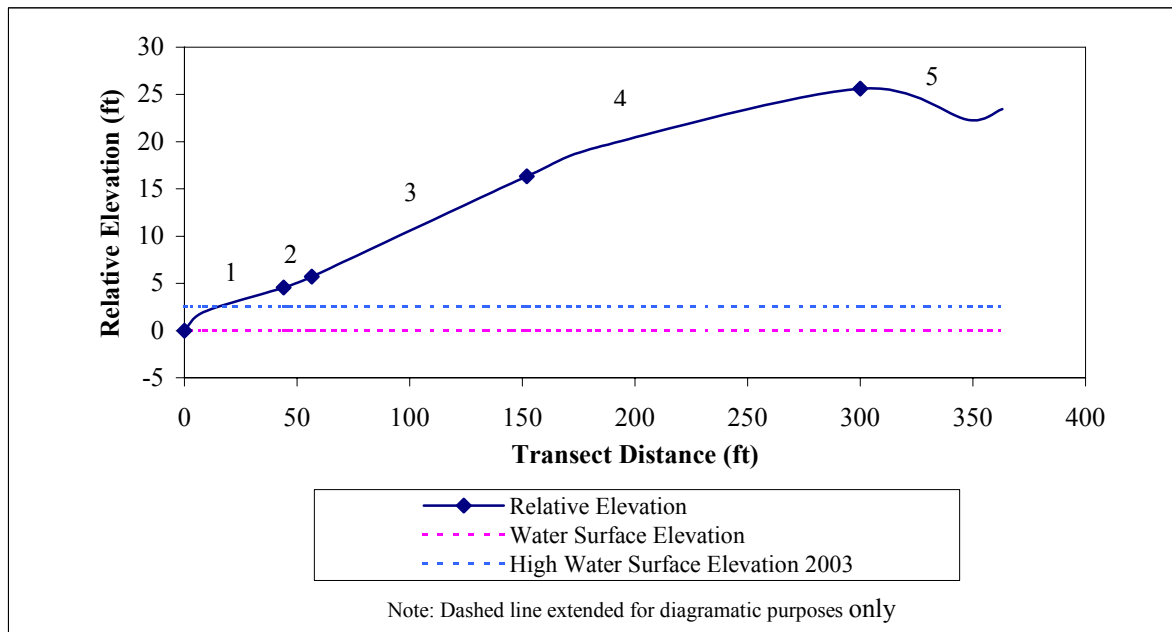
Figure 4.2.4-7. Union Valley Reservoir Wetland 5: Transect 1. Y axis 0 at -1.3 ft water depth.

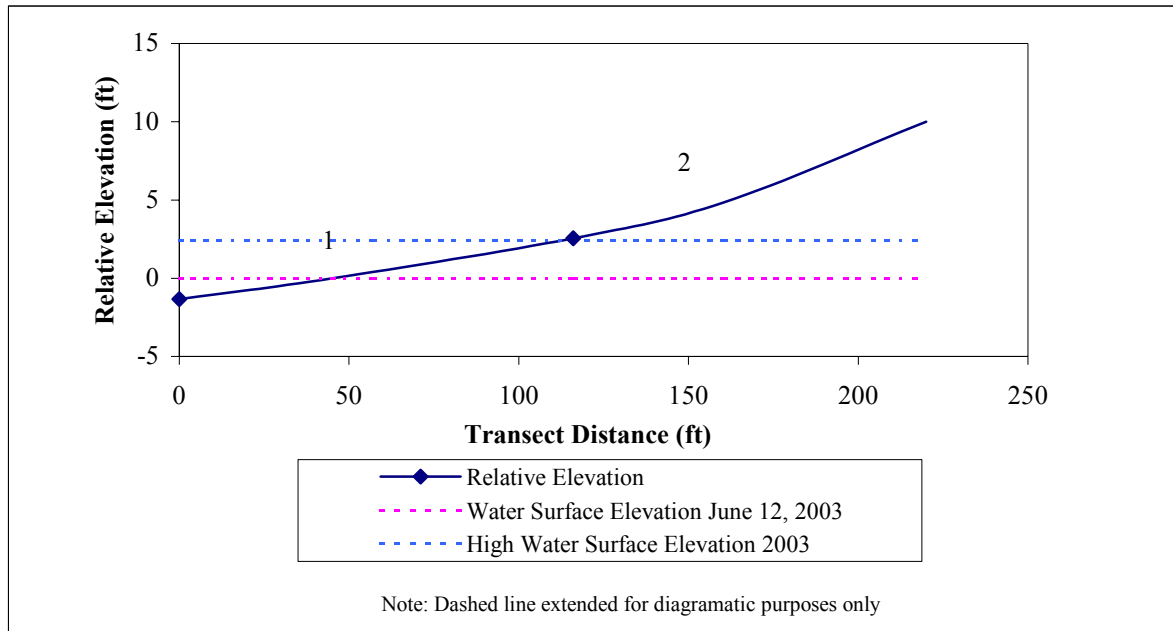
Figure 4.2.4-8. Union Valley Reservoir Wetland 5: Transect 2. Y axis 0 at -1.2 ft water depth.

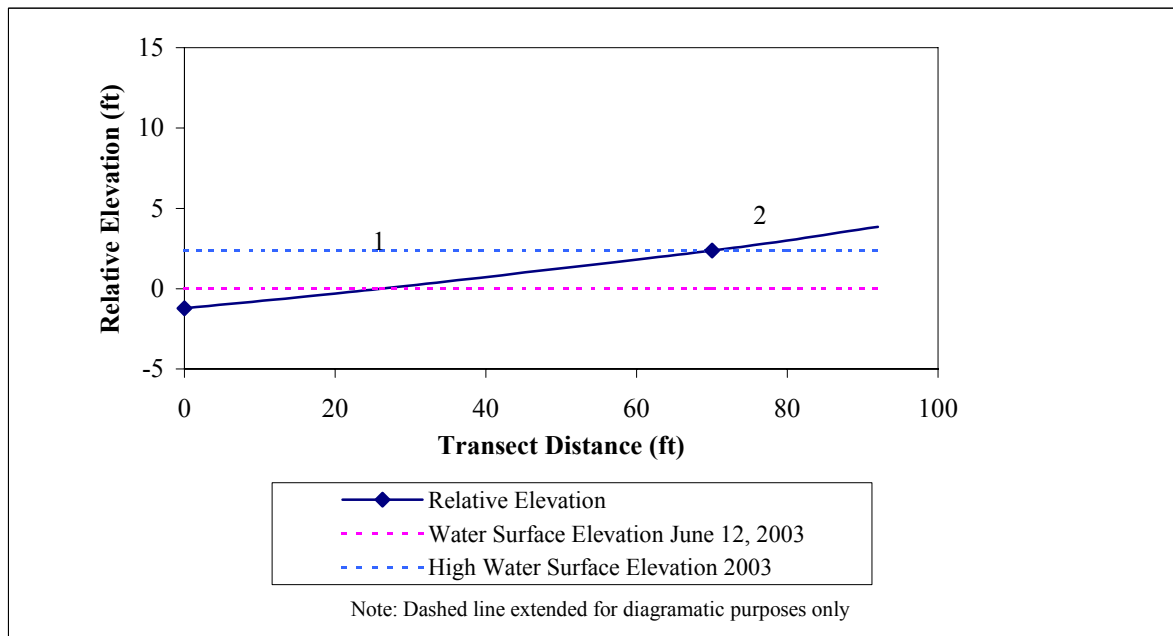
Figure 4.2.4-9. Union Valley Reservoir Wetland 6: Transect 1. Y axis 0 at -1.2 ft water depth.

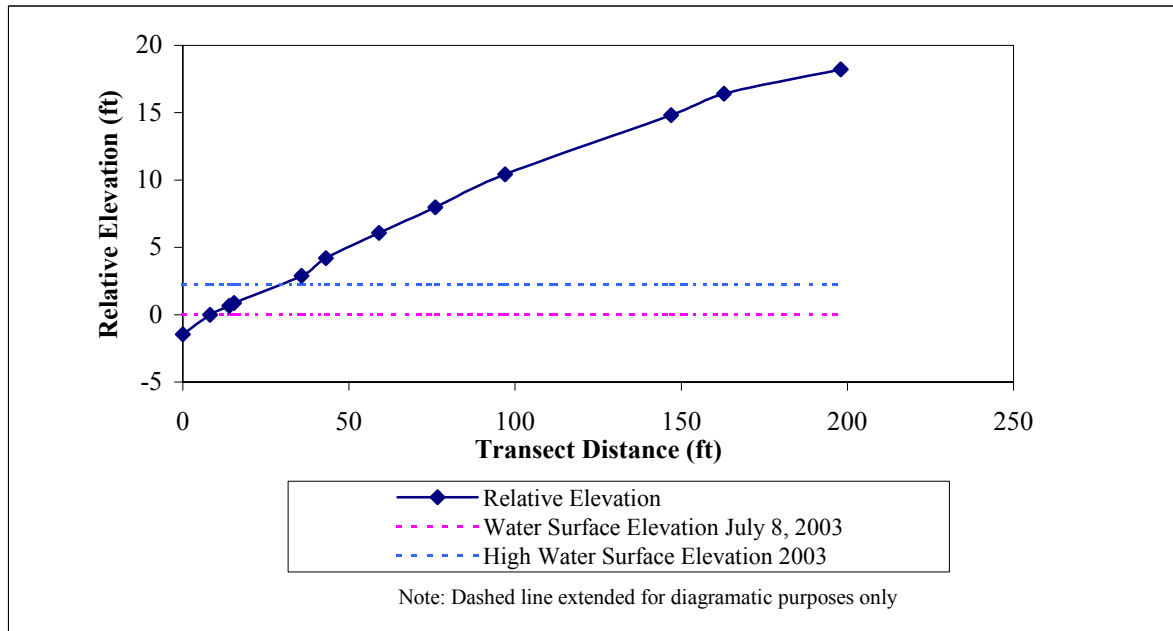
Figure 4.2.4-10. Union Valley Reservoir Wetland 6: Transect 3. Y axis 0 at -0.8 ft water depth.

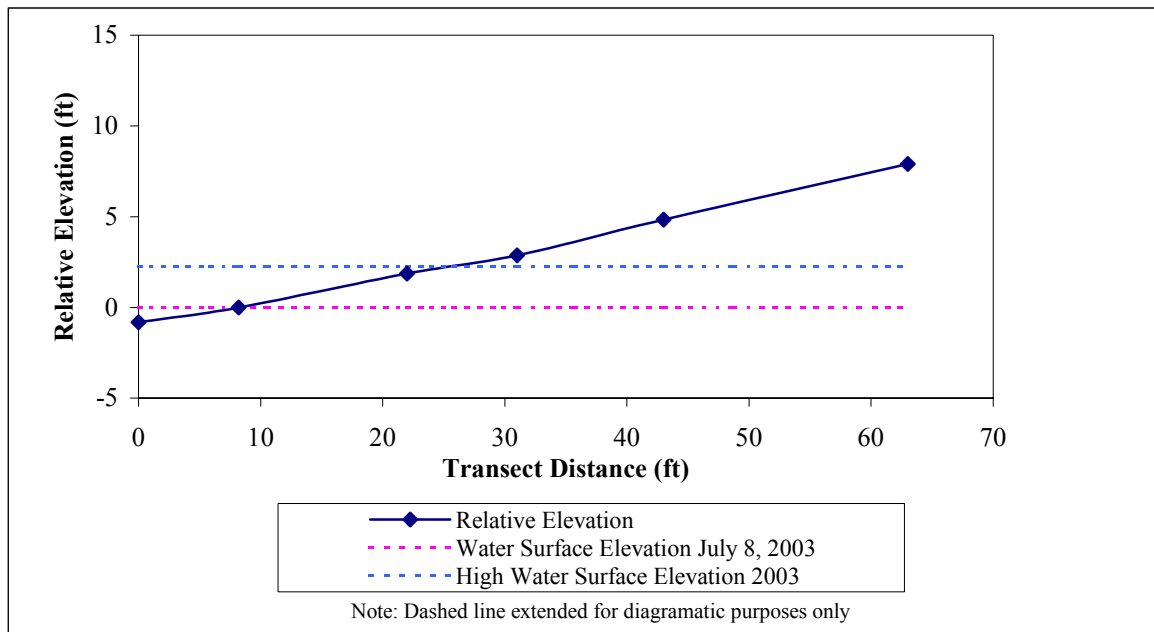
Figure 4.2.4-11. Union Valley Reservoir Site 10: Transect 1. Y axis 0 at -0.9 ft water depth.

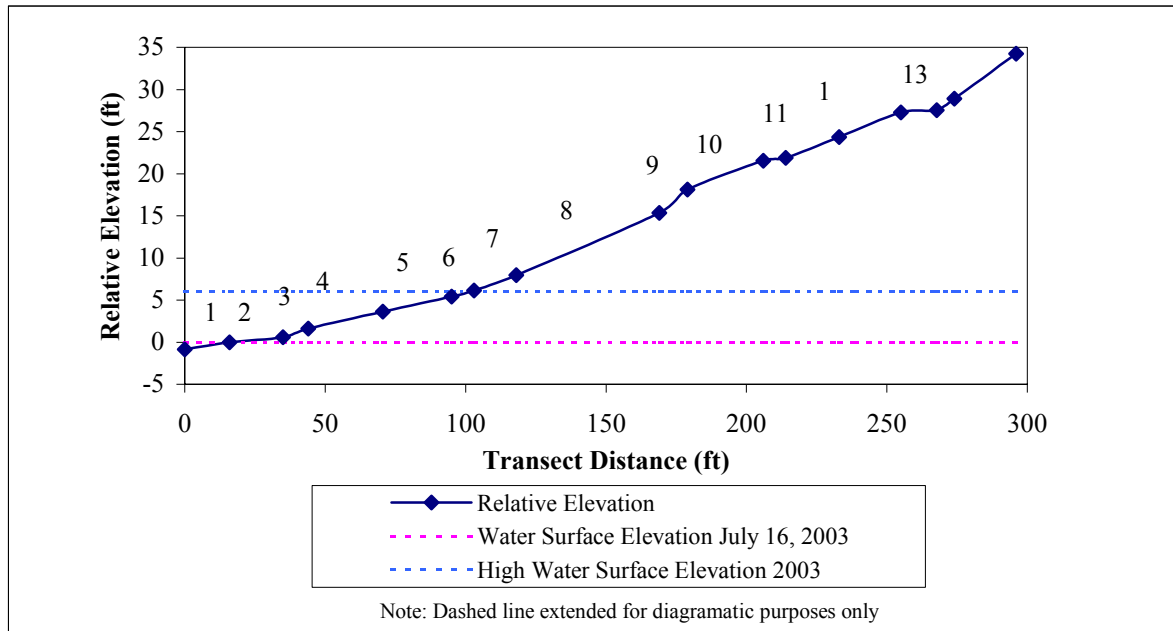
Figure 4.2.4-12. Union Valley Reservoir Wetland 10: Transect 2. Y axis 0 at -0.5 ft water depth.

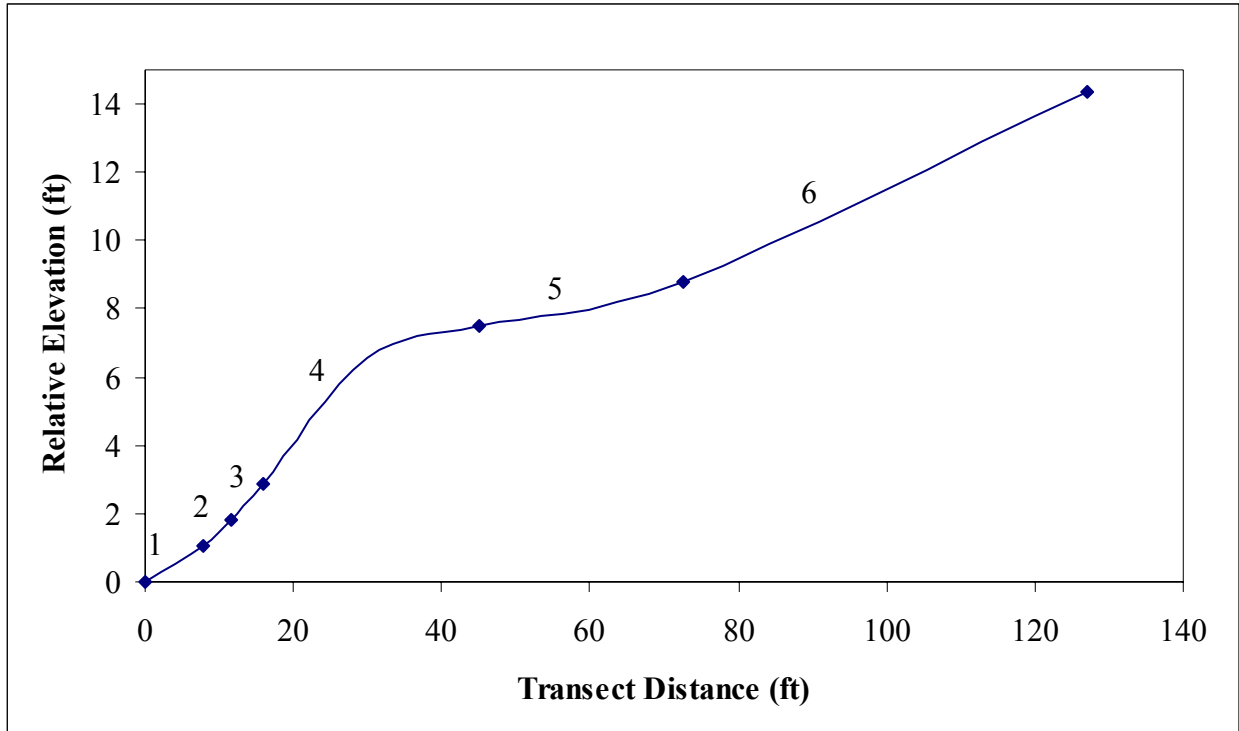
Figure 4.1.13-4. Reach Downstream of Chili Bar-Coloma Sub-Reach-Clark Creek Site: Transect 2. Transect is shown so that the right bank headpin is equal to a distance of 0.0 ft.
