**SACRAMENTO MUNICIPAL UTILITY DISTRICT
UPPER AMERICAN RIVER PROJECT
(FERC Project No. 2101)**

**PACIFIC GAS AND ELECTRIC COMPANY
CHILI BAR PROJECT
(FERC Project No. 2155)**

**RIPARIAN VEGETATION AND WETLANDS
TECHNICAL REPORT**

OCTOBER 2004

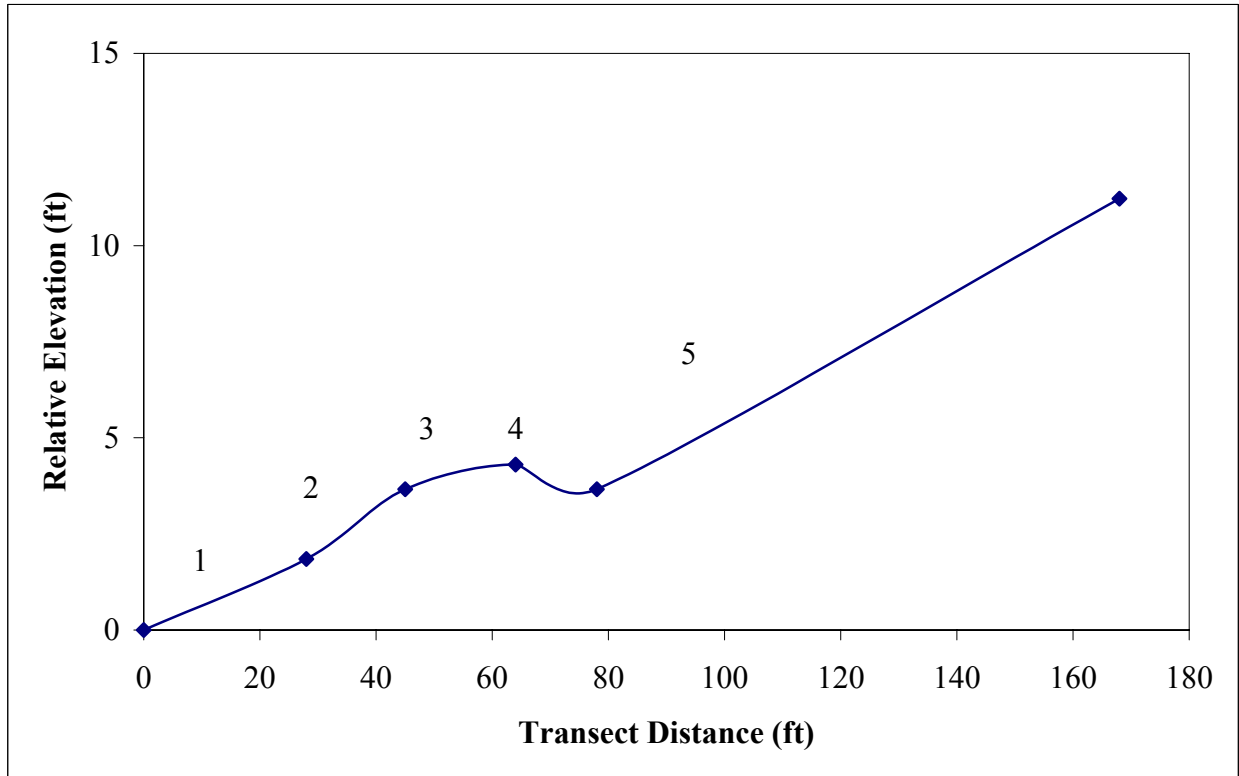
Figure 4.1.13-5. Reach Downstream of Chili Bar-Coloma Sub-Reach-Clark Creek Site: Transect 3.
Transect is shown so that the right bank headpin is equal to a distance of 0.0 ft.

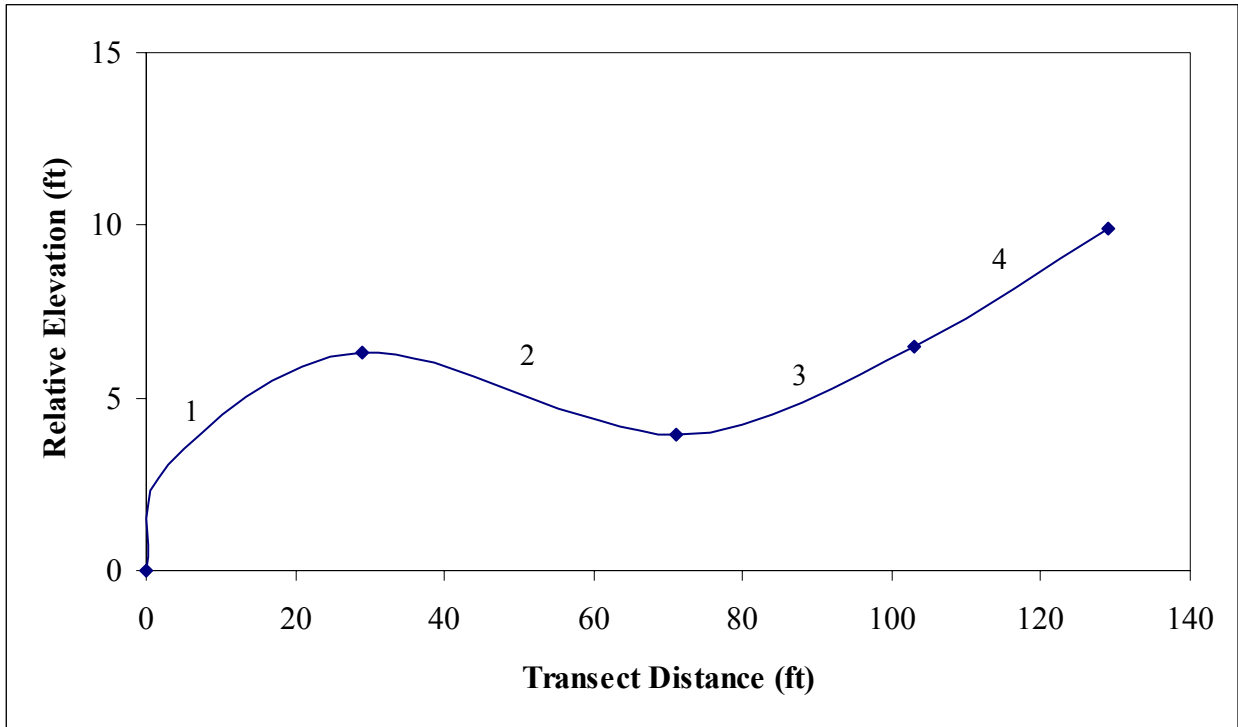
Figure 4.1.13-6. Reach Downstream of Chili Bar-Coloma Sub-Reach-Hastings Creek. Transect is shown so that the right bank headpin is equal to a distance of 0.0 ft.

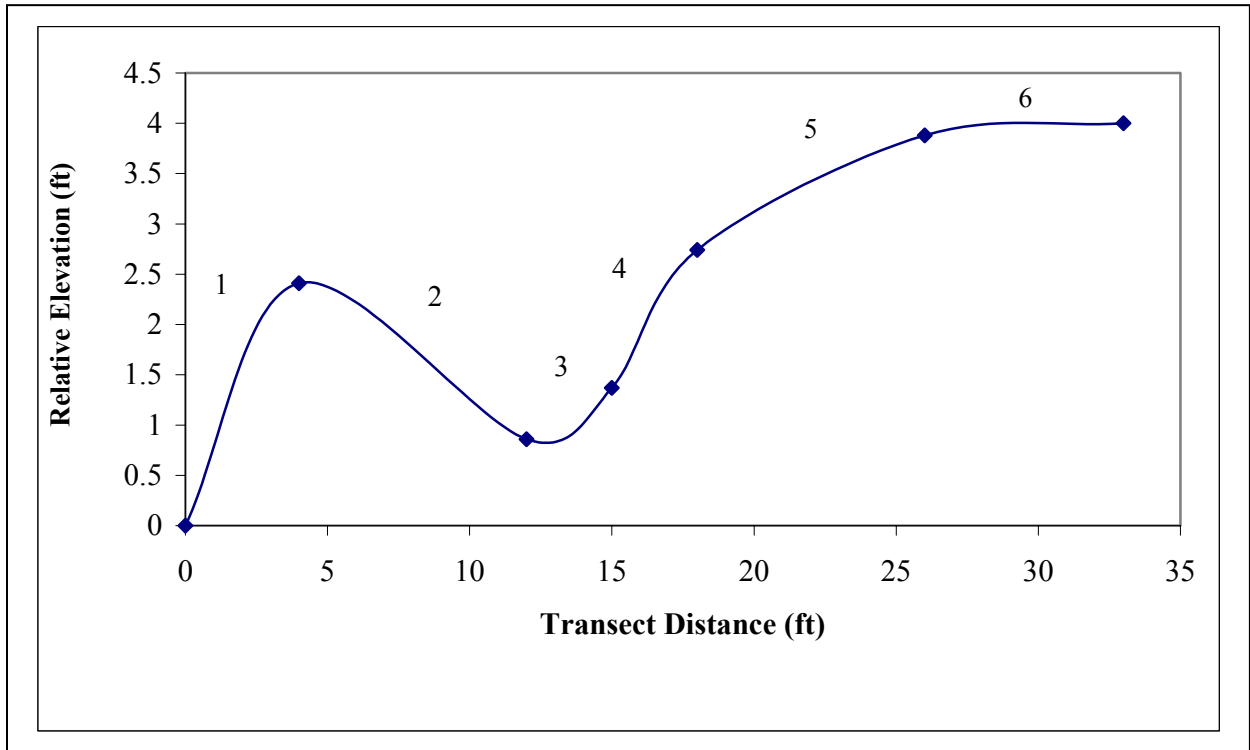
Figure 4.1.13-7. Reach Downstream of Chili Bar-Upper Canyon Sub-Reach: Transect 1. Transect is shown so that the left bank headpin is equal to a distance of 0.0 ft.
