# Monitoring Program 2023 Final Annual Report Sacramento Municipal Utility District

Hydro License Implementation • June 2024

Upper American River Project

FERC Project No. 2101

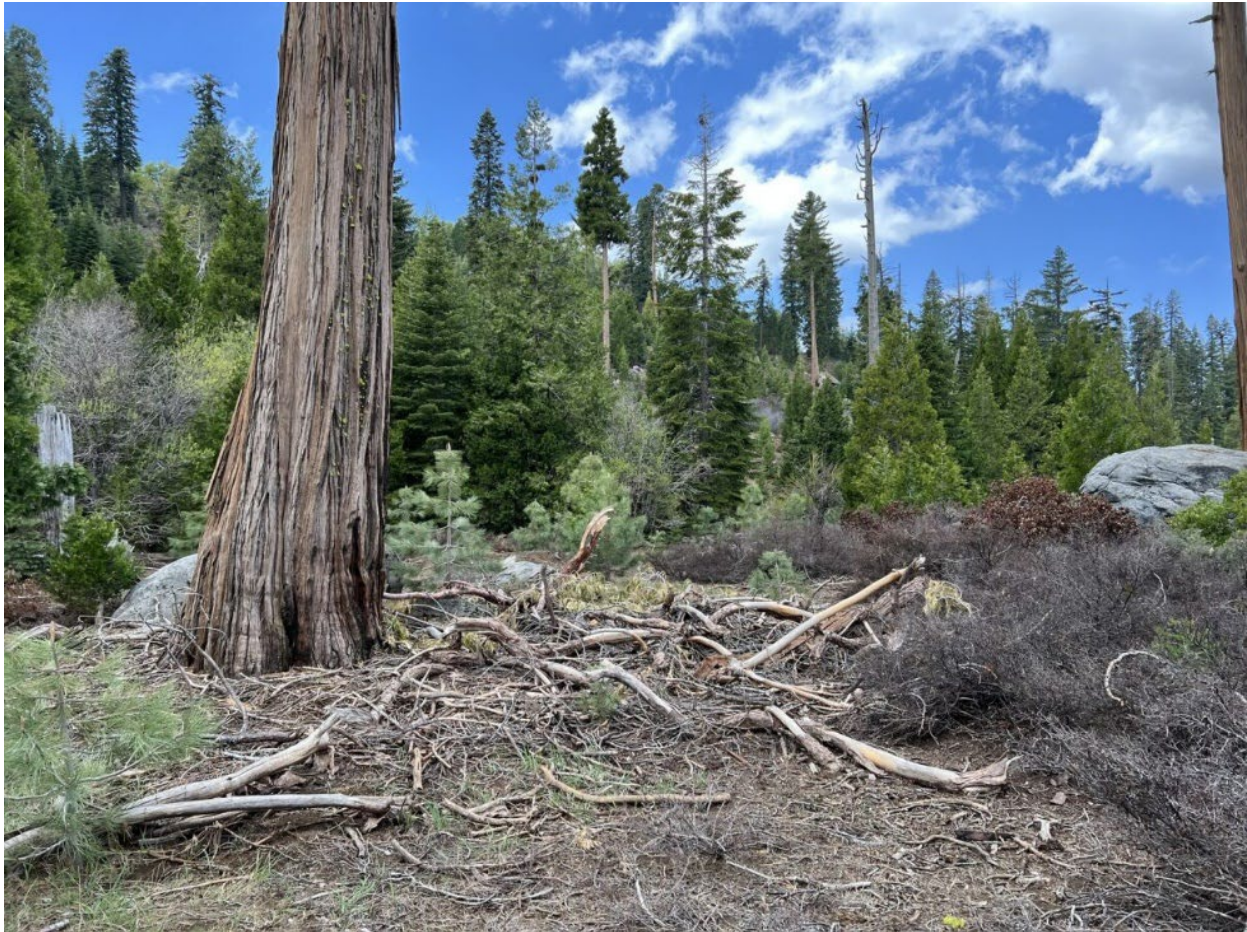
**Figure 2-6. Remnant nest material and pieces of supporting limb at base of nest tree on Ice House Reservoir, May 2023.**

Bald eagles continue to use the habitat surrounding Ice House Reservoir, although they did not successfully reproduce at this location in 2023 (Section 2.3.2). Severe weather may have been an influential factor, and the damage to the nest and supporting branches described in Section 2.3.2 is likely attributable to inclement conditions. Snowpack in the area (as recorded daily by water content) at Robbs Peak Powerhouse, approximately 4 miles north of Ice House Reservoir, increased gradually from 5 to 13 inches through January and most of February, then rapidly accumulated to a peak of 27 inches during a series of storms in late February and March (DWR 2023b, Station ID: RBP). In mid-March, about a week before the early breeding season survey when damage to the nest tree was noted, peak wind speed at Big Hill, approximately 2.5 miles west of Ice House Reservoir, reached 60 miles per hour. The entire surface of Ice House Reservoir was frozen and covered with snow through mid-April, and sections of the reservoir remained in this condition into early May with minimum air temperatures regularly dropping below freezing (DWR 2023b, Station ID: BHS). Snowpack (as recorded monthly by water content) at Ice House Reservoir did not dissipate entirely until early June (DWR 2023b, Station ID: IHS). Reservoir levels, which ranged from 5,416 to 5,446 above mean sea level during the breeding season (DWR 2023b, Station ID: ICH), were favorable for bald eagle foraging once the water surface was free of ice and snow.

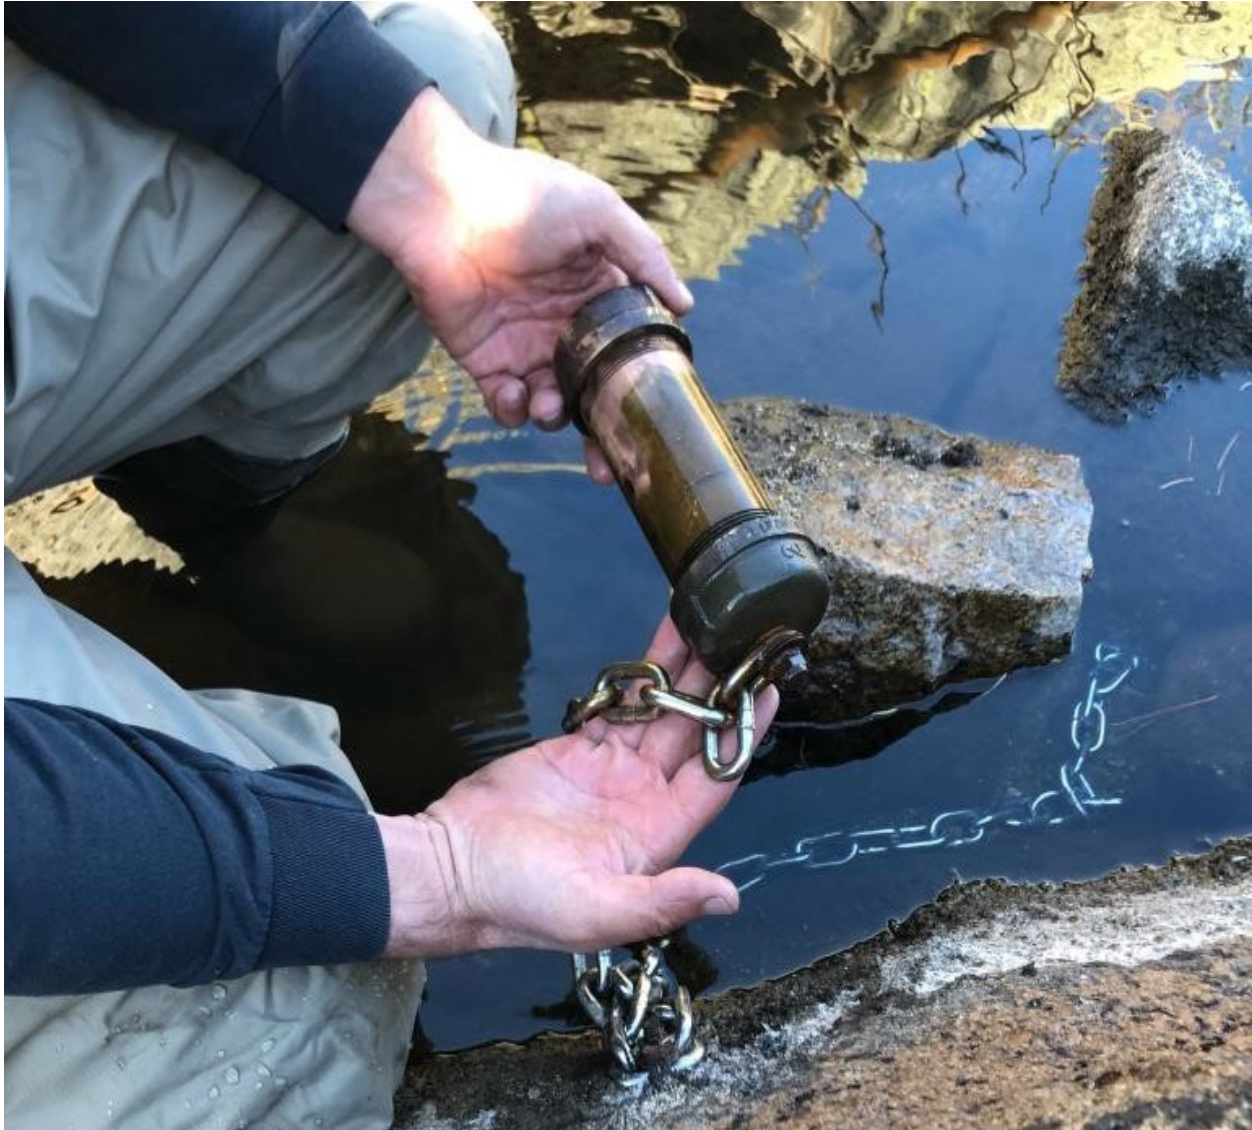
**Figure 6-1. Water temperature datalogger housing, Rubicon River below confluence of Little Rubicon River.**

Each housing was secured to large boulders or bedrock using hardened 3/8-inch chain and placed to ensure that the sensor remained submerged and was not exposed to direct sunlight (Figure 6-1). Two dataloggers were installed at each site to protect against data loss in the event of equipment failure or drift. Dataloggers were deployed in habitat strata where the water was well mixed, typically at the head of a pool just below a riffle input. Table 6-2 describes the equipment specifications for all sensors selected for water temperature monitoring.

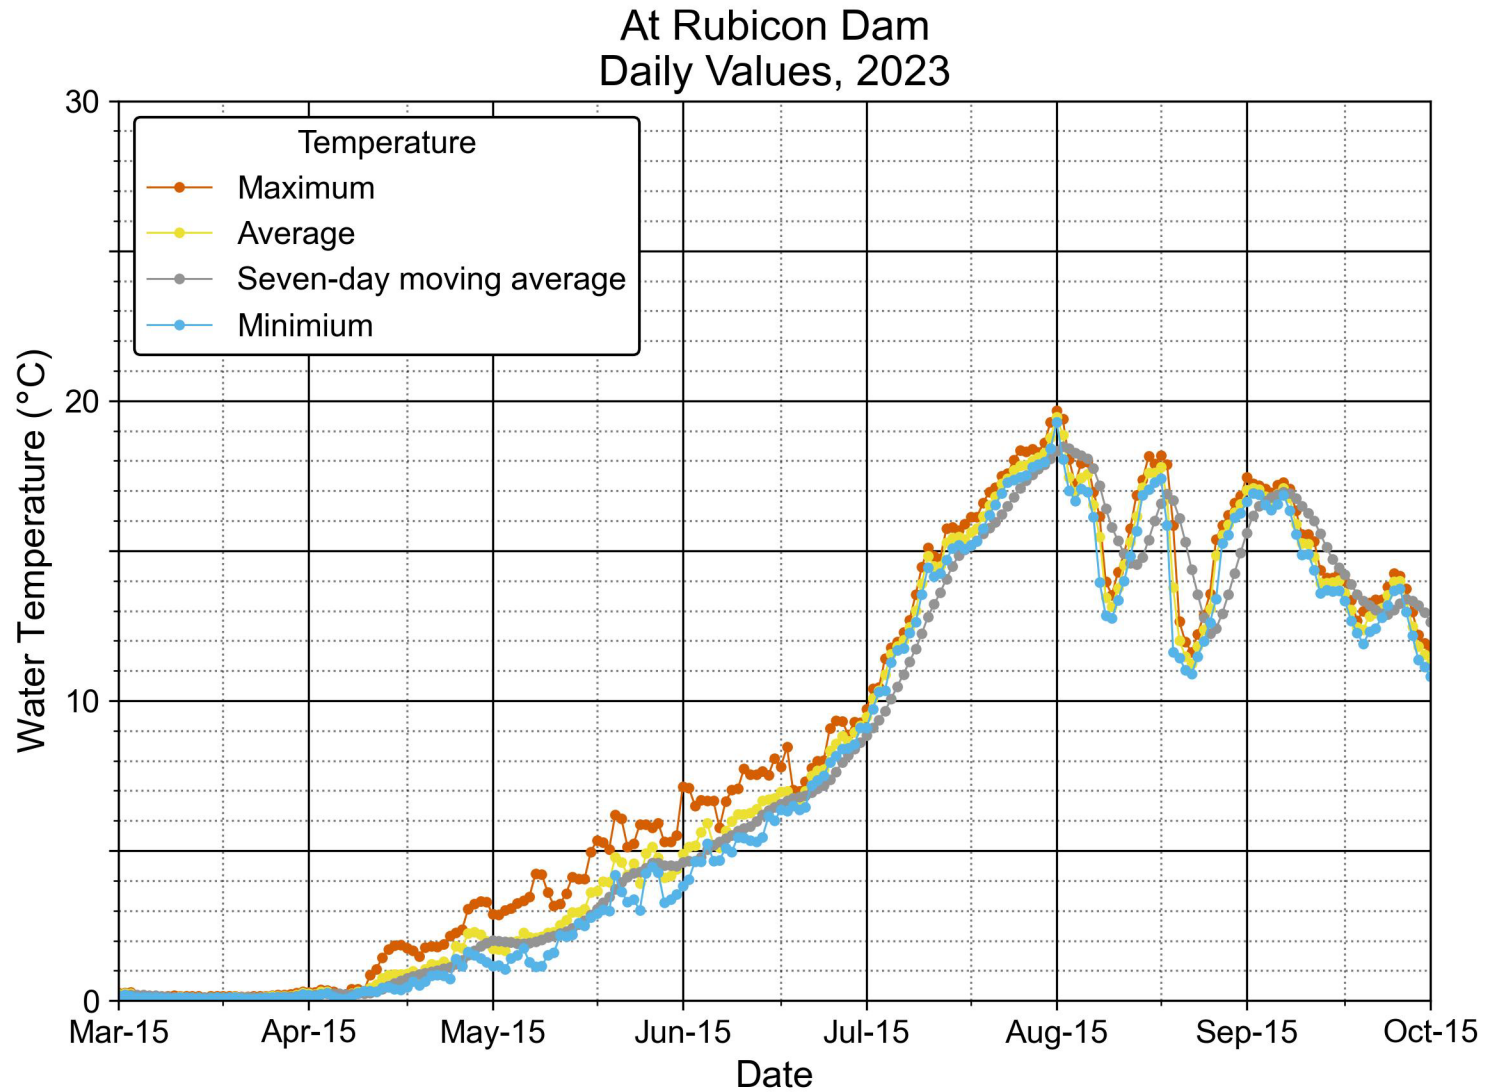
**Figure D-1. Rubicon River immediately below Rubicon Reservoir Dam (Site RR5).**

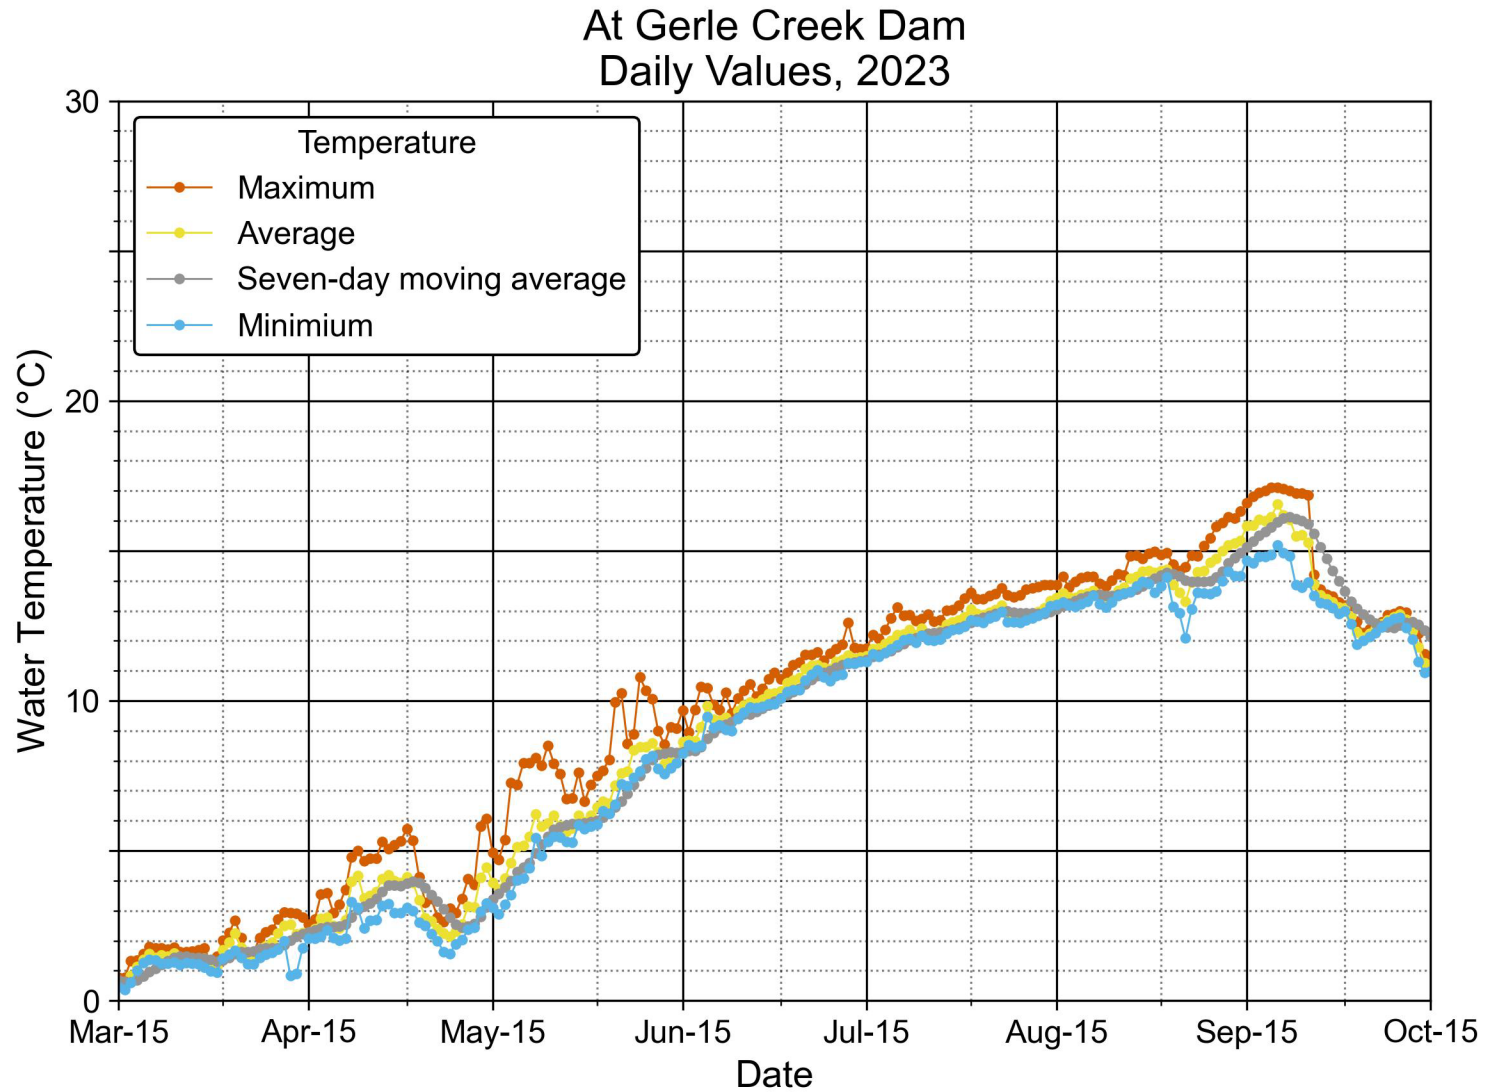
**Figure D-5. Gerle Creek immediately below Gerle Creek Reservoir Dam (Site GC8).**

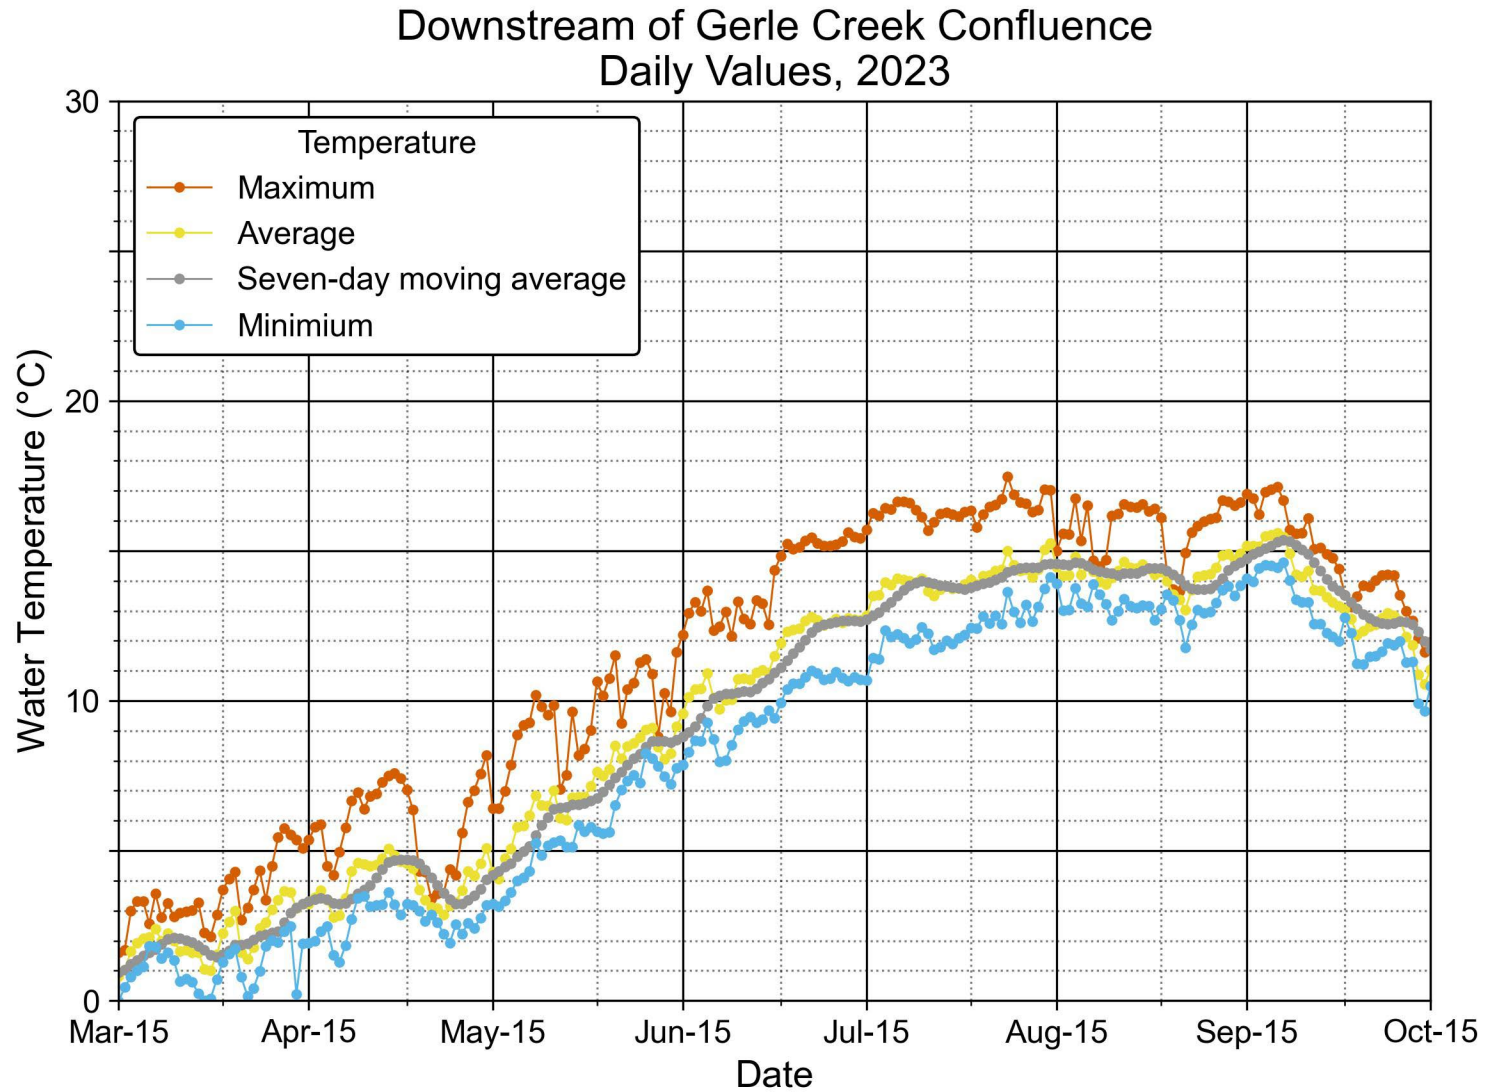
**Figure D-7. South Fork Rubicon River below confluence of Gerle Creek (Site SFRR6).**

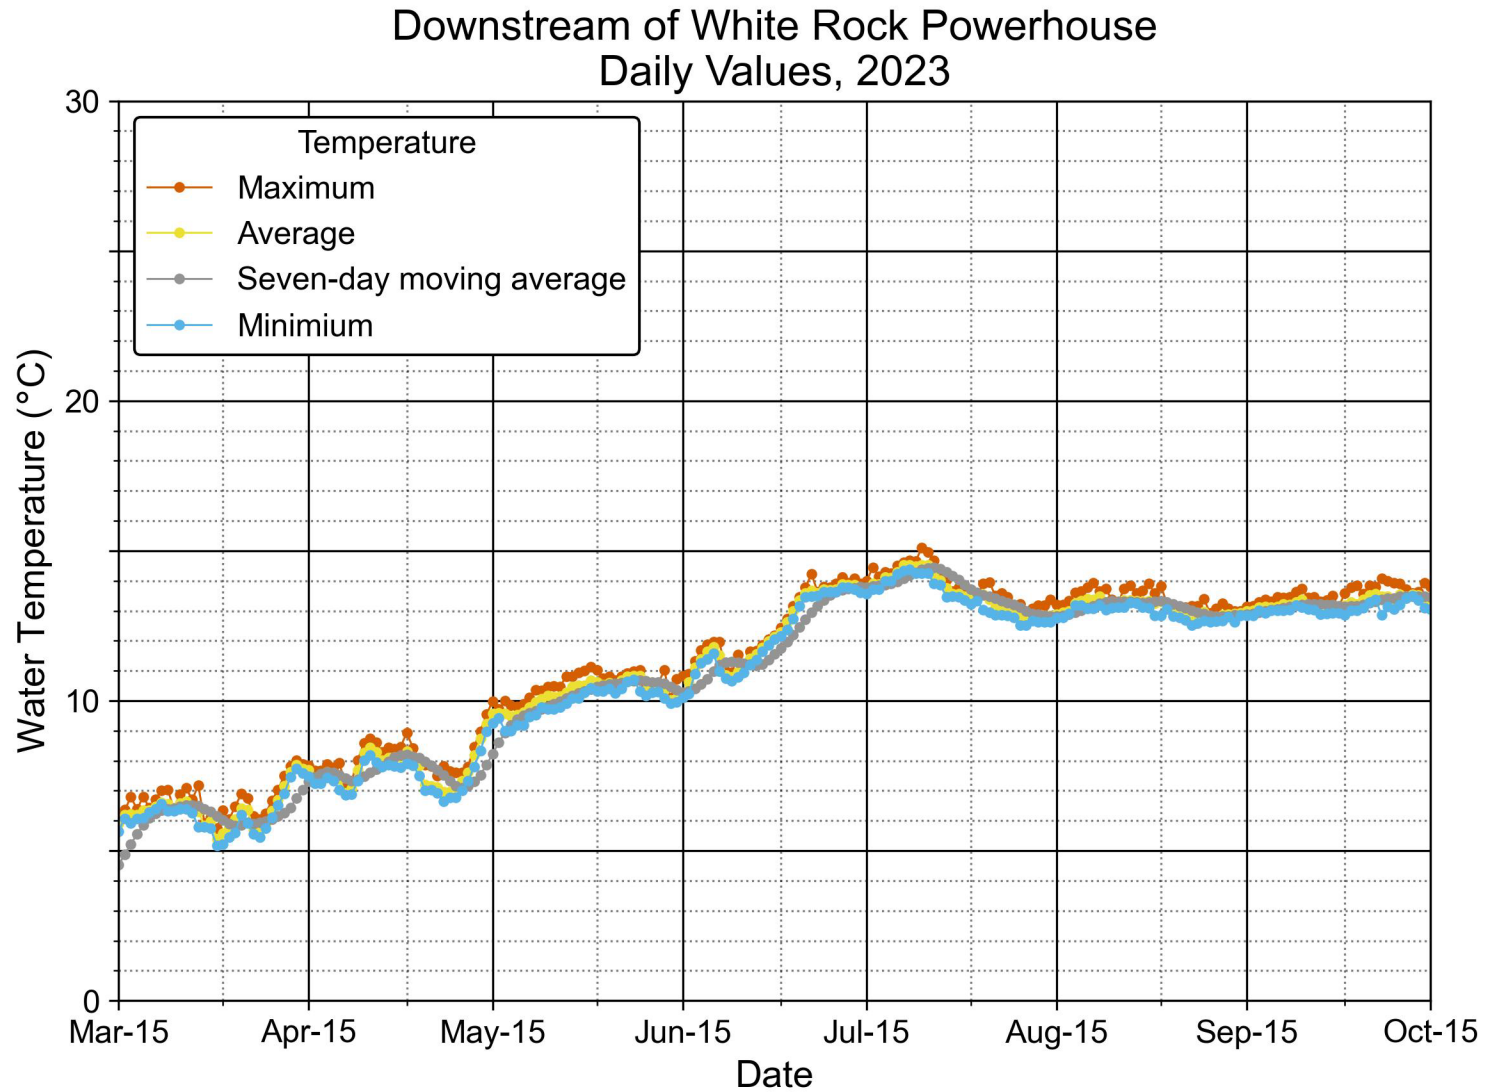
**Figure D-18. South Fork American River to record White Rock Powerhouse discharge temps (Site SFAR16).**
