Dolphin System Water Treatment Study

**Sacramento Local OPS Facility
11085 Sun Center Drive
Rancho Cordova, CA 95670**

October 27, 2004

Dolphin Non-Chemical Water Treatment System Test

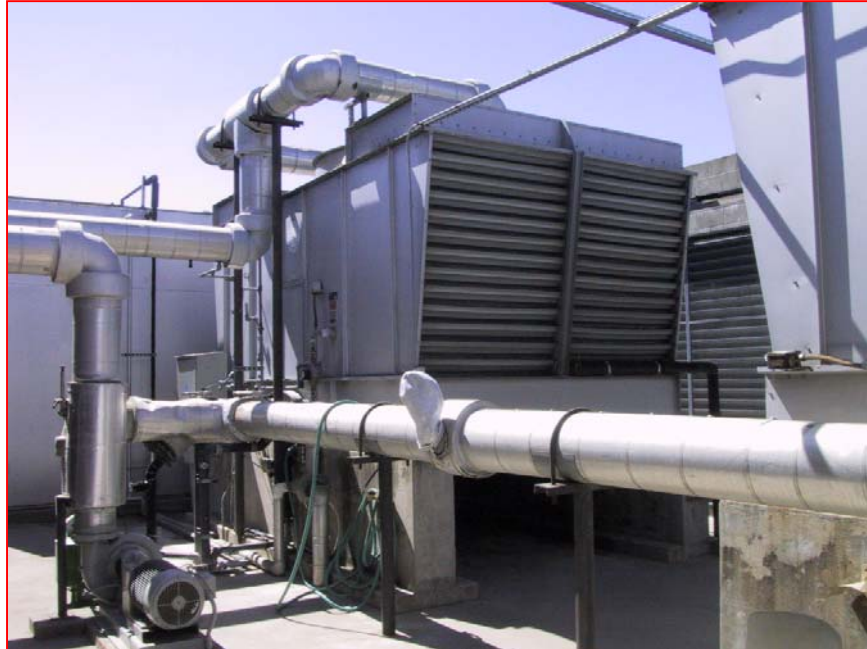
MCI's Sacramento OPS Facility has primary and back up 330-ton cooling towers that cool an HVAC closed loop through a "Superchanger" model UX-A16-HP-139 plate-and-frame heat exchanger. The tower has been chemically treated since installation to control scale, corrosion and biological activity. Under chemical treatment the cooling tower was operated at approximately 2.5 cycles of concentration or "cycles".

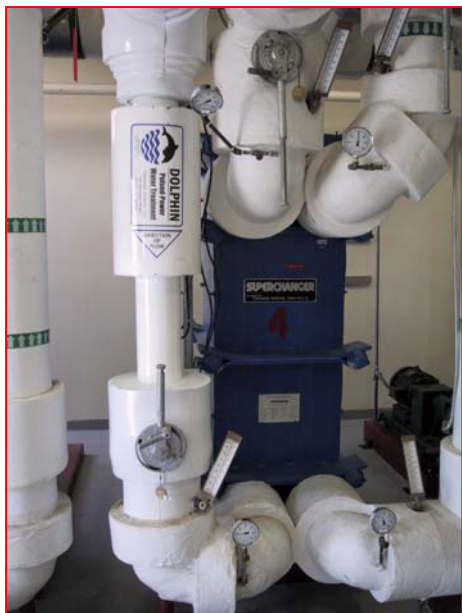
MCI purchased a Dolphin Series Pulsed Power Water Treatment System to test its effectiveness in controlling scale, corrosion and biological activity in the cooling tower "open loop" without the use of chemicals. The Dolphin unit was installed on the open loop directly in front of the inlet to the heat exchanger in February 2004.

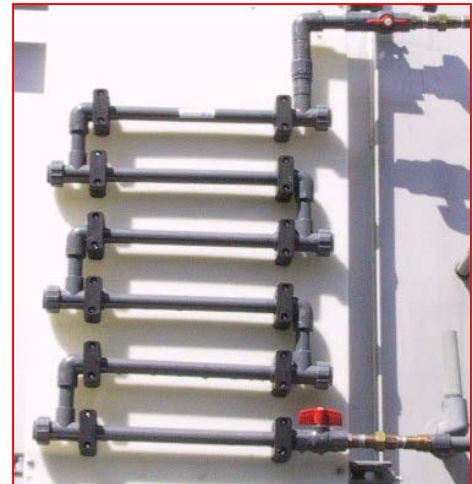
Corrosion Coupon Test: Corrosion coupon tests were conducted in accordance with ASTM D 2688-94, Standard Test Methods for Corrosivity of Water in the Absence of Heat Transfer (Weight Loss Methods), using Test Method A - Coupons. A PVC coupon rack containing six coupon positions was installed in the conductivity controller sample stream of the cooling tower. Flow within the sample stream was regulated to 5 gallons per minute, providing approximately 3.6 ft/sec through the rack. Steel (C1010) and copper (CDA110) alloy coupons were provided and analyzed by Metal Samples Company, Inc. of Munford AL. Since corrosion will be high initially and then fall to a lower, nearly constant rate, two time series were conducted: a short-term (5, 10 and 15-day) and long-term (30, 60 and 90-day) sample interval. The short-term intervals were to determine the rate at which passivity occurs. The long-term intervals were to determine the annual corrosion rate.

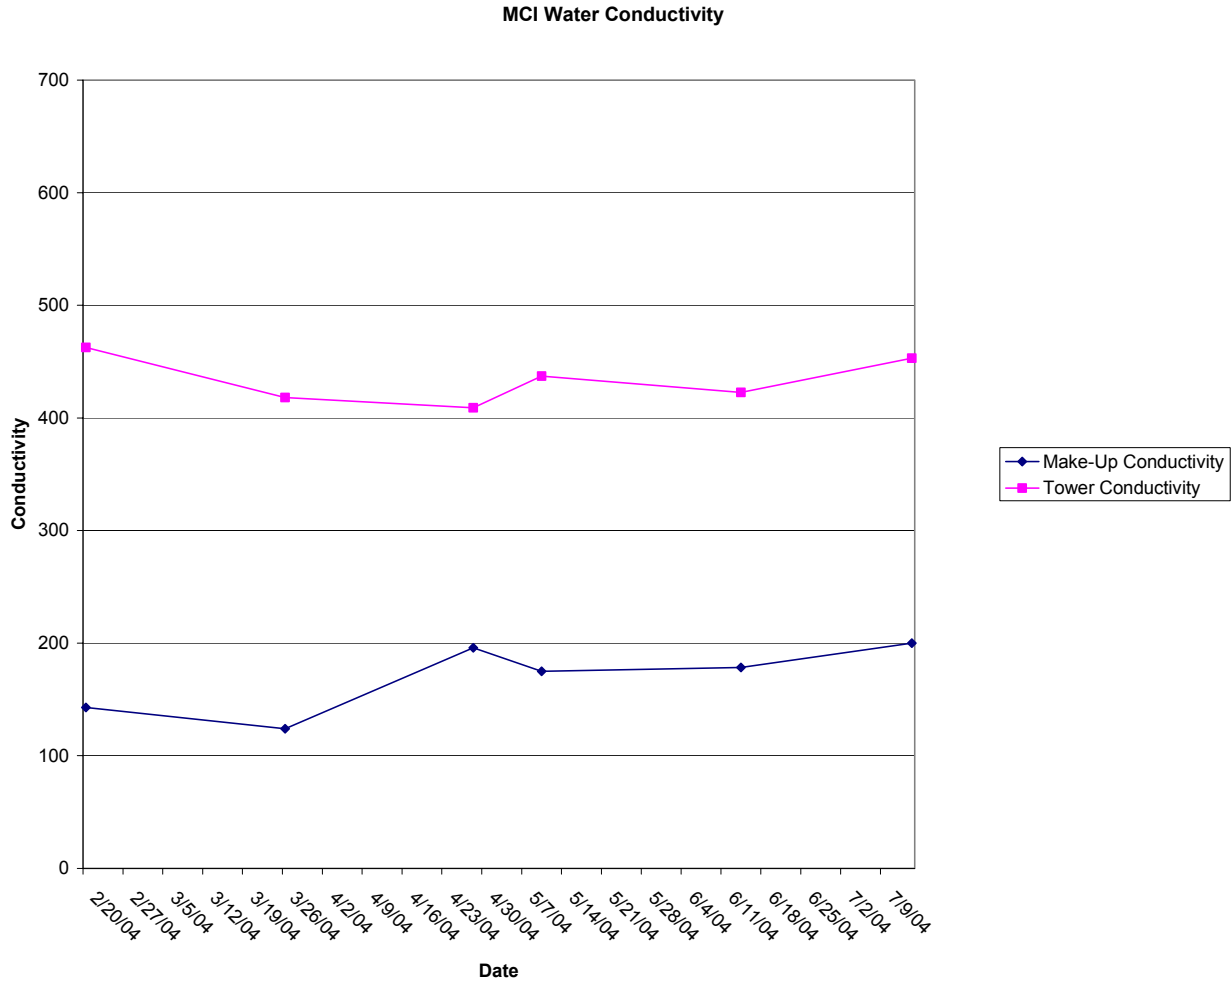
levels of conductivity without reaching the 150 ppm silica “danger level.” A conductivity controller set point of 650-700 microsiemen is reasonable.

During the test period, the MCI staff, with input from the local Dolphin supplier (Precision Environmental and Power, El Dorado Hills, CA), kept the cooling tower conductivity levels nearly equivalent to levels maintained using chemical treatment because of silica concerns

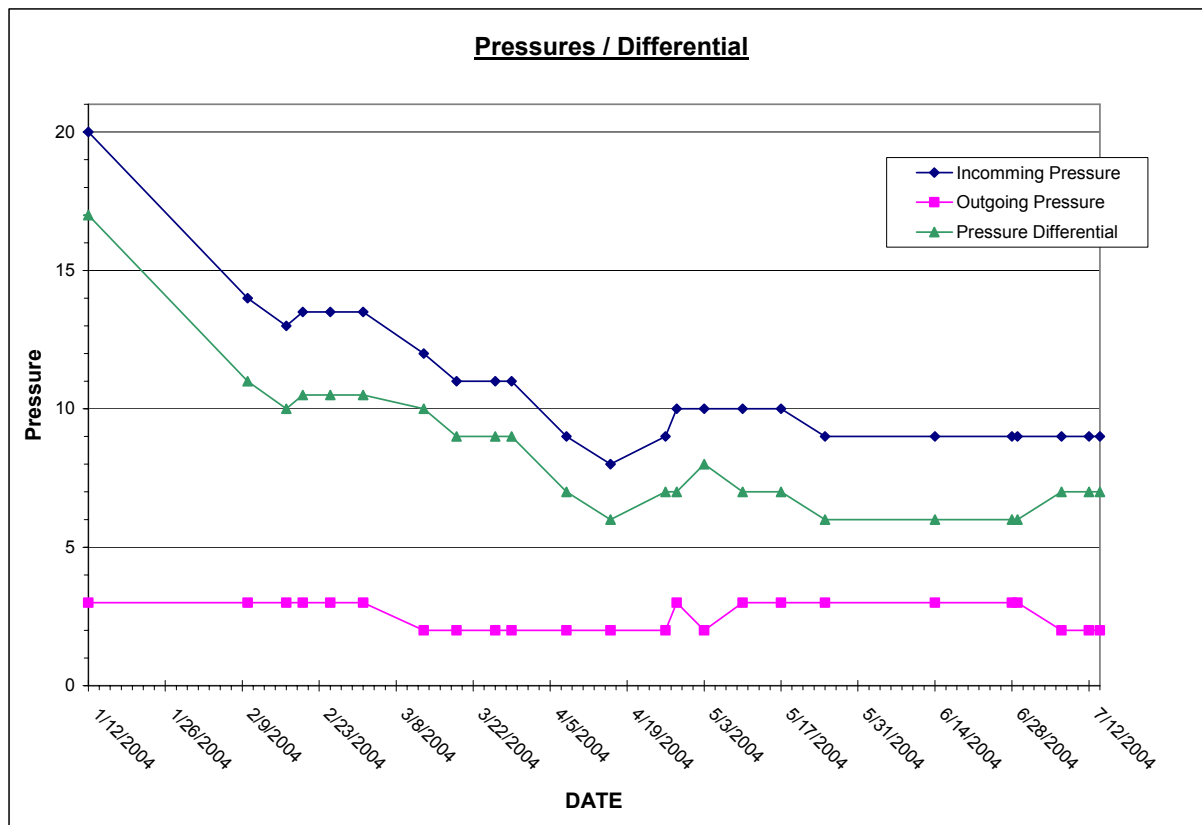
Operating Results: The result of the Dolphin System operation was significant cleaning of the plate-and-frame heat exchanger from starting differential pressure of 17 psi to 7 psi, a drop of 10 psi.

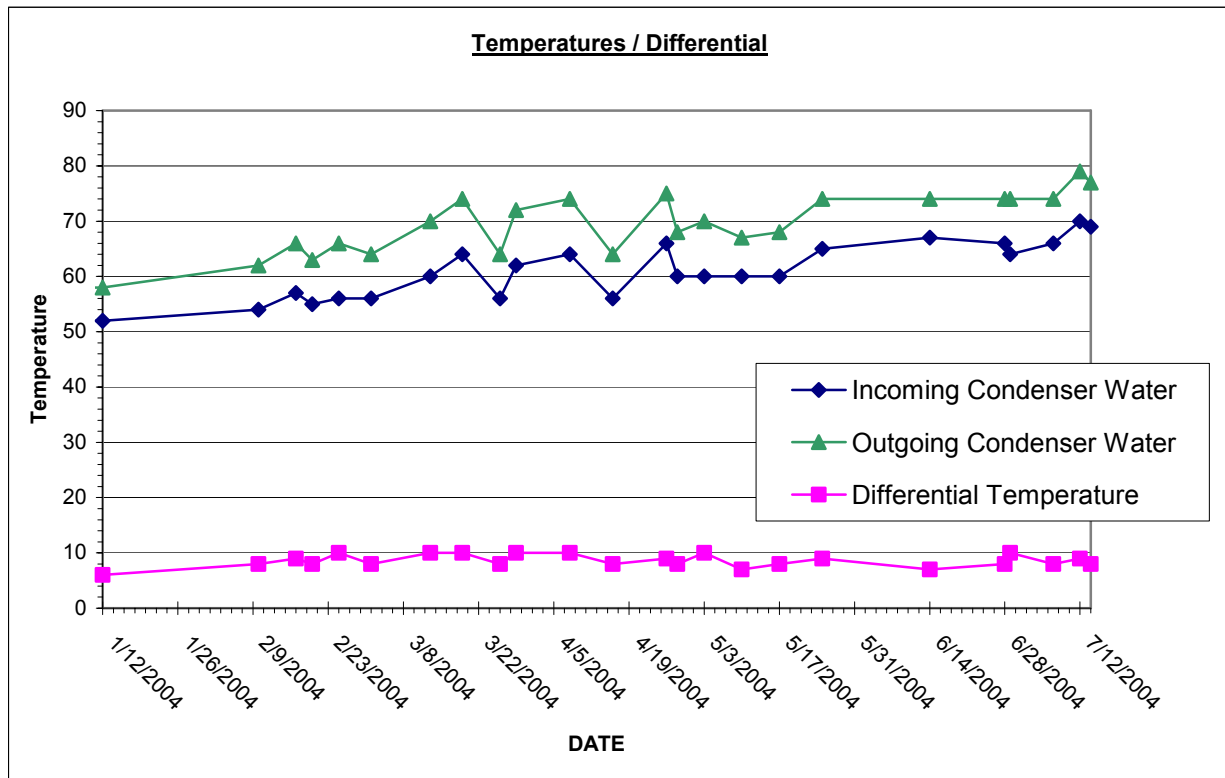
No significant change was seen in the heat exchanger open loop differential temperature over the test period. The lack of increased differential temperature indicates that although the heat exchanger flow rate was restricted at the start of the study by scale, the plate surface area was adequate to remove the required heat load. The closed loop temperature was not monitored during the study.
