BR-2 – DRAFT AQUATIC RESOURCES DELINEATION REPORT

Draft Aquatic Resources Delineation Report Country Acres Solar Project

Prepared for:
Sacramento Municipal Utility District
6201 S Street, Mail Stop B209
Sacramento, CA 95817

April 2022

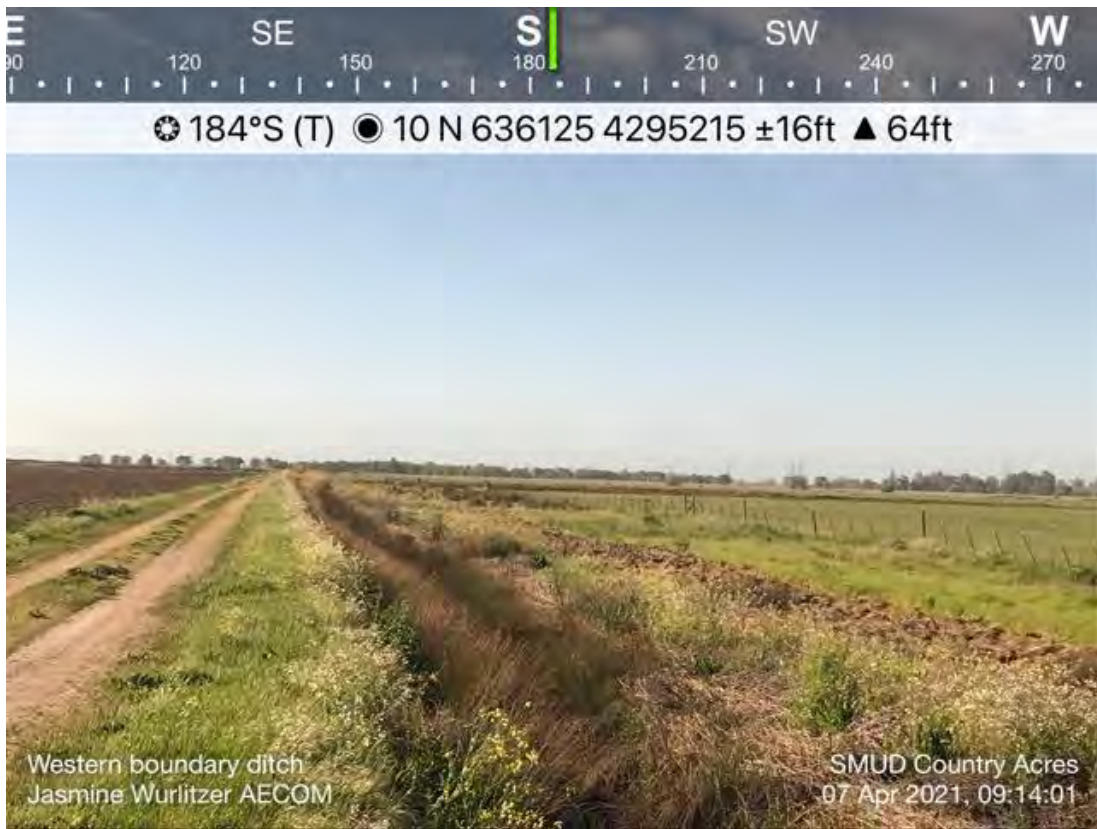
Photo 1. Agricultural canal, AC-01 (other waters). Looking south. April 7, 2021.

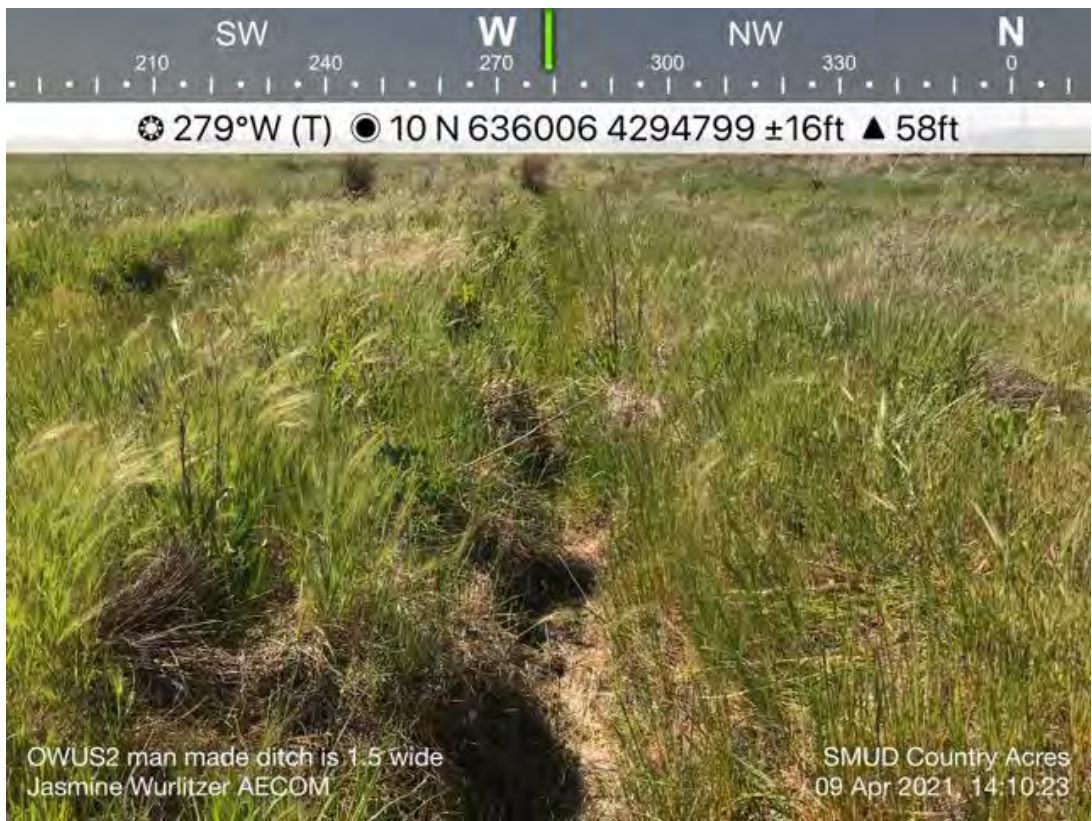
Photo 2. Agricultural ditch, AD-01 (other waters). Looking west. April 9, 2021.

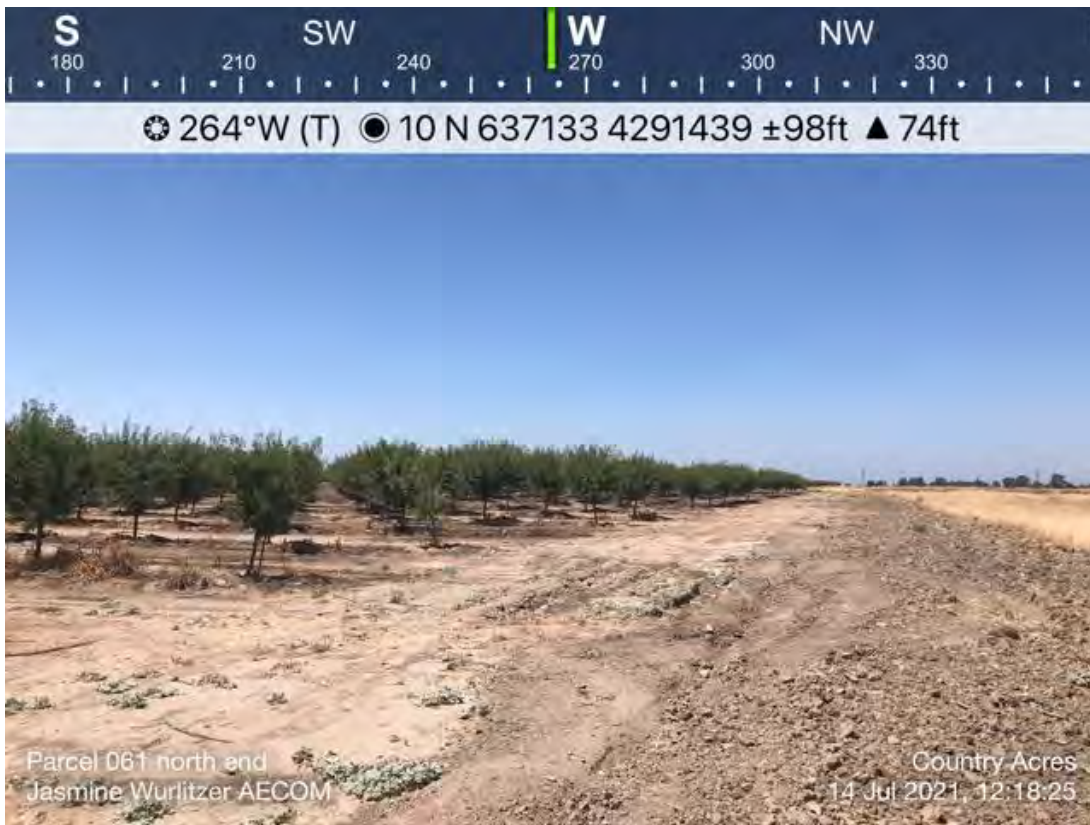
Photo 3. Almond orchard and disturbed (road) land cover types. Looking west. July 14, 2021.

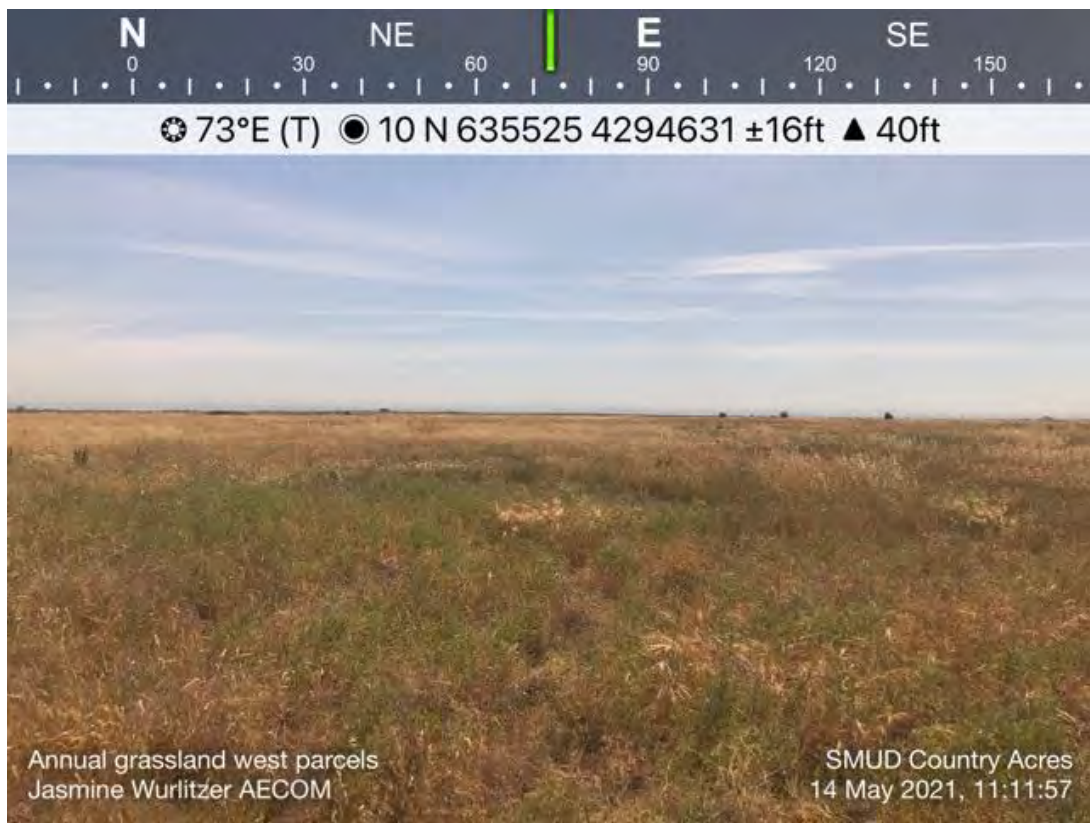
In the study area, grassland vegetation cover is dominated by nonnative annual grasses consisting of wild oats, medusahead (*Elymus caput-medusae*) (NL), ripgut brome (*Bromus diandrus*) (NL), softchess brome (*Bromus hordeaceus*) (FACU), and brome fescue (*Festuca bromoides*) (FACU), as well as a mixture of native and nonnative herbs, including miniature lupine (*Lupinus bicolor*) (NL), wild radish (*Raphanus sativus*) (NL), filaree (*Erodium botrys*) (FACU), and narrow tarplant (*Holocarpha virgata*) (NL). Other common species observed in

Photo 4. Annual grassland land cover type. Looking east. May 14, 2021.

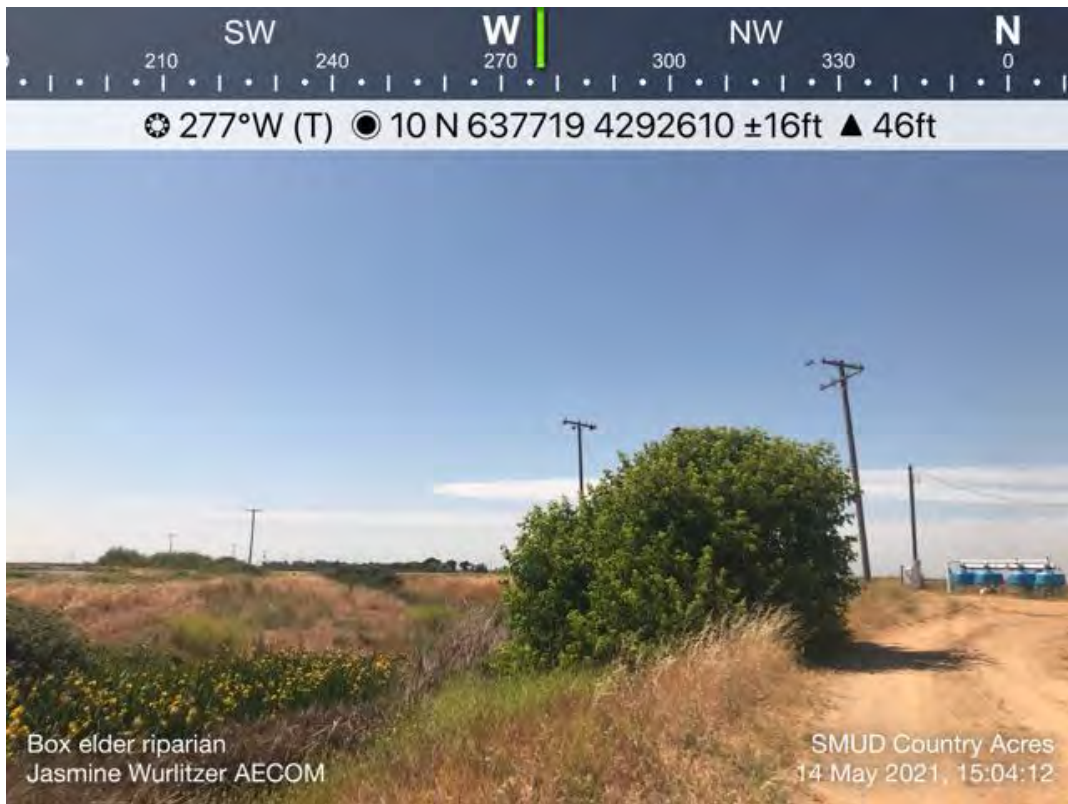
**Photo 5. Intermittent Drainage (ID-01) (other waters).
Looking west. May 14, 2021.**

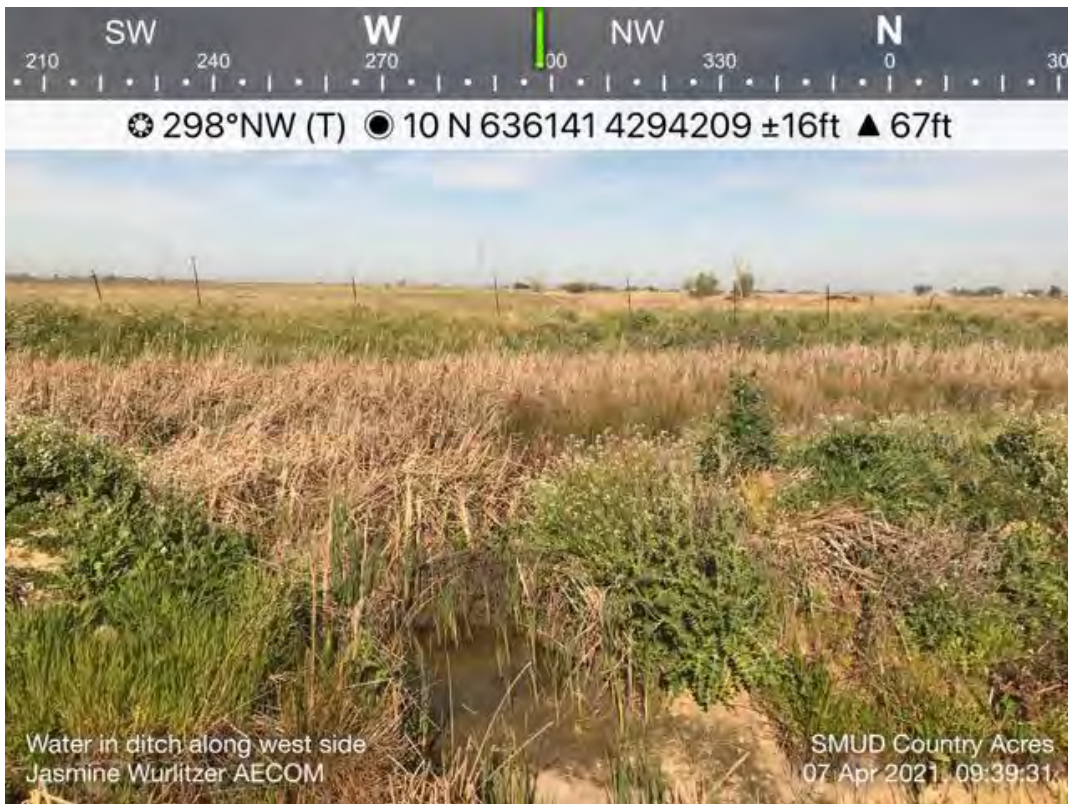
In the study area, the cattail marsh vegetation community is dominated by broadleaf cattail (OBL) with spikerush (*Eleocharis macrostachya*) (OBL), iris-leaved rush (*Juncus xiphioides*) (OBL), hyssop loosestrife (*Lythrum hyssopifolium*) (OBL), soft rush (*Juncus effusus*) (FACW), tall flatsedge (*Cyperus eragrostis*) (FACW), barnyard grass (*Echinochloa crus-galli*) (FACW), rabbitsfoot grass (*Polypogon monspeliensis*) (FACW), and smartweed (*Persicaria* sp.). A large break in an approximately 15-foot tall berm west of the rice fields connects an irrigation canal to a natural drainage/creek that is dominated by cattail marsh vegetation and flows westward outside of the study area to eventually connect with Curry Creek to the west and south. The floodplain of this creek appears to be inundated year-round and is densely vegetated by broadleaf cattail that is co-dominant with floating mosquito fern (*Azolla* sp.) (OBL) and tule (*Shoenoplectus* spp.) (OBL). Occasional sandbar (*Salix exigua*) (FACW) and black willow (*Salix gooddingii*) (FACW) trees are present along marsh edges, with Italian ryegrass, curly dock, jointed crown grass (*Paspalum distichum*) (FACW), yellow glandweed (*Parentucellia viscosa*) (FAC), willowherb (*Epilobium brachycarpum*) (FAC), spiny-leaf sow-thistle (*Sonchus asper*) (FAC), English plantain (*Plantago lanceolata*) (FAC), and bristly ox-tongue (*Helminthotheca echioides*) (FAC).

Photo 6. Cattail marsh land cover type. Looking northwest. April 7, 2021.

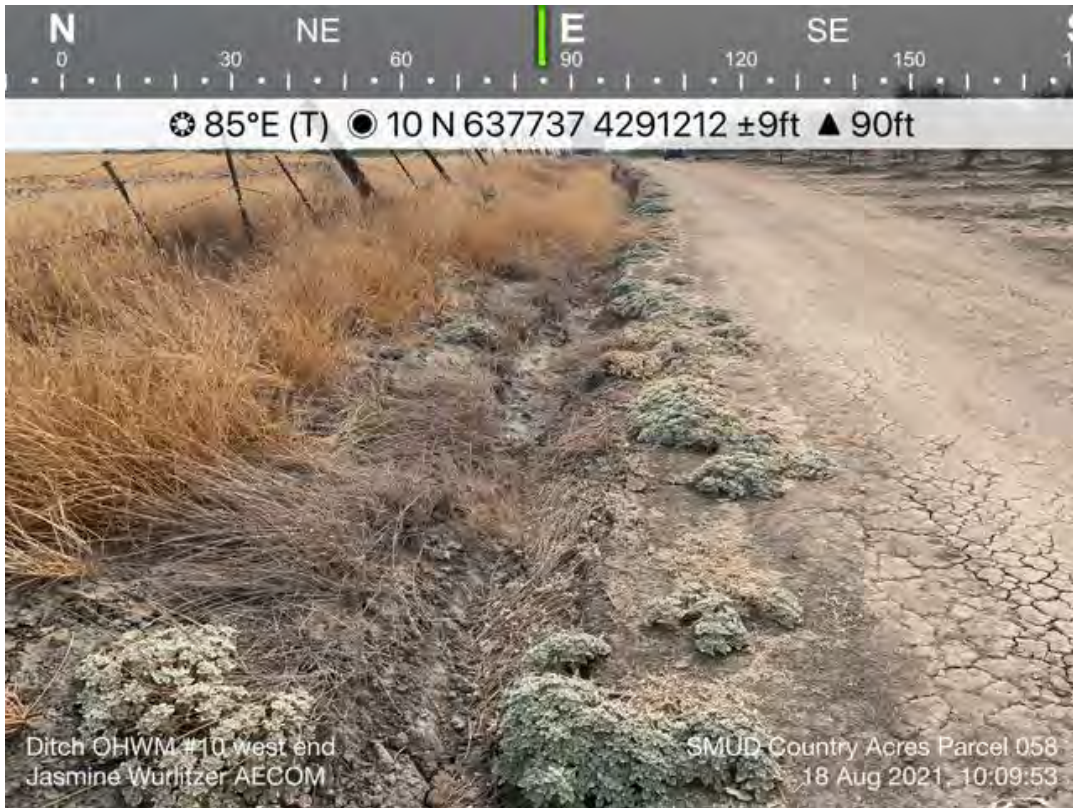
Photo 7. Ditch, D-43, along fence line north of orchard access road. Looking east. August 18, 2021.

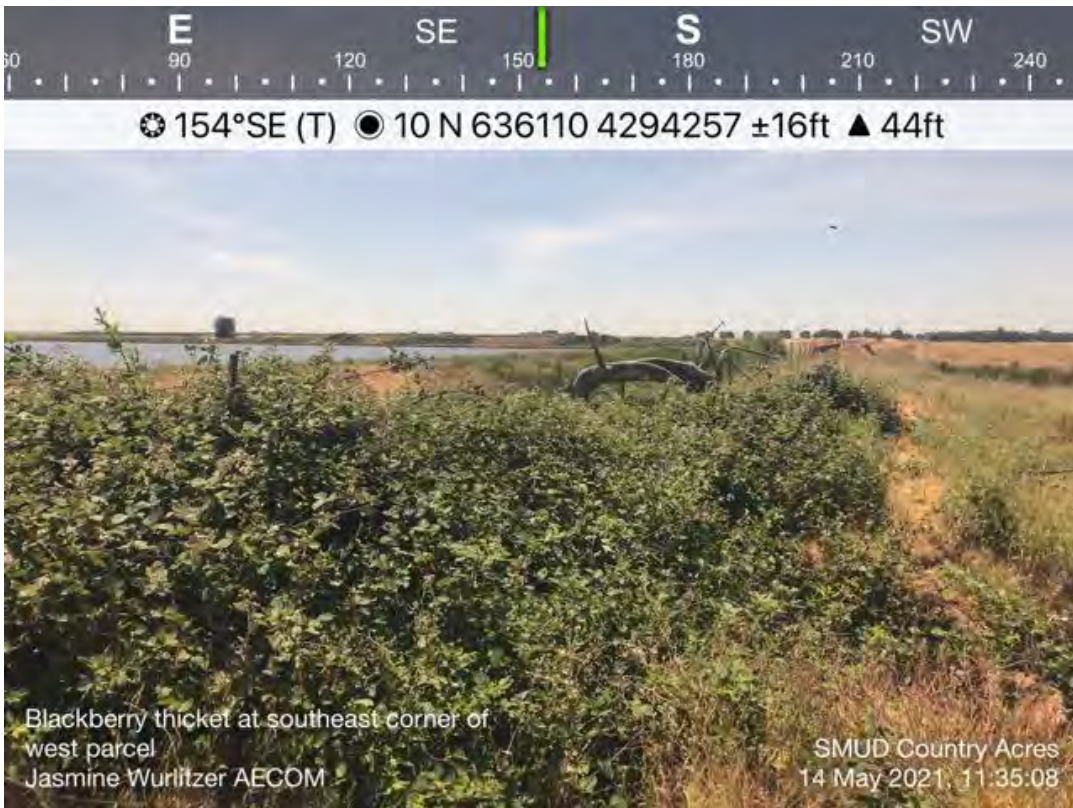
Photo 8. Himalayan blackberry thicket land cover type. Flooded rice fields in background to the east, and annual grassland in the background to the west. Looking southeast. May 14, 2021.

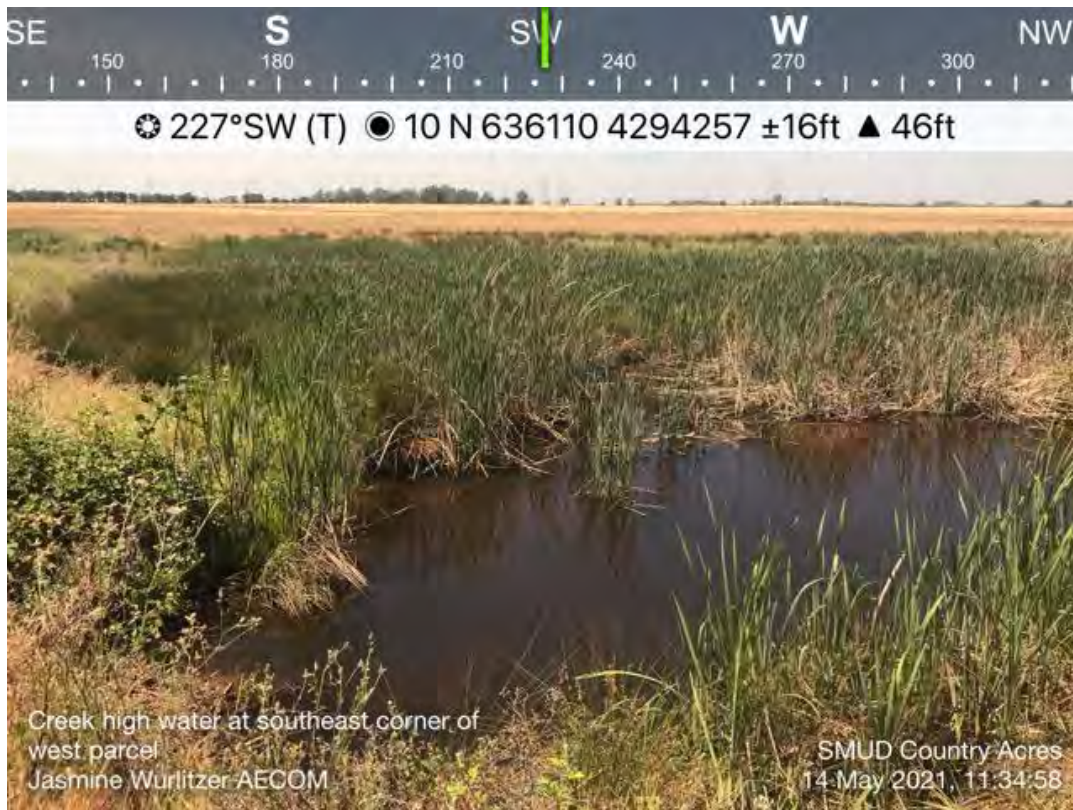
Photo 9. Intermittent drainage, ID-04. Looking southwest. May 14, 2021.

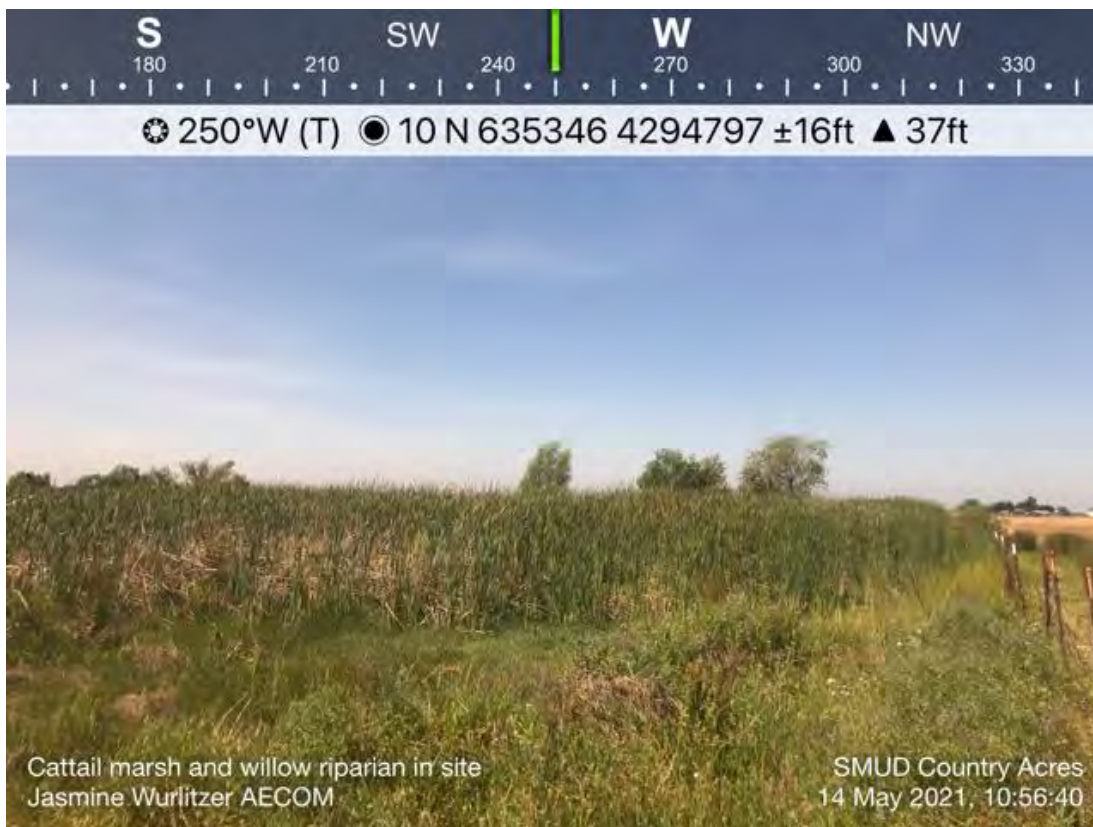
Photo 10. Perennial emergent marsh, PEM-26. Looking west. May 14, 2021.

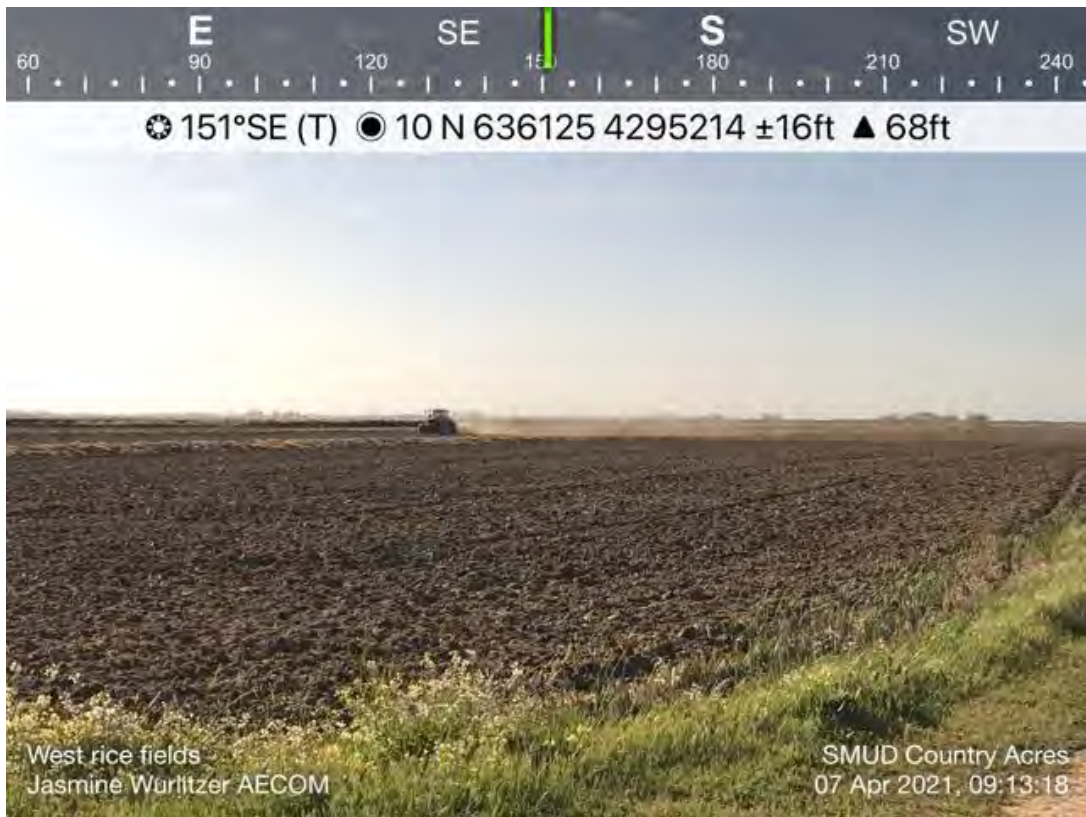
At the time of the wetland delineation surveys in early April 2021, the rice fields were being disked and leveled; by April 30, 2021, fields were being flooded in series from east to west. During field surveys conducted on July 14, 2021, all irrigation ditches and channelized drainages in the study area were full of water, which flowed from east to west through the study area through a series of culverts and eventually drained to natural drainages to the west of the site. Also at this time, delineators observed that these natural drainages and their associated floodplains outside of the study area were full of standing water resulting from agriculturally-influenced water inputs.

Photo 11. Rice field land cover type. Looking southeast. April 7, 2021.

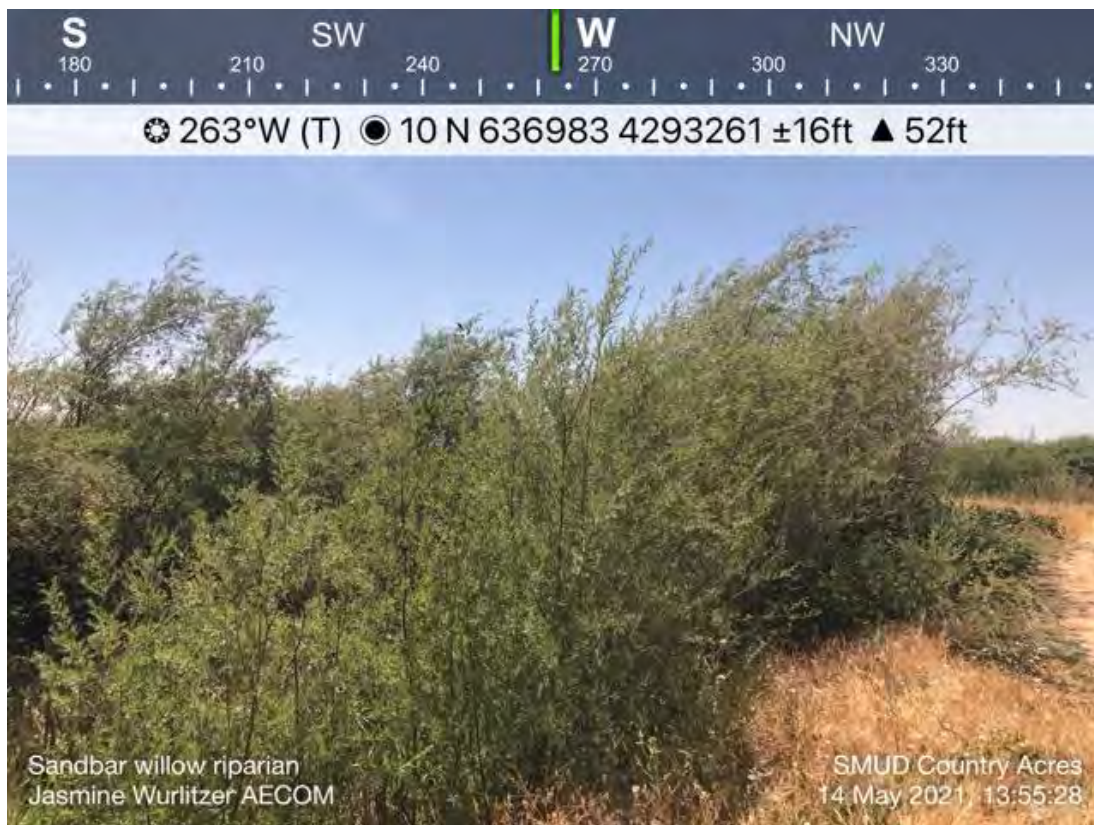
Photo 12. Willow riparian land cover type, along ID-02. Looking west. May 14, 2021.

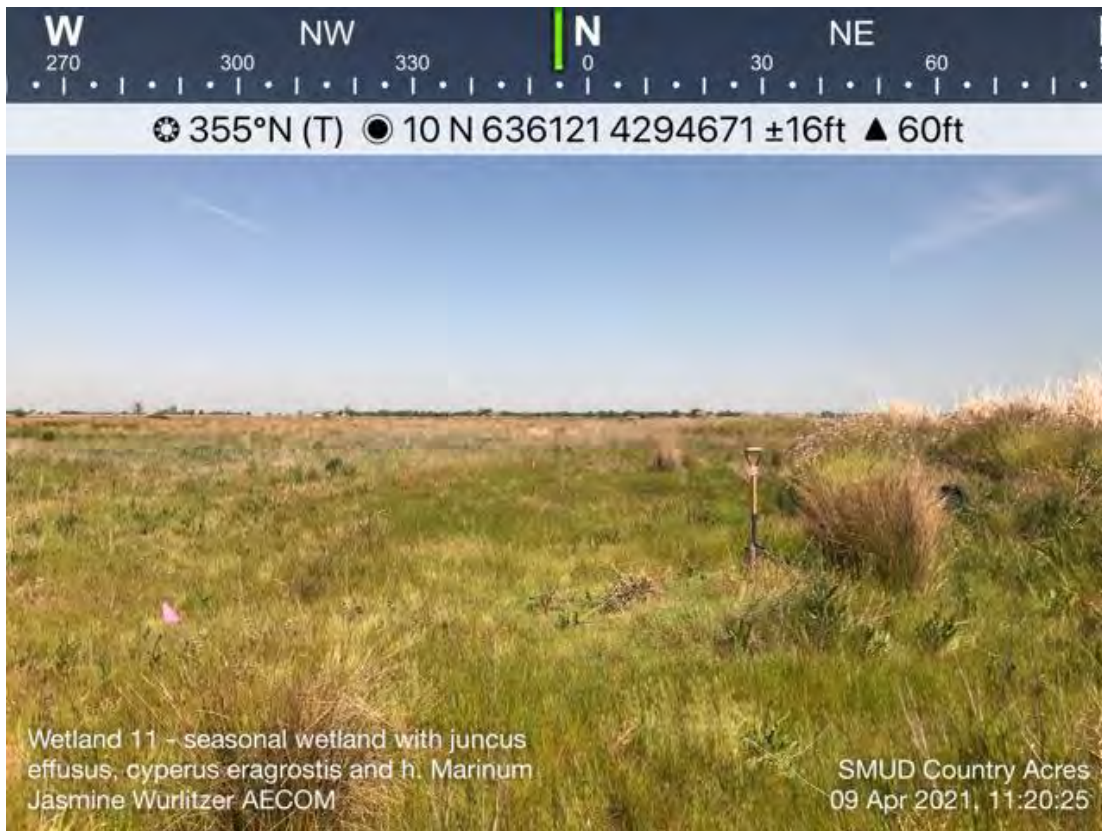
Dominant plant species in seasonal wetlands in the study area include Italian ryegrass, spikerush, tall flatsedge, willow herb, hyssop loosestrife, curly dock, prickly lettuce, hawkbit, seaside barley (*Hordeum marinum*) (FAC), Mediterranean beard grass (*Polypogon maritimus*) (OBL), and popcornflower (*Plagiobothrys stipitatus*) (FACW). Other common species observed in seasonal wetland habitats were Fremont cottonwood, black willow, wild geranium, spiny-leaf sow thistle, English plantain, soft rush, filaree, sixweeks rattail fescue (*Festuca myuros*) (FACU), gumweed (*Grindelia camporum*) (FACW), white hyacinth (*Triteleia hyacinthina*) (FAC), blow wives (*Achyraea mollis*) (FAC), California false semaphore grass (*Pleuropogon californicus*) (OBL), short-awn meadow foxtail (*Alopecurus aequilis*) (OBL), and harding grass (*Phalaris aquatica*) (FACU).

Photo 13. Seasonal wetland, SW-11. Looking north. April 9, 2021.

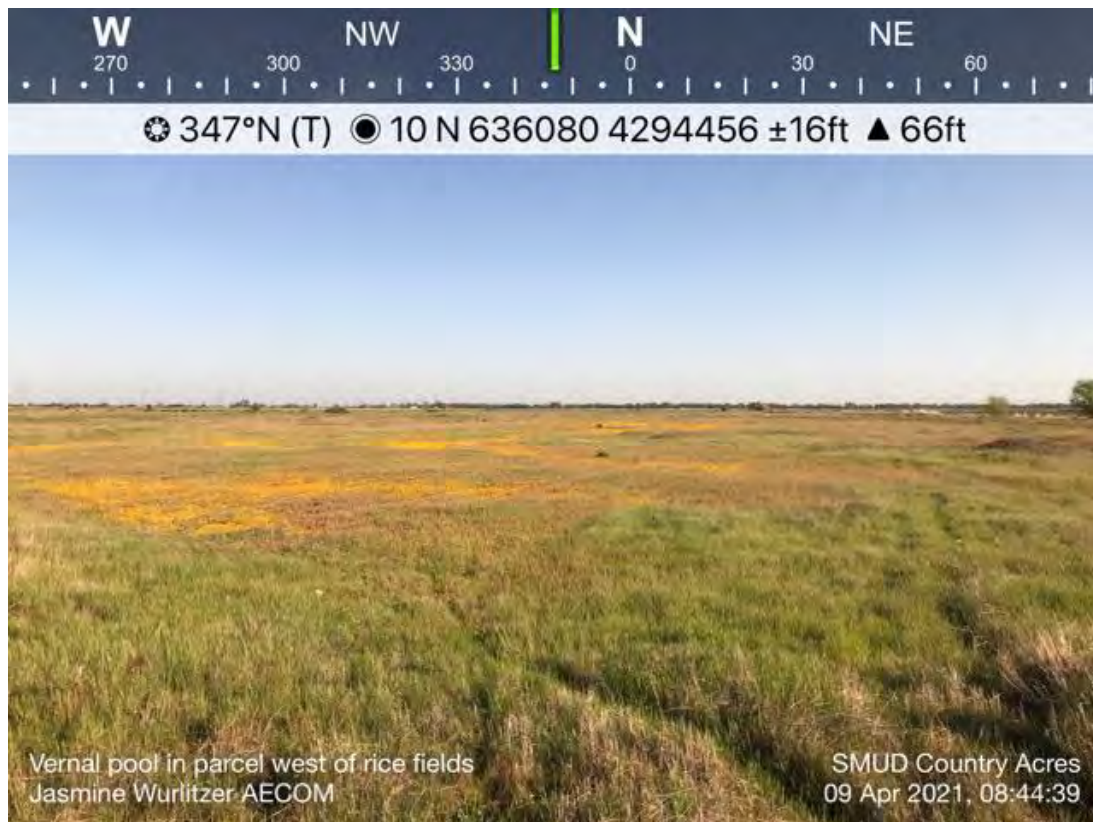
Vernal pools in the study area were either dominated by smooth goldfields (OBL) or Fremont's goldfields (OBL), with deeper pools tending to be dominated by smooth goldfields. Other species commonly associated with vernal pools and observed in association with goldfields in vernal pools in the study area include coyote thistle (*Eryngium vaseyi*) (FACW), vernal pool buttercup (*Ranunculus bonariensis* var. *trisepalus*) (OBL), vernal-pool Indian-paintbrush (*Castilleja campestris*) (FACW), annual hairgrass (*Deschampsia danthanioides*) (FACW), dwarf woolly marbles (*Psilocarphus brevissimus*) (FACW), Oregon woolly marbles (*Psilocarphus oregonus*) (OBL), white-flower pincushion-plant (*Navarretia leucocephala*) (OBL), double-horn calico-flower (*Downingia bicornuta*) (OBL), bractless hedge-hyssop (*Gratiola ebracteata*) (OBL), water-starwort (*Callitriche* sp.) (OBL), toad rush (*Juncus bufonius*) (FACW), and water pygmyweed (*Crassula aquatica*) (OBL).

Photo 14. Vernal pool, VP-5, in grassland matrix. Looking north. April 9, 2021.

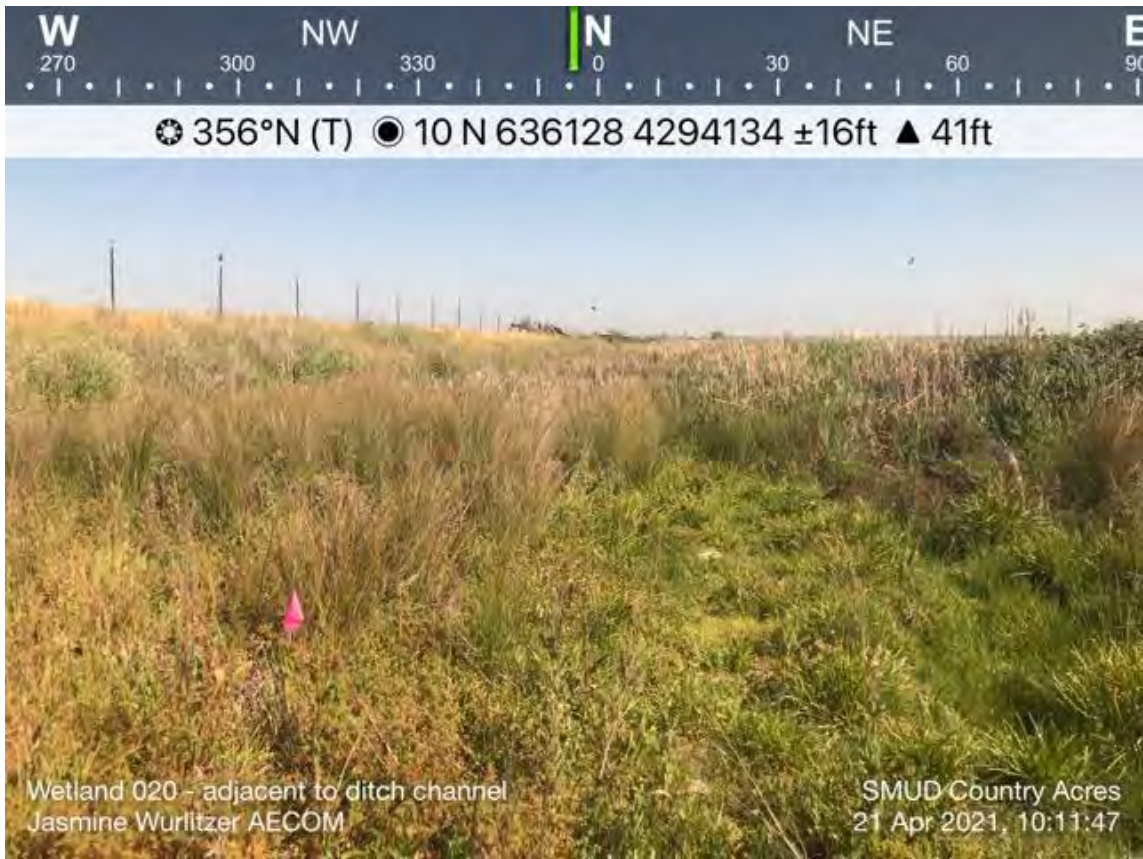
Photo 15. Wetland, W-20, adjacent to AC-01. Looking north. April 21, 2021.
