Monitoring Program 2019 Final Annual Report Sacramento Municipal Utility District

Hydro License Implementation • June 2020

Upper American River Project

FERC Project No. 2101

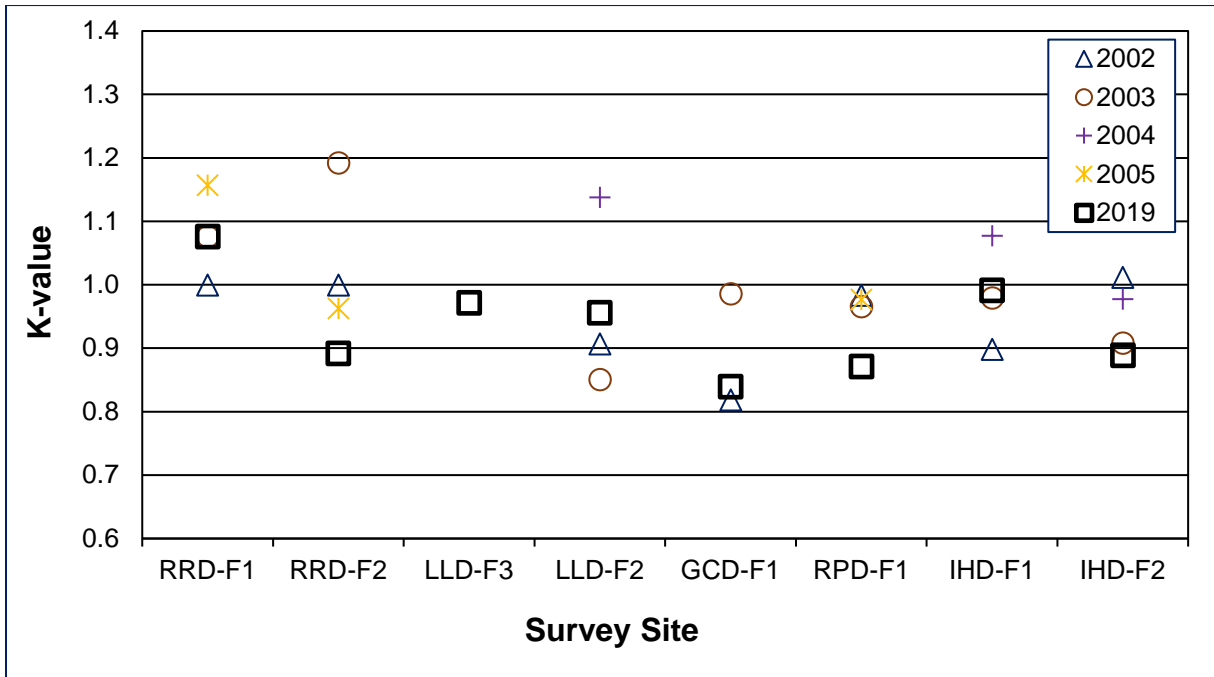
Figure 2-5. Condition factors for rainbow trout captured by electrofishing in the UARP study area by site, arranged left to right by decreasing elevation, 2002–2019.

Condition factors (K-values) indicate that rainbow trout were generally in good condition in 2019¹; however, the average condition factor for all sites was lower than prior survey years (Figure 2-5, Table 2-3, and Appendix B3). The condition factors also indicate that brown trout were in good condition in 2019, and their average condition factor was comparable to previous survey years (Figure 2-6, Table 2-3, and Appendix B3).

The average condition factors for rainbow and brown trout ($K=1.08$ and 1.10 , respectively) in 2019 suggests that trout were in good condition, which was generally consistent with previous monitoring years (Table 2-3, Figure 2-5, and Figure 2-6).

Rainbow trout condition ($K=0.87$) was lower than the previous sampling years, on average (Figure 2-5), whereas brown trout were of similar condition ($K=1.01$) to prior years (Table 2-3, Figure 2-6).

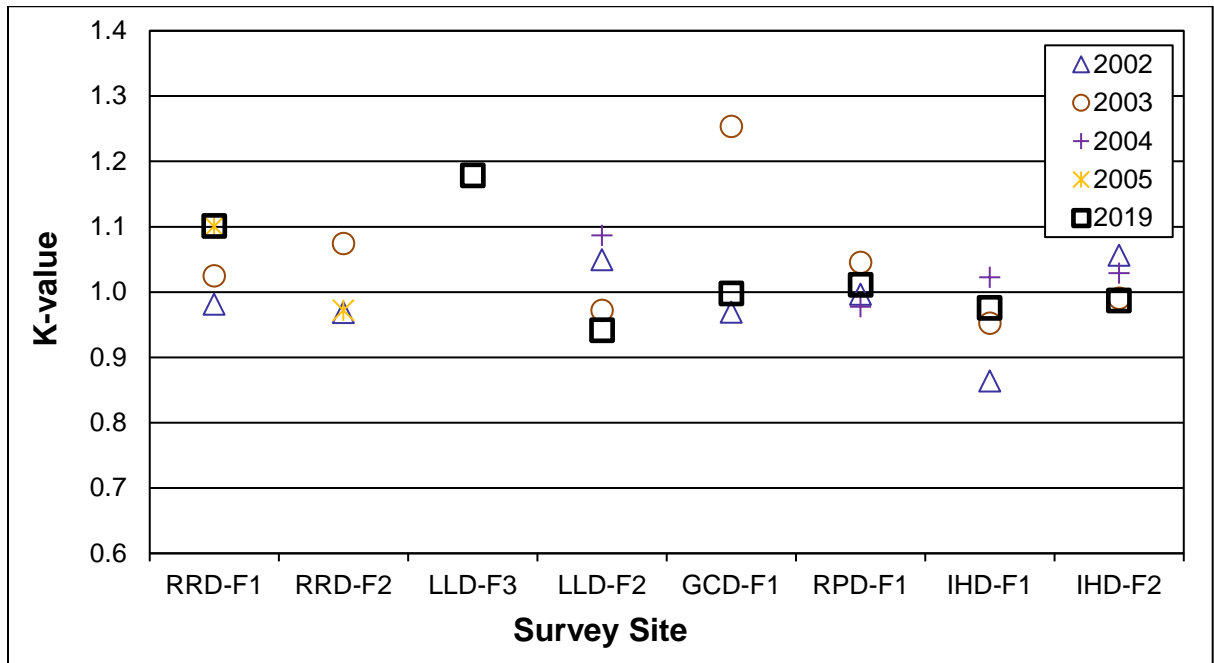
Figure 2-6. Condition factors for brown trout captured by electrofishing in the UARP study area by site, arranged left to right by decreasing elevation, 2002–2019.

Rainbow trout condition was similar among years sampled, although the average condition was relatively low ($K=0.84$) at this site compared to the rest of the study area (Table 2-3, Figure 2-5). The single brown trout observed was in good condition ($K=1.0$) (Table 2-3, Figure 2-6).

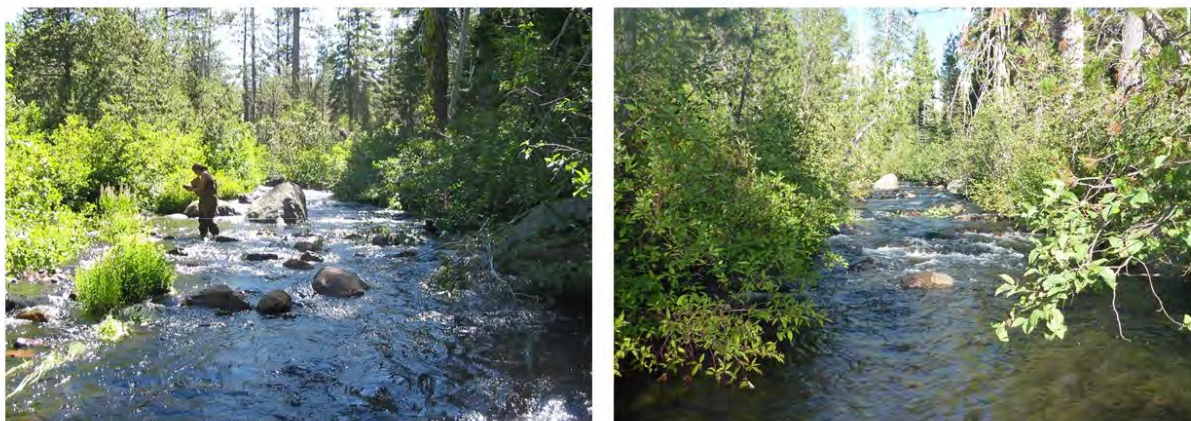
Figure 4-10. Site LLD-G2 looking upstream from XS-2 in 2003 (left) and 2019 (right).

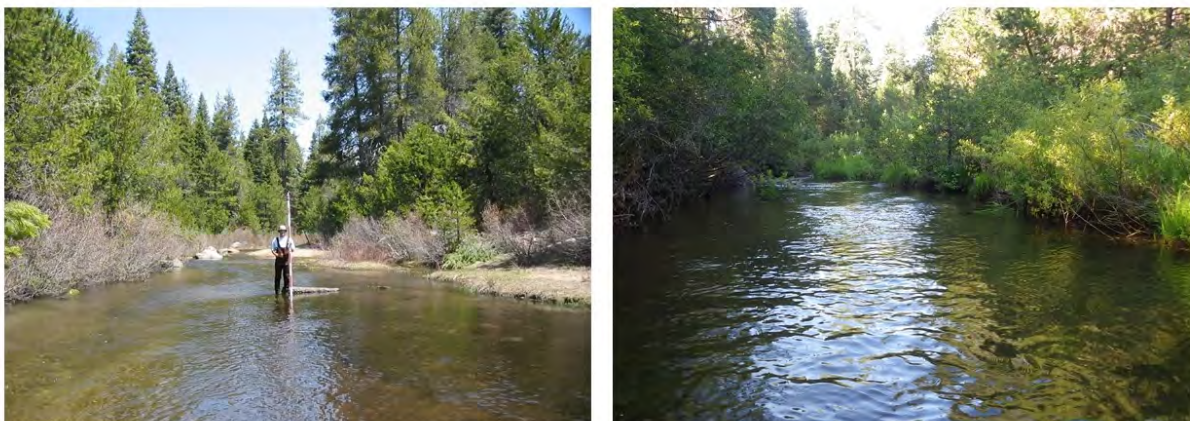
Figure 4-11. Site IHD-G1 looking upstream from XS-2 in 2003 (left) and 2019 (right).

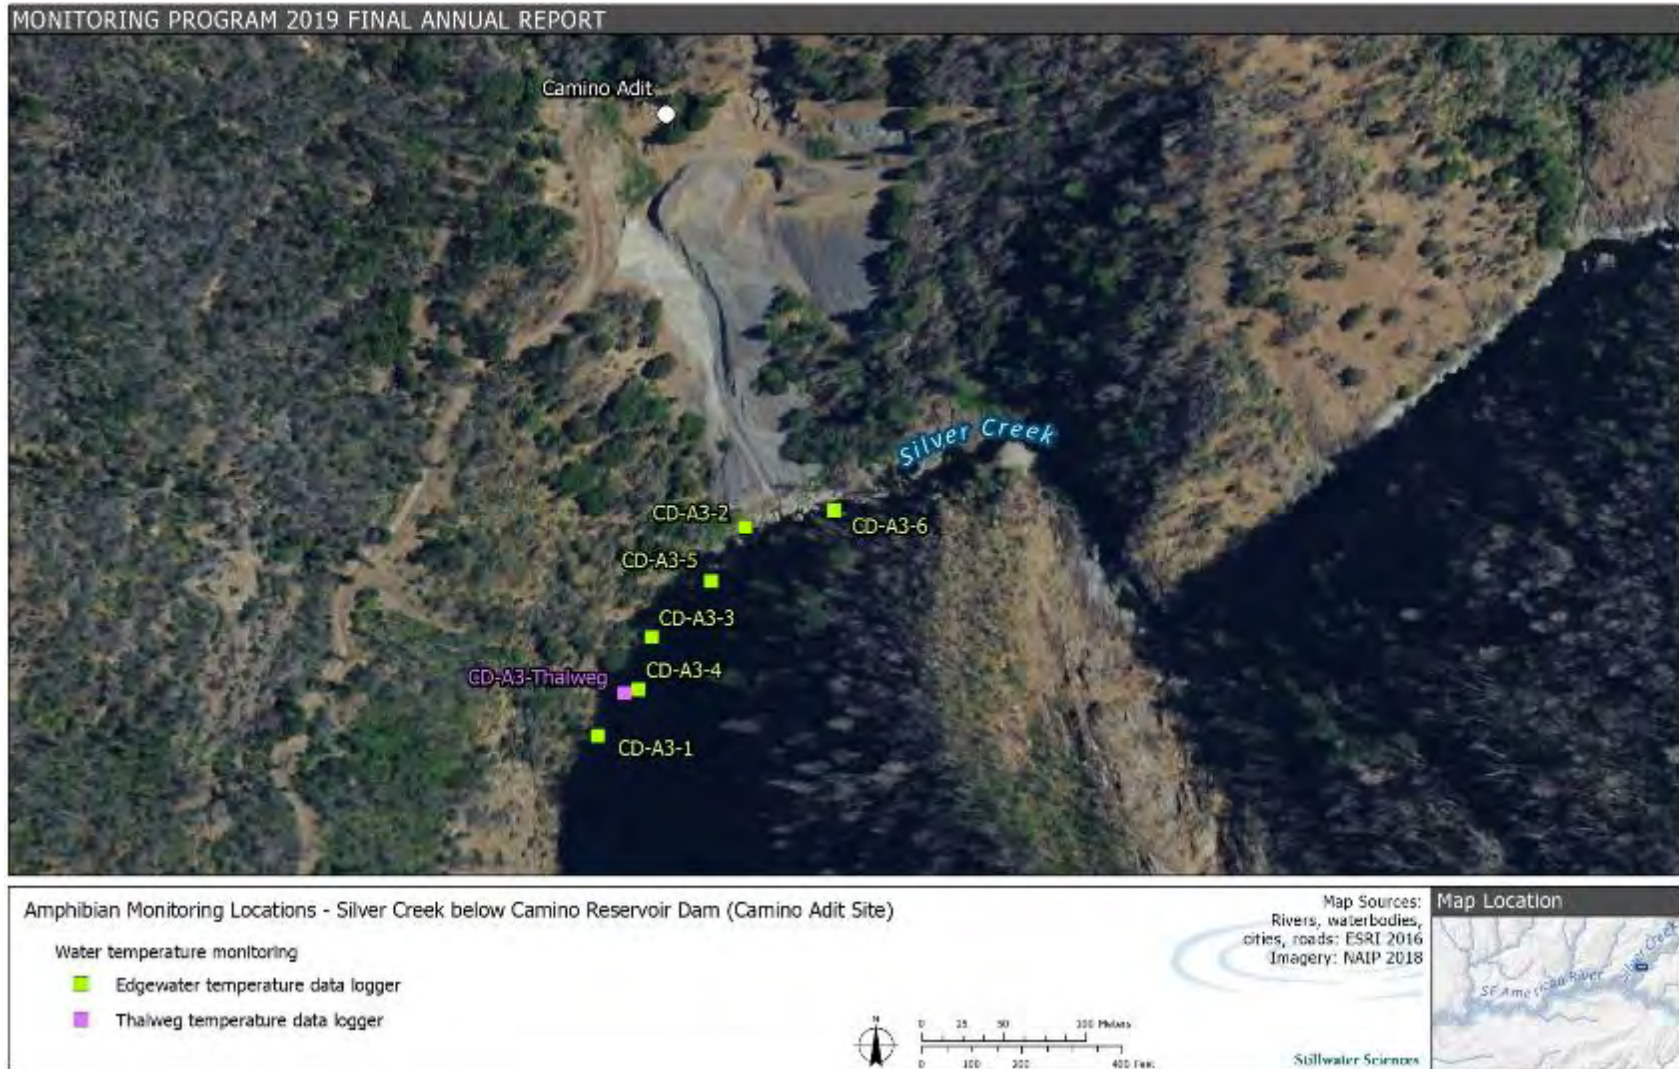
Figure 8-1. Temperature logger locations at amphibian monitoring site CD-A3, 2019.

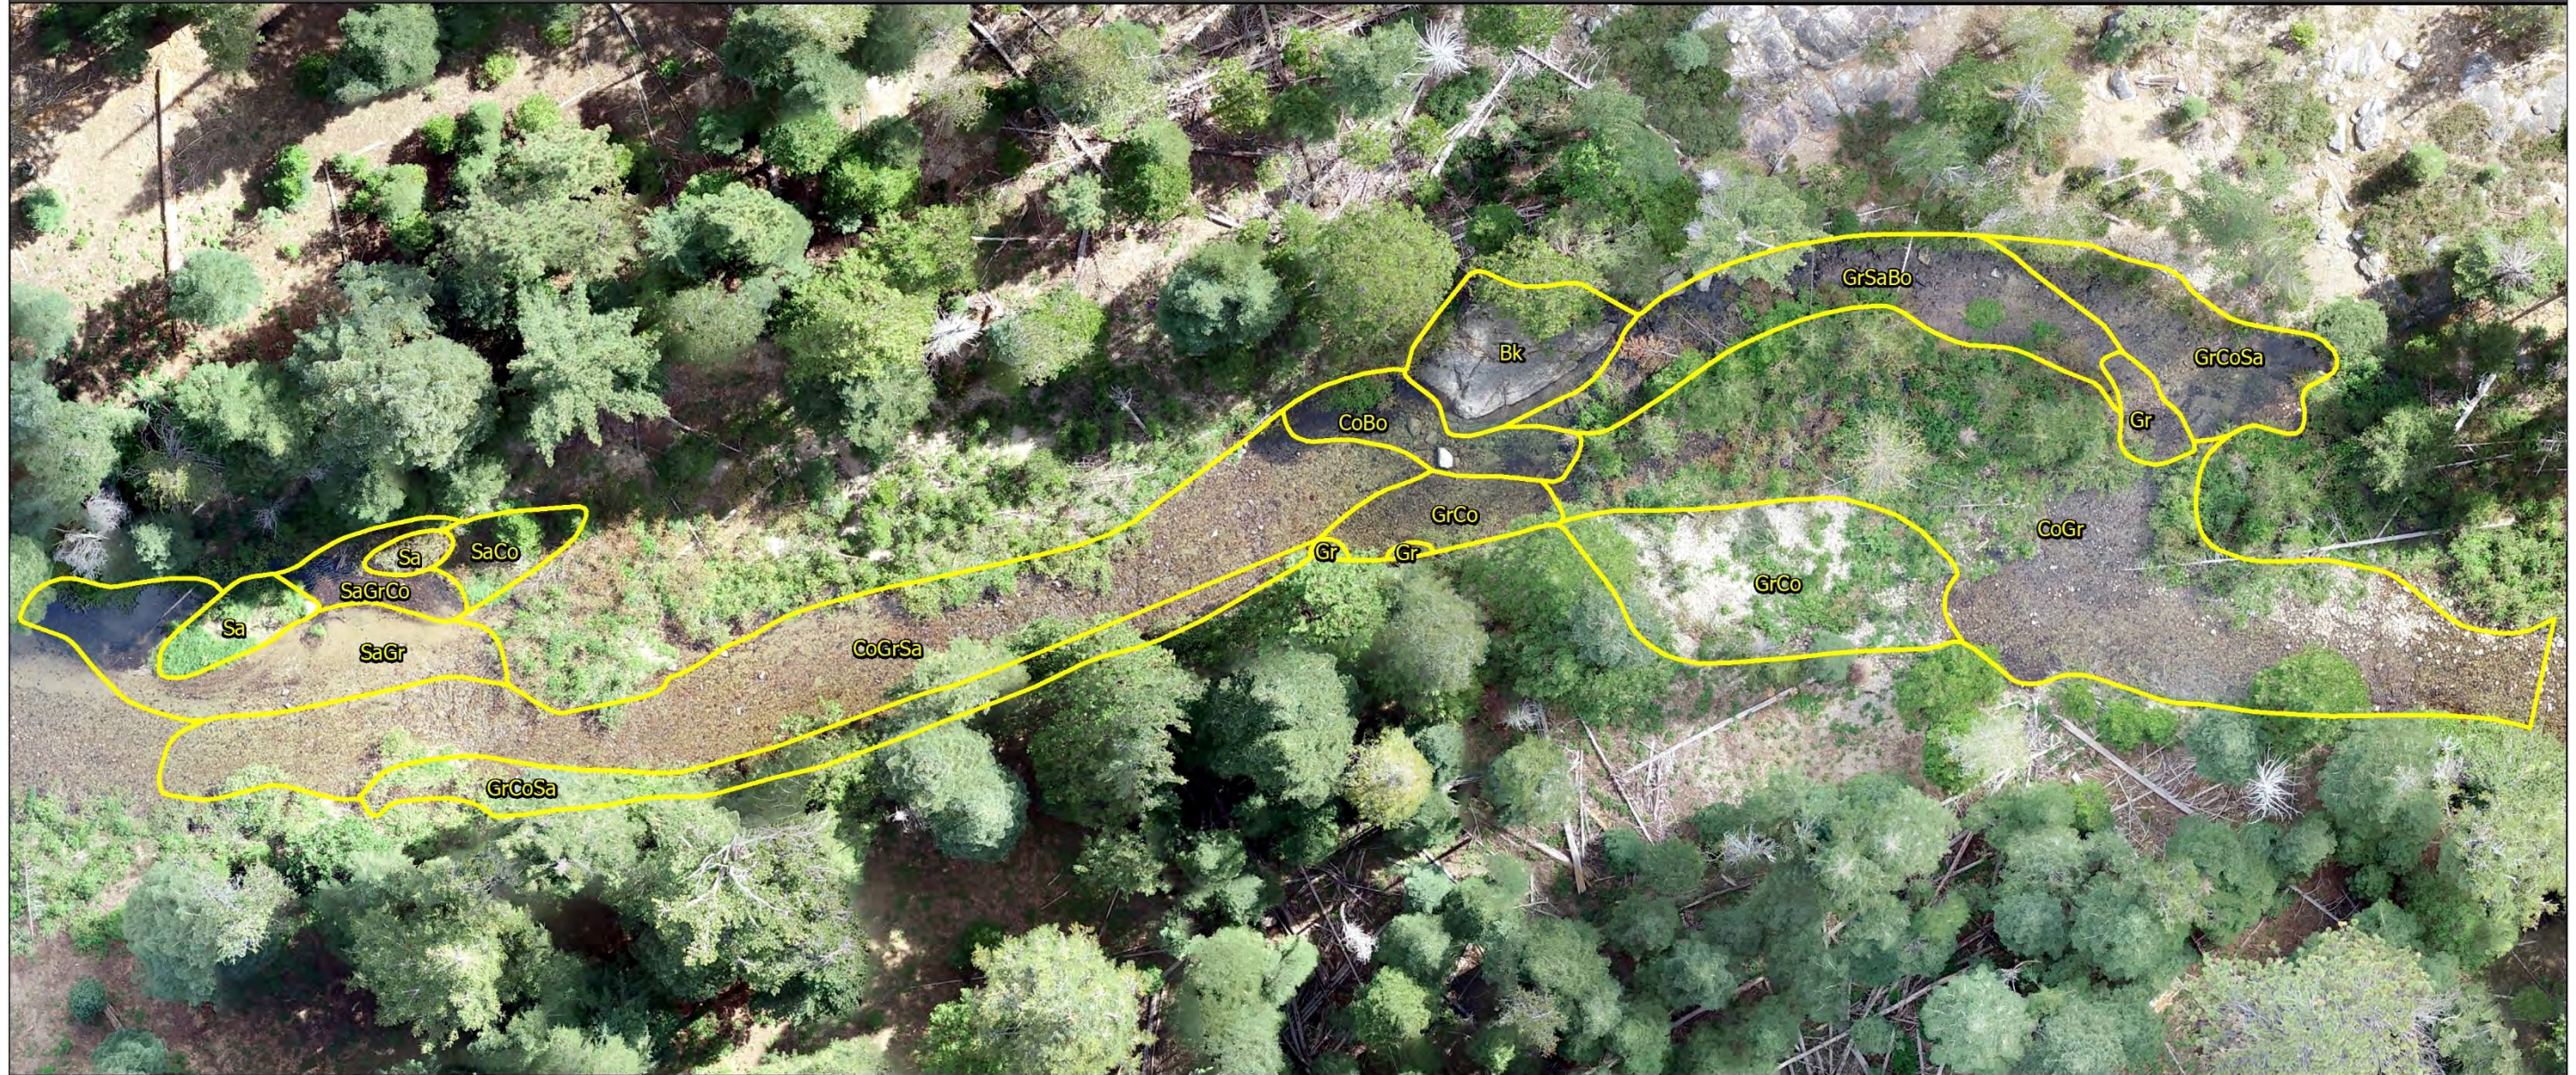
Figure D7-1. Rubicon River Below Rubicon Dam (Site RRD-G1).

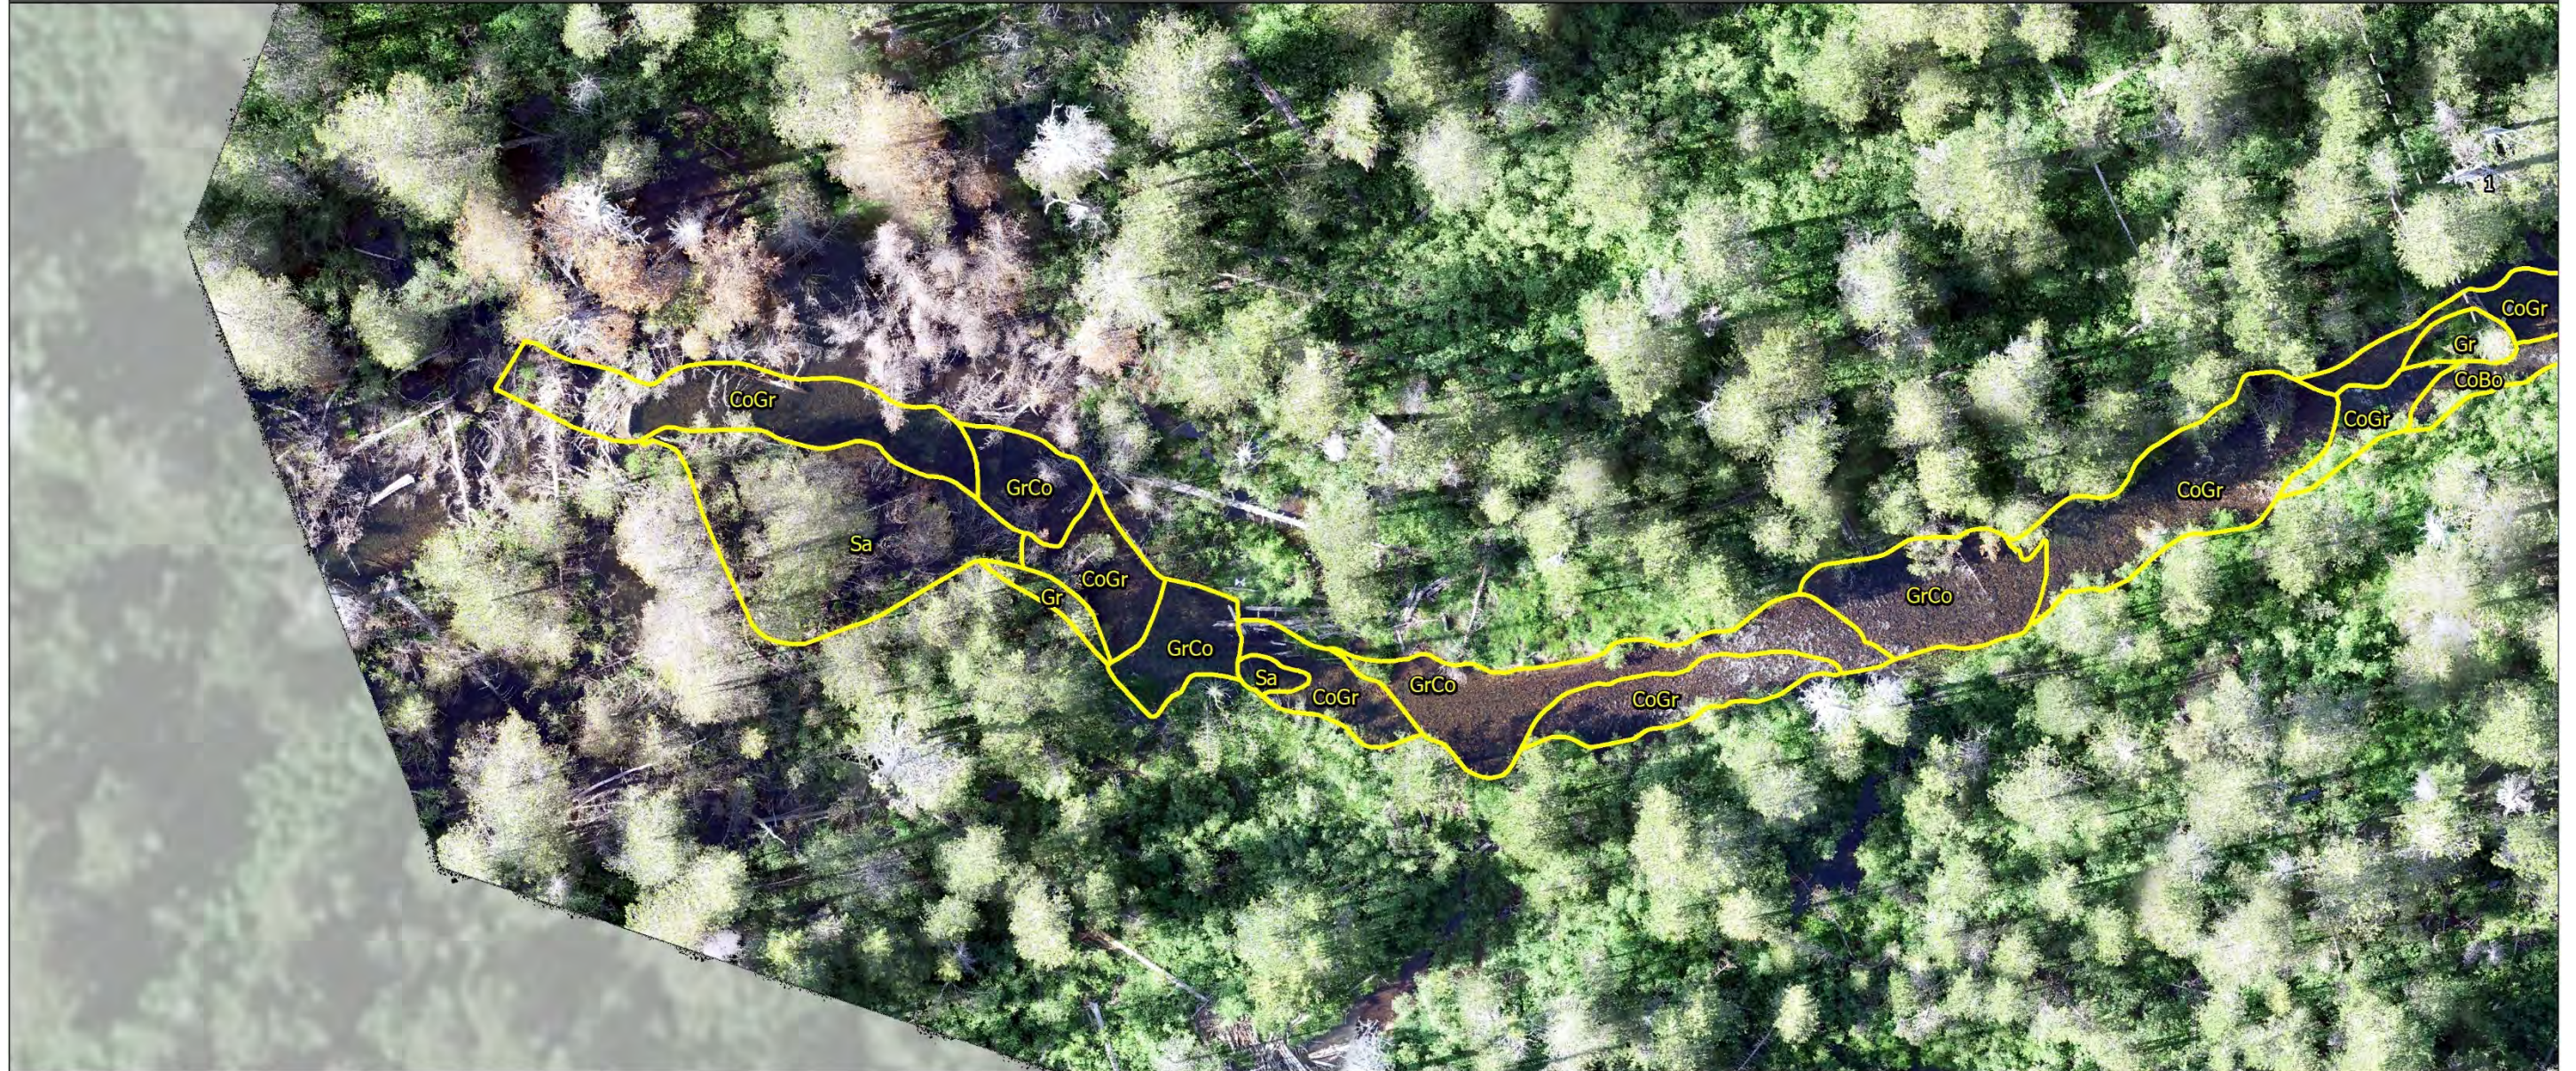
Facies Mapping at LLD-G2 (Loon Lake Middle Reach)

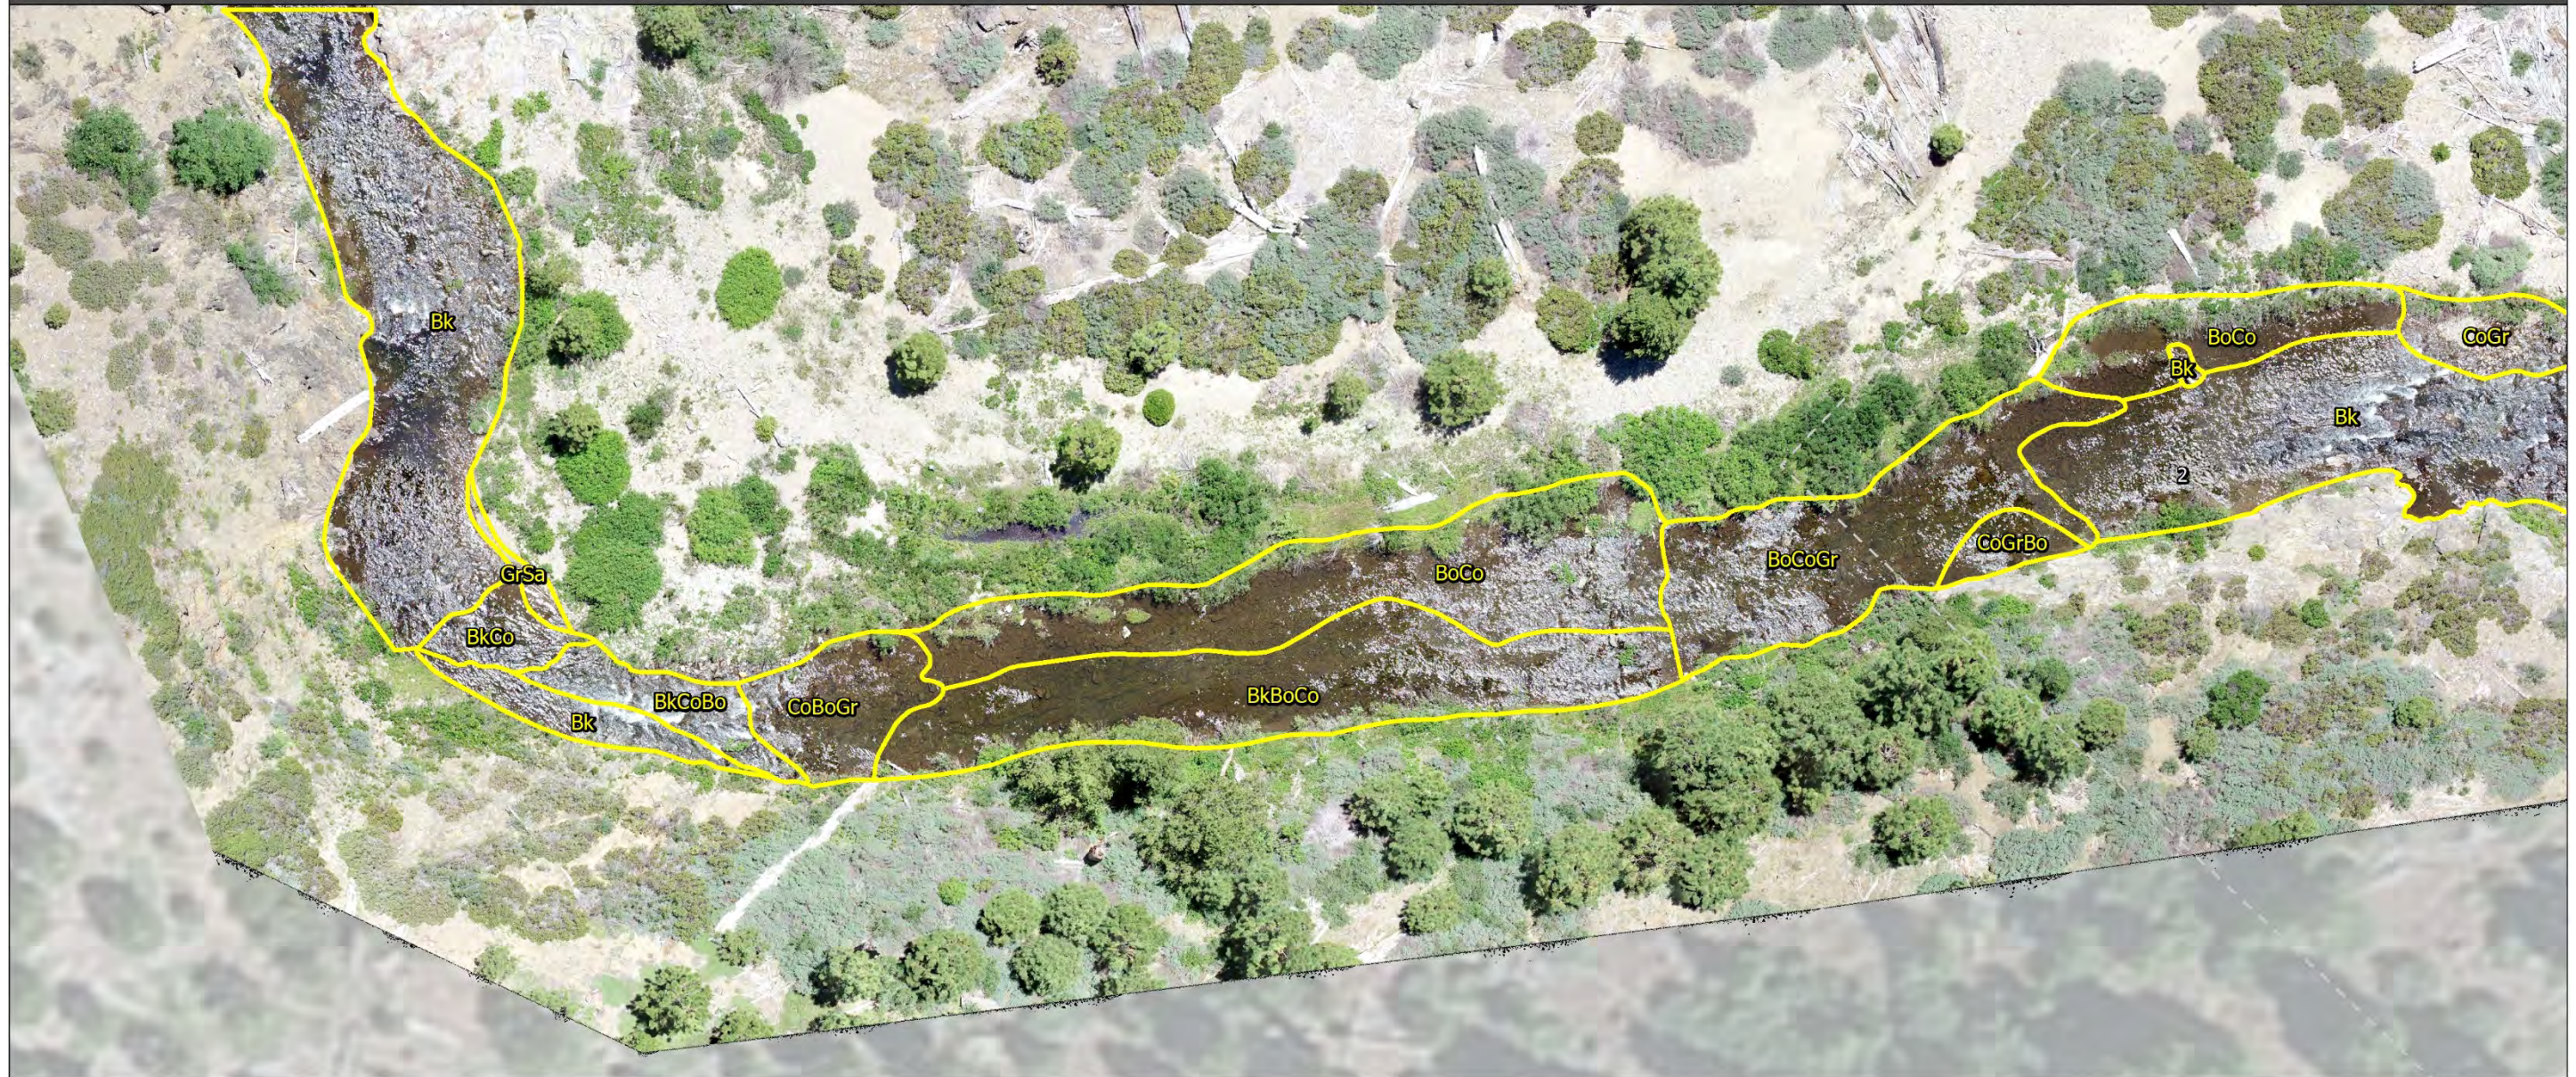
Facies Mapping at IHD-G2 (Ice House Lower Reach)

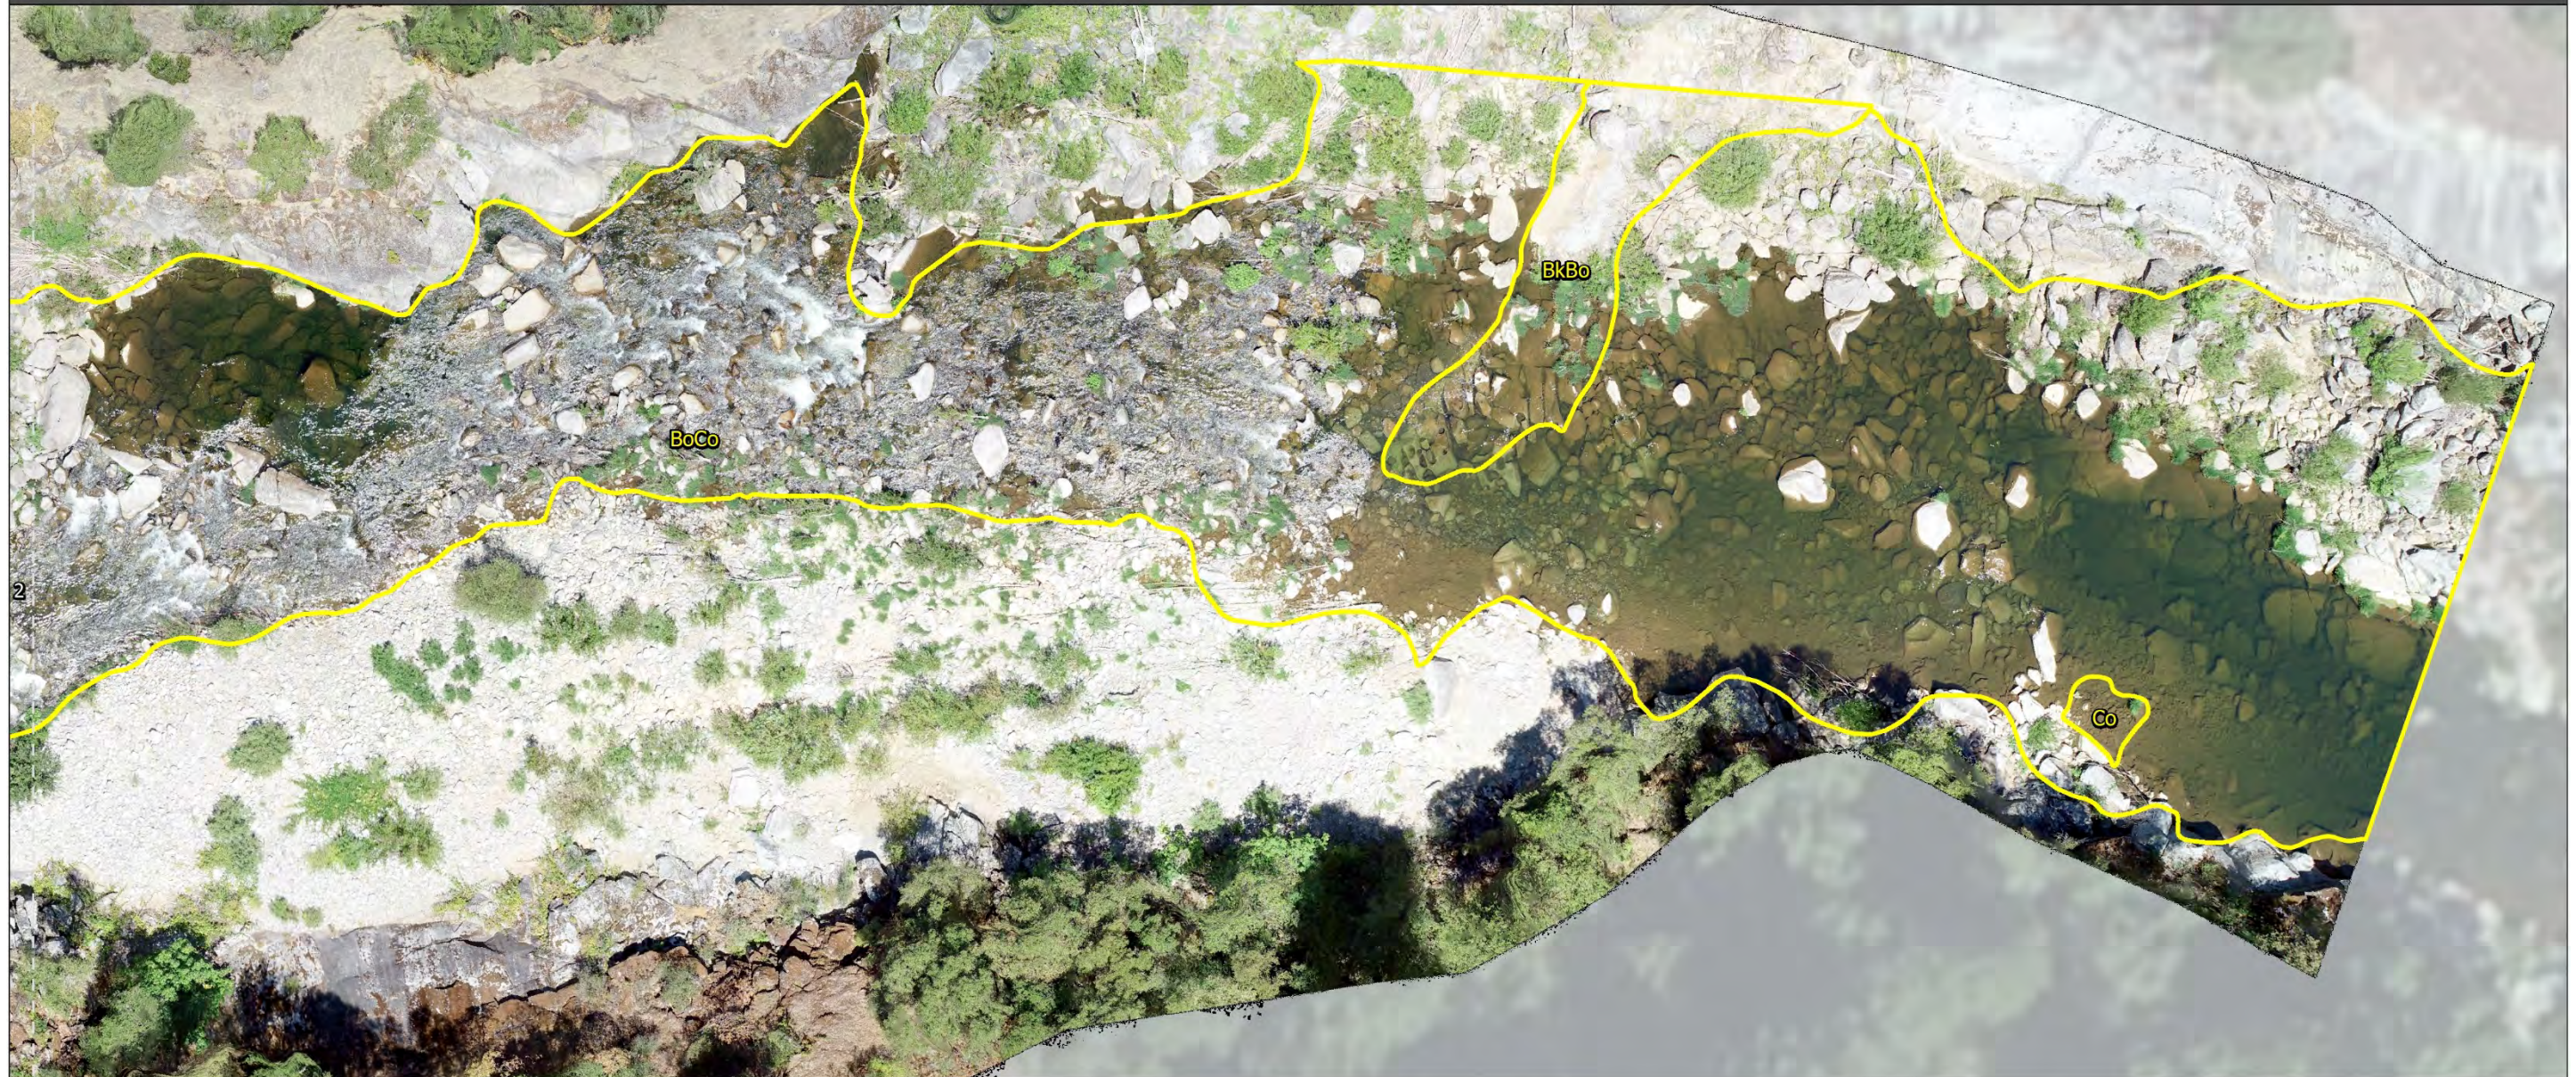
Facies Mapping at SCD-G1 (Slab Creek Reach)

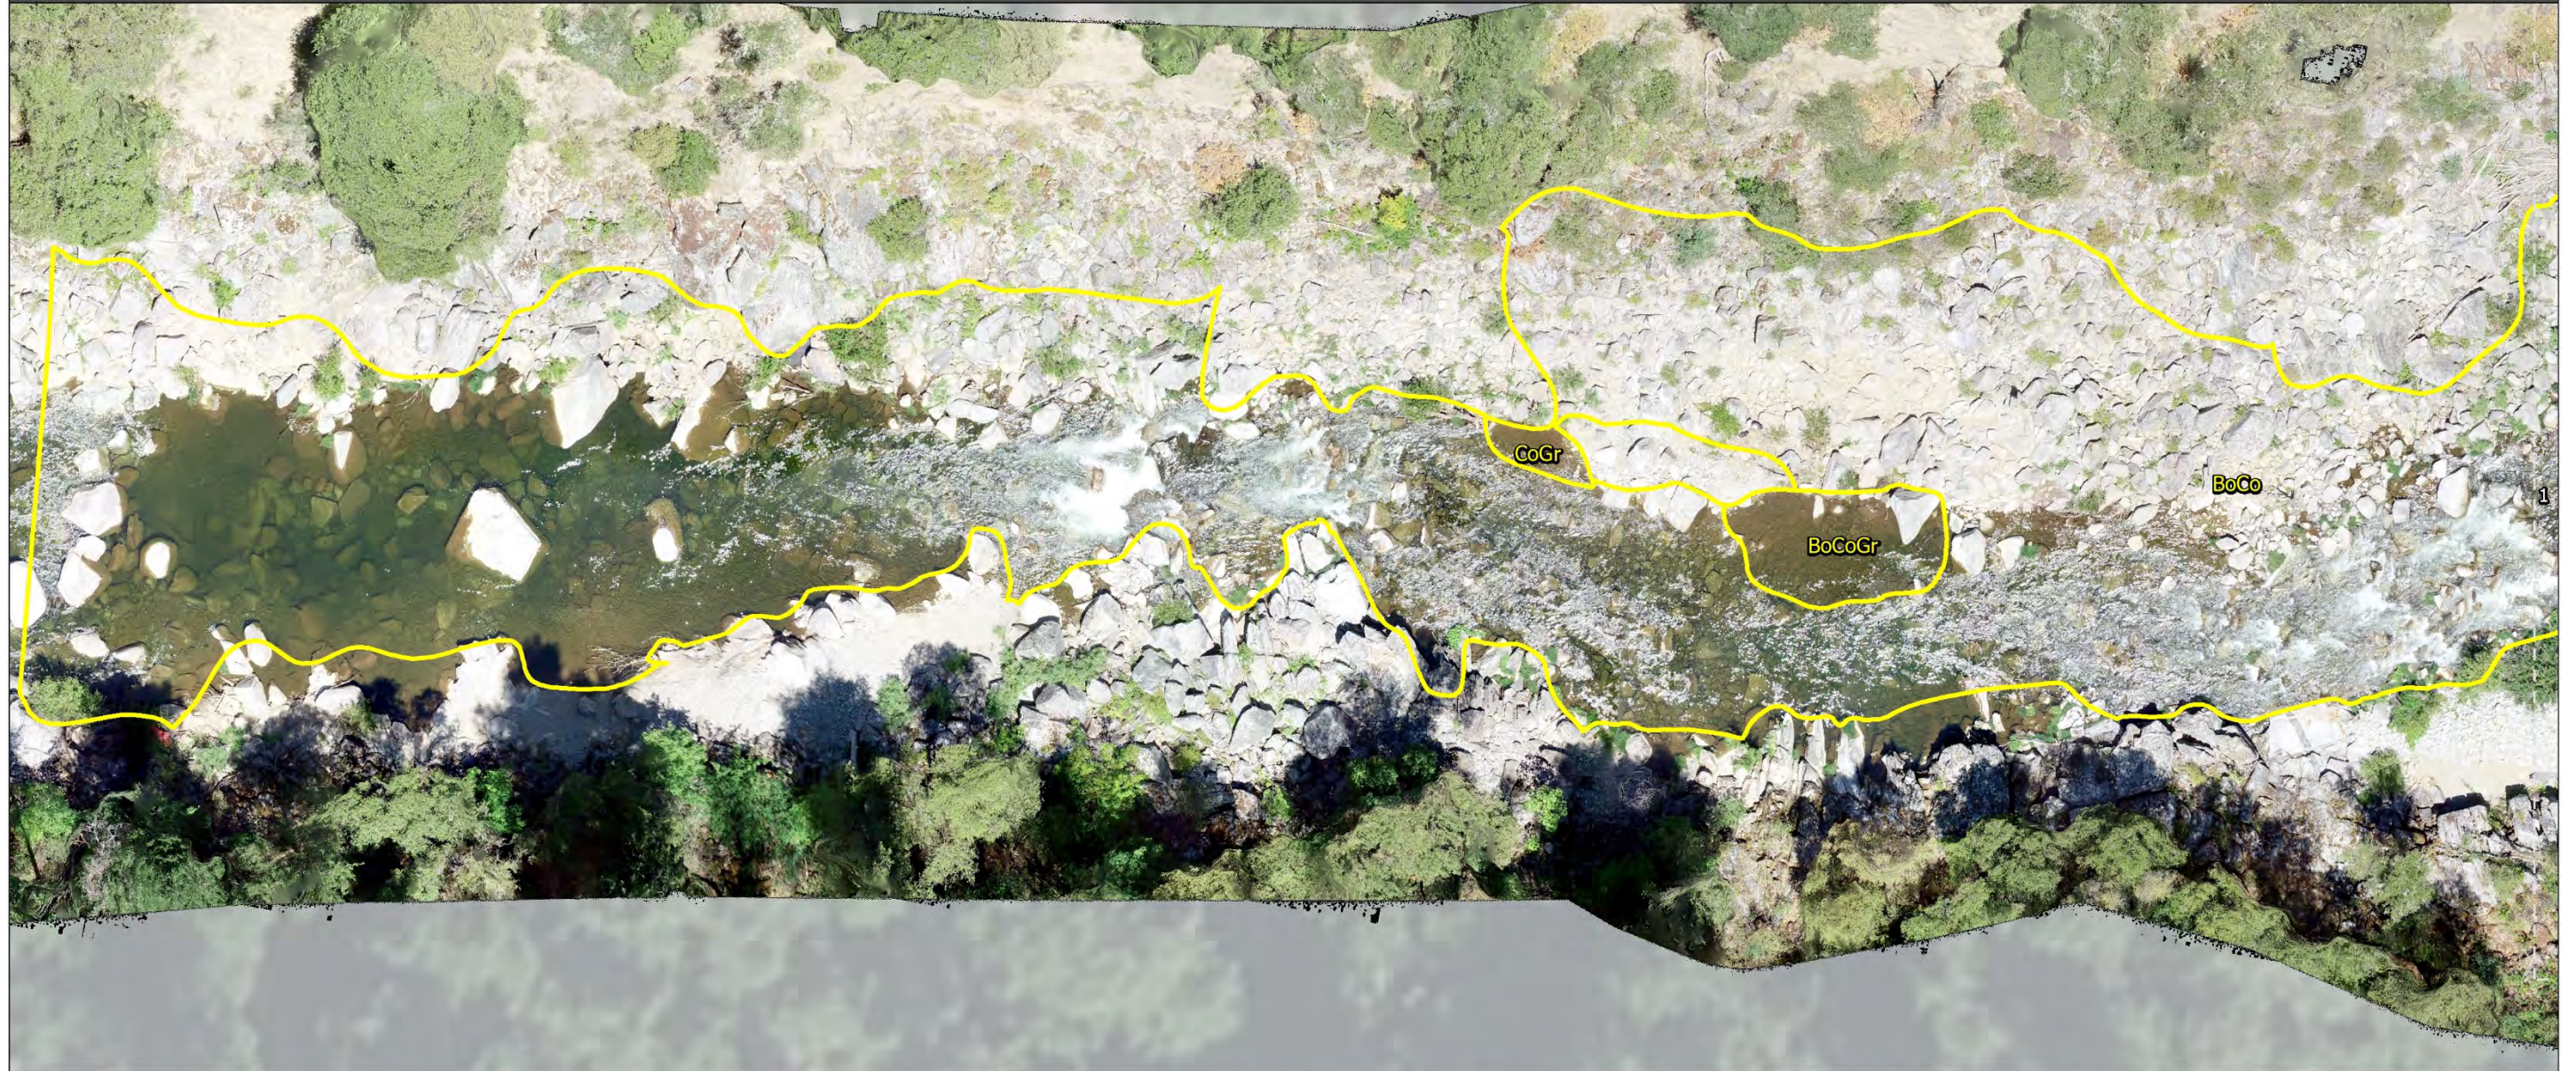
Facies Mapping at SCD-G1 (Slab Creek Reach)
