Monitoring Program 2021 Final Annual Report Sacramento Municipal Utility District

Hydro License Implementation • June 2022

Upper American River Project

FERC Project No. 2101

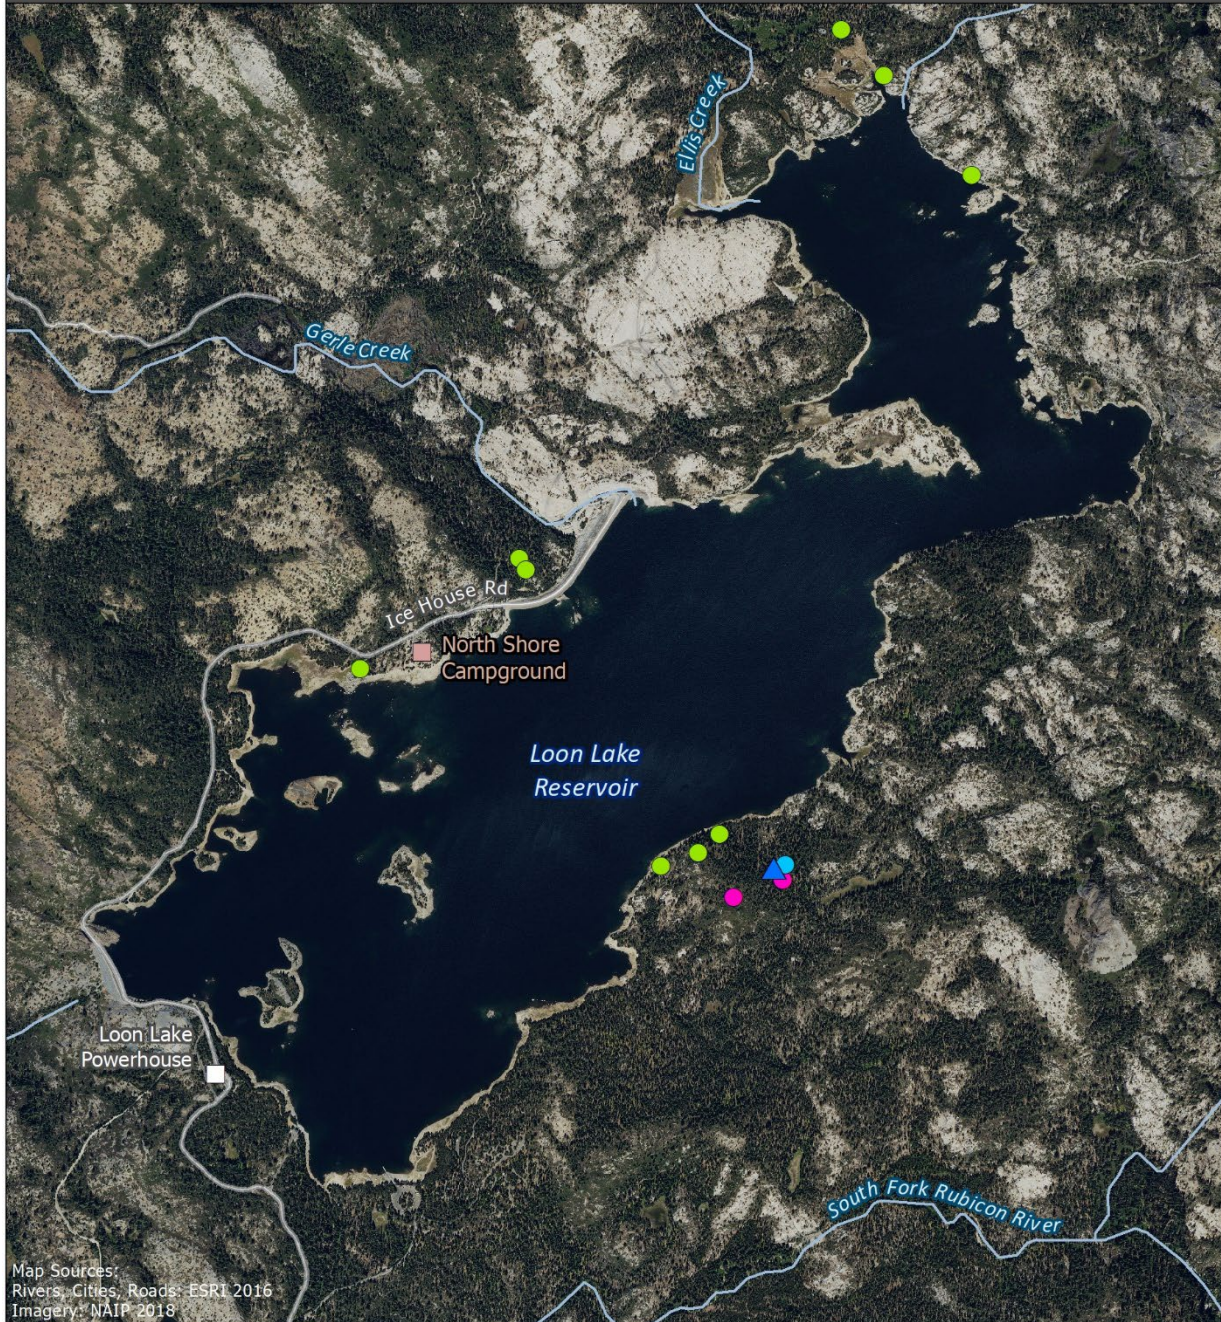
Figure 2-7. Bald eagle activity sites at Loon Lake Reservoir.

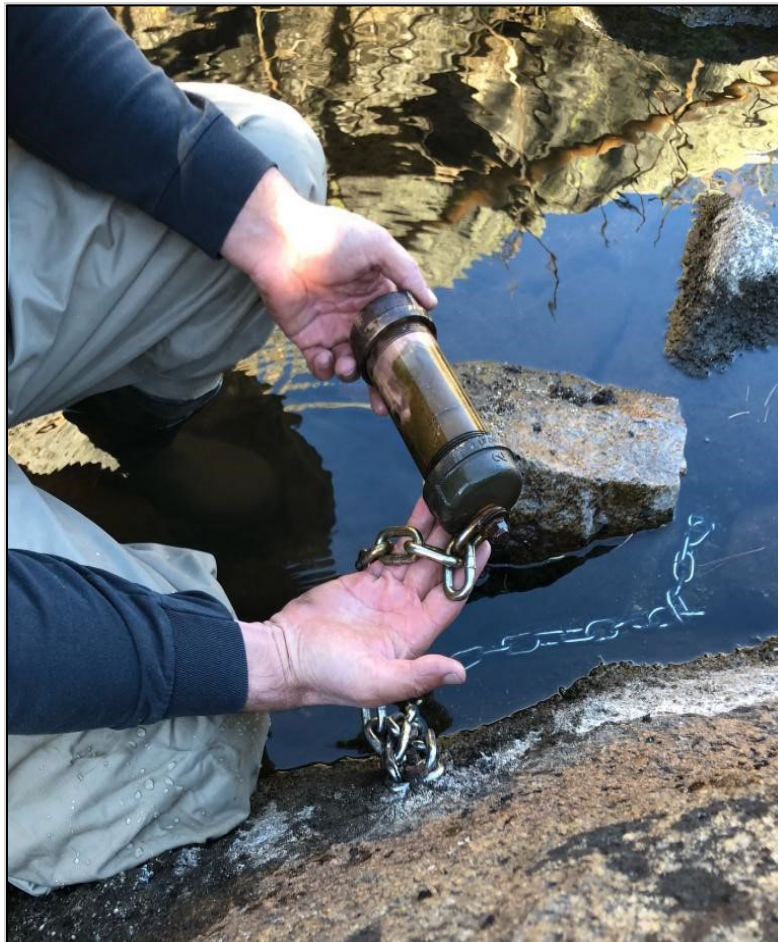
Figure 6-1. Photograph of the water temperature datalogger housing, Rubicon River below confluence of Little Rubicon River.

Each housing was secured to large boulders or bedrock using hardened 3/8-inch chain and placed to assure that the sensor remained submerged and was not exposed to direct sunlight (Figure 6-1). Two dataloggers were installed at each site to protect against data loss in the event of equipment failure or drift. Dataloggers were deployed in habitat strata where the water was well mixed, typically at the head of a pool just below a riffle input. Table 6-2 describes the equipment specifications for all sensors selected for water temperature monitoring.
