Monitoring Program 2022 Final Annual Report Sacramento Municipal Utility District

Hydro License Implementation • June 2023

Upper American River Project

FERC Project No. 2101

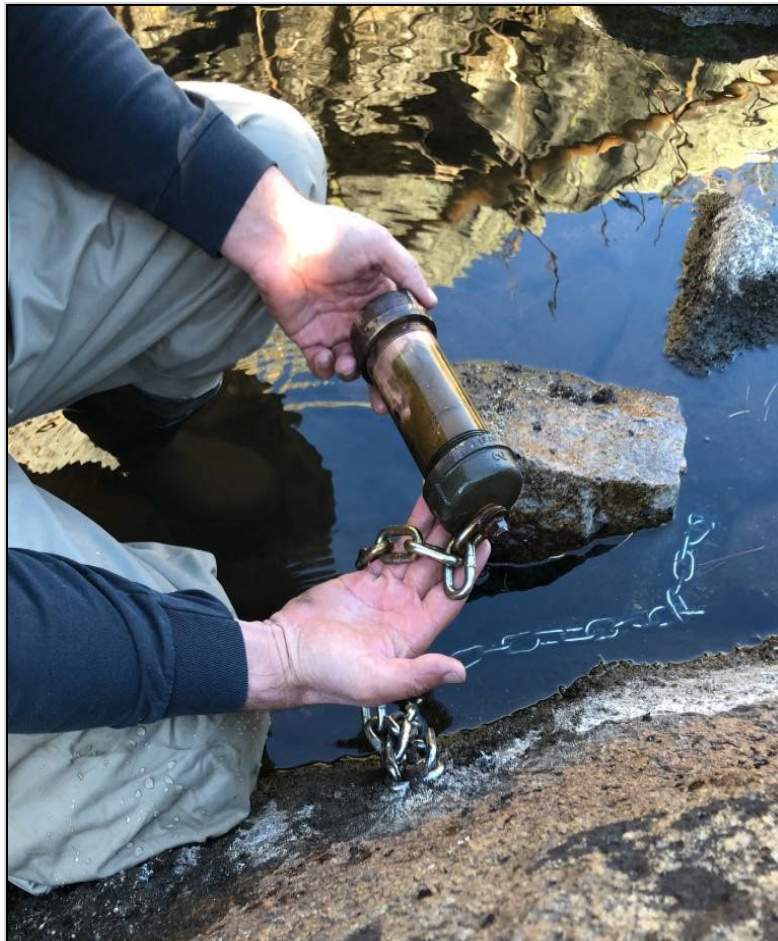
Figure 5-1. Photograph of the water temperature datalogger housing, Rubicon River below confluence of Little Rubicon River.

Each housing was secured to large boulders or bedrock using hardened 3/8-inch chain and placed to assure that the sensor remained submerged and was not exposed to direct sunlight (Figure 5-1). Two dataloggers were installed at each site to protect against data loss in the event of equipment failure or drift. Dataloggers were deployed in habitat strata where the water was well mixed, typically at the head of a pool just below a riffle input. Table 5-2 describes the equipment specifications for all sensors selected for water temperature monitoring.
