APPENDIX O

FACIES MAPS FOR THE UARP PROJECT AREA SITES

UARP:

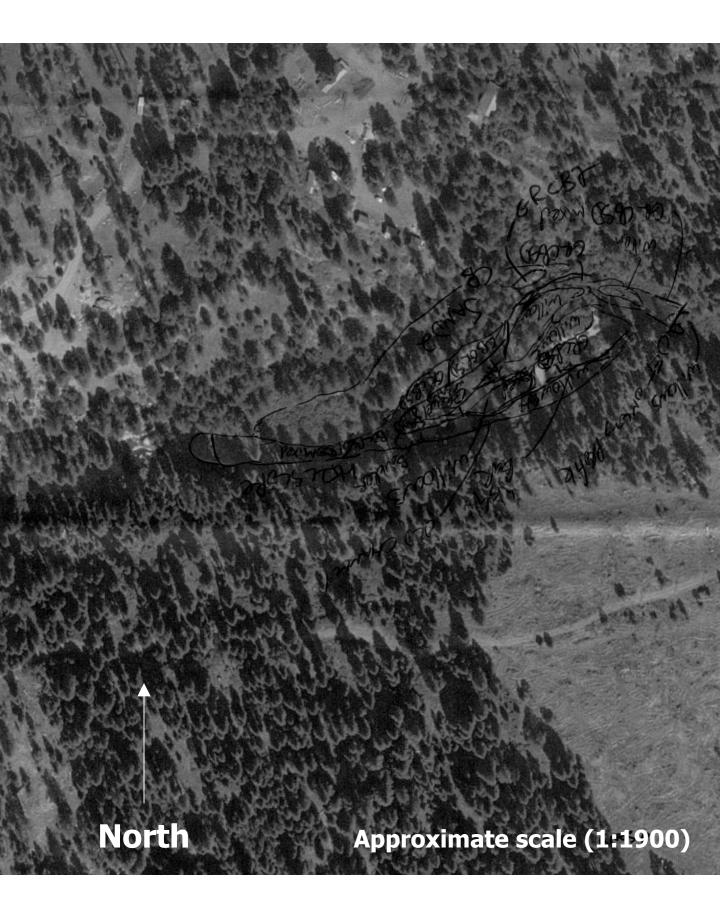
Robbs Peak Dam Reach Site (RPD-G1)

The channel substrate at the Robbs Peak Dam Reach Site is primarily coarse gravel, mixed with cobble and sand. Dense boulder deposits also exist, but are discontinuous. The active floodplain is wide with multiple flow paths, and sand is deposited on the margins and along the inside of the river meanders. Willows and some conifers grow in the channel, with frequent large woody debris piles observed above the low-flow wetted channel.

GRCBSD = Mixed gravel, cobble, and sand. Algae covering rocks.

CB = Cobble sorted on outside of bend. Estimated d50 = 70mm.

CBGRSD = mixed cobble, gravel, and sand. Coarser than upstream unit. Estimated d50 = 60 mm.

BOCBSD1 = Deposits of boulder, cobble, and sand with minor amounts of gravel. Estimated d50 without the sand = 120mm.

Mixed GRCBBOSD = Gravel, cobble, boulder, and sand mixed. Sand is in discrete patches. Estimated d50 = 100mm. Very high widely distributed . Sediment covered with algae. Channel boulders dense in some places, but not continuous.

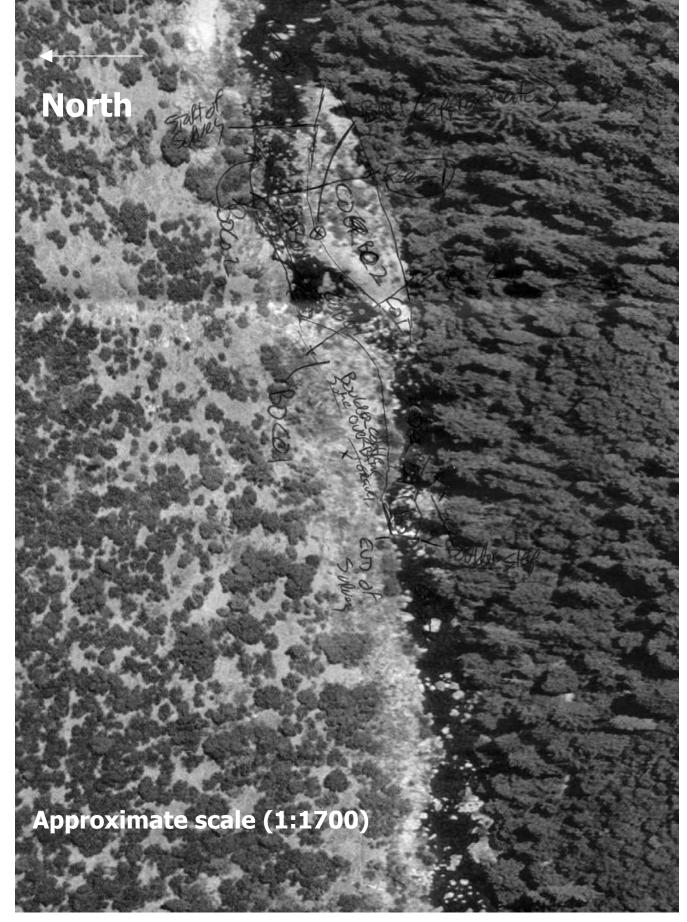
Slab Creek Dam Reach Site (SC-G1)

Boulders and large cobble dominate substrate facies along the channel at the Slab Creek Dam Reach Site. The upper banks are characterized by moderate slopes with large boulders and bedrock outcrops. Primary channel flow meanders around two large boulder and cobble point bars. Minimal amounts of gravel are deposited in the low velocity areas behind boulders and bedrock flow obstructions. A thin veneer of silt is deposited along the margins of the low flow channel. Light shrubs and small trees are scattered in the boulder banks, but become denser up slope from the boulders.

CO1 = Cobble with few boulders on downstream end of bar. Estimated d50 is 80mm.

BOCO1 = Boulder field with cobbles and small patches of overbank gravel deposits. Estimated d50 is 500 mm.

BO1 = Boulder and bedrock steps in channel.

COBO1 = Channel cobbles and boulders, with very little gravel. Boulders arrangedon small steps. Estimate <math>d50 = 200 mm.

COBO2 = Cobble and boulder bar on left bank, with some gravel. Boulders are not arranged as steps. Estimated d50 = 180mm.
