Water Temperature Monitoring Report

Sacramento Municipal Utility District

Hydro License Implementation • June 2018

Upper American River Project

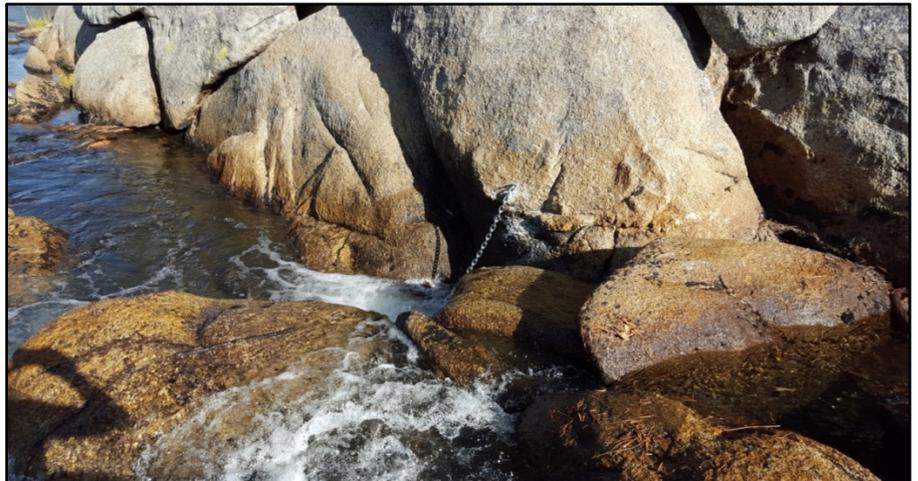
Photo 1 – Typical install for the ONSET HOBO water temperature sensors. Sensors were installed in a metal housing secured to bedrock by heavy chain.

Each housing was secured to large boulders or bedrock using hardened 3/8" chain and placed to assure that the sensor remained submerged and was not exposed to direct sunlight (Photos 1, 2). Two dataloggers were installed at each site to protect against data loss in the event of equipment failure or drift. Dataloggers were deployed in habitat strata where the water was well-mixed, typically at the head of a pool just below a riffle input.

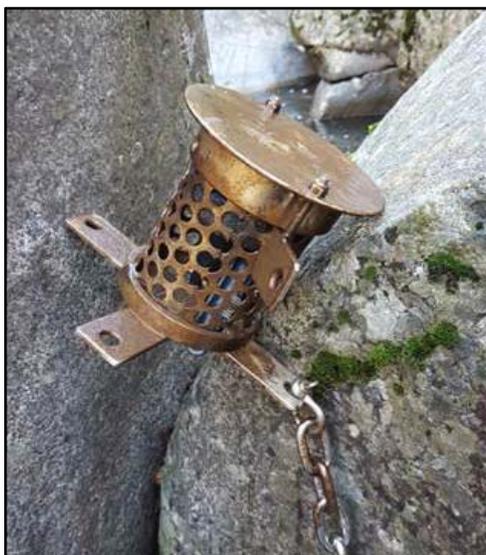
Photo 2 – Recovered datalogger showing the standard metal housing that the HOBO dataloggers were installed in.

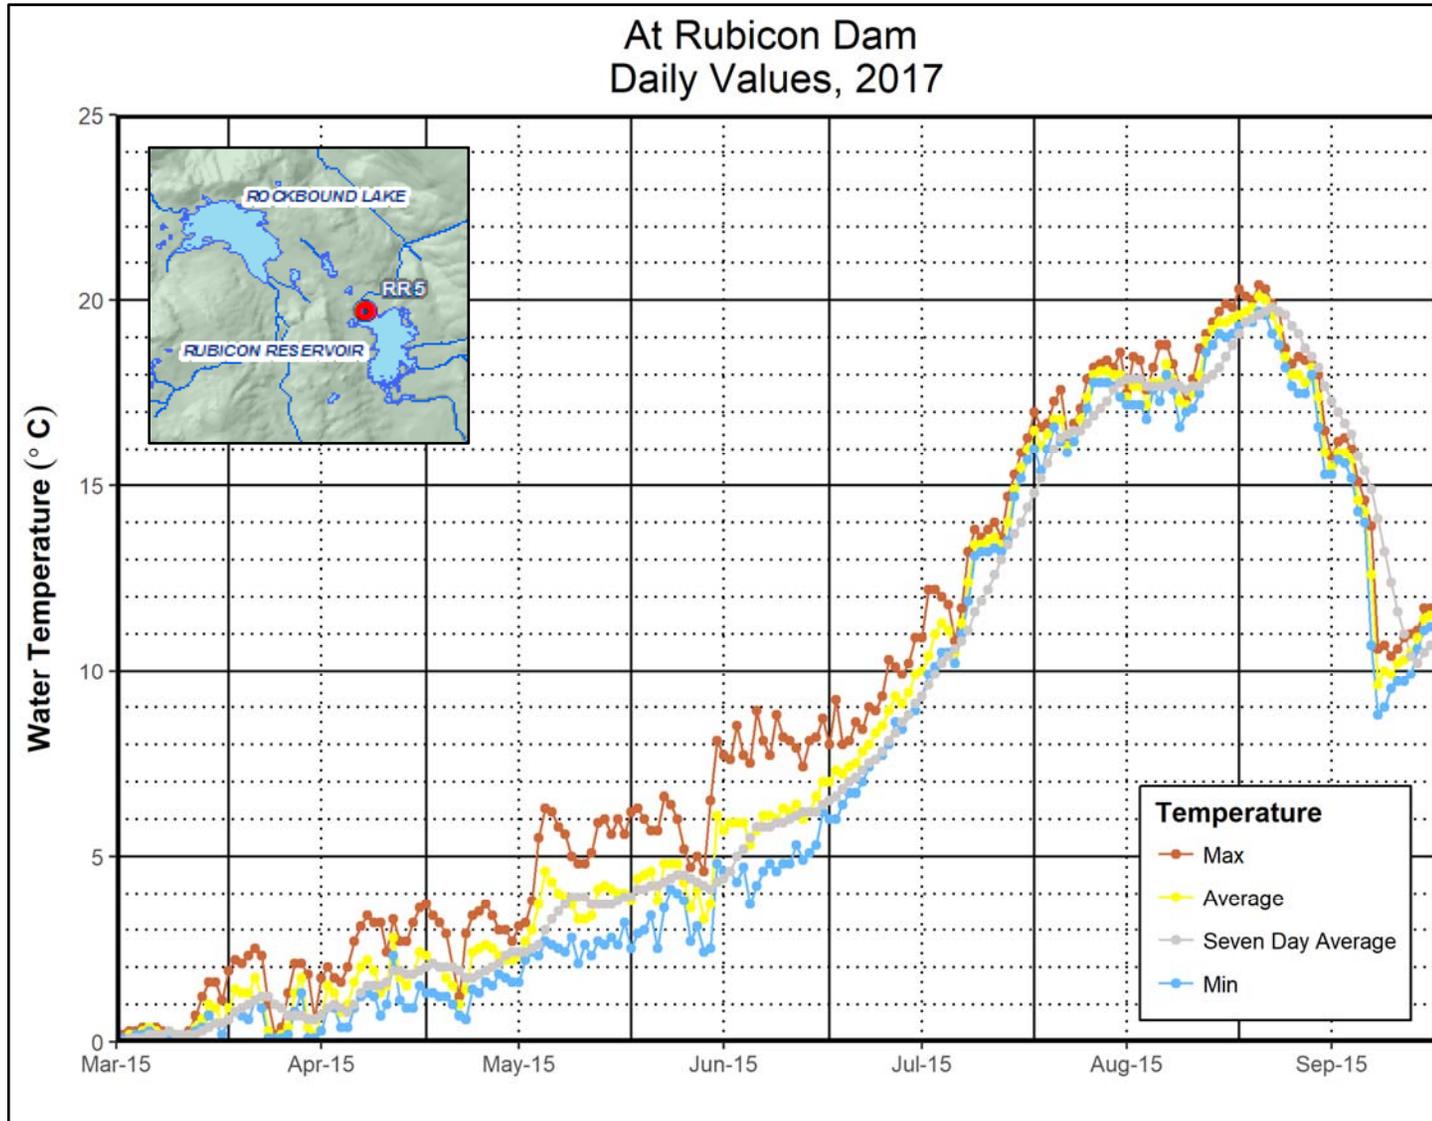
Figure 1 - Little Rubicon River immediately below Rubicon Reservoir Dam (RR5)

Water temperature data is presented graphically in figures one through sixteen. It is impractical to place hourly and daily data for all sites into this report, although this data will be made available upon request.

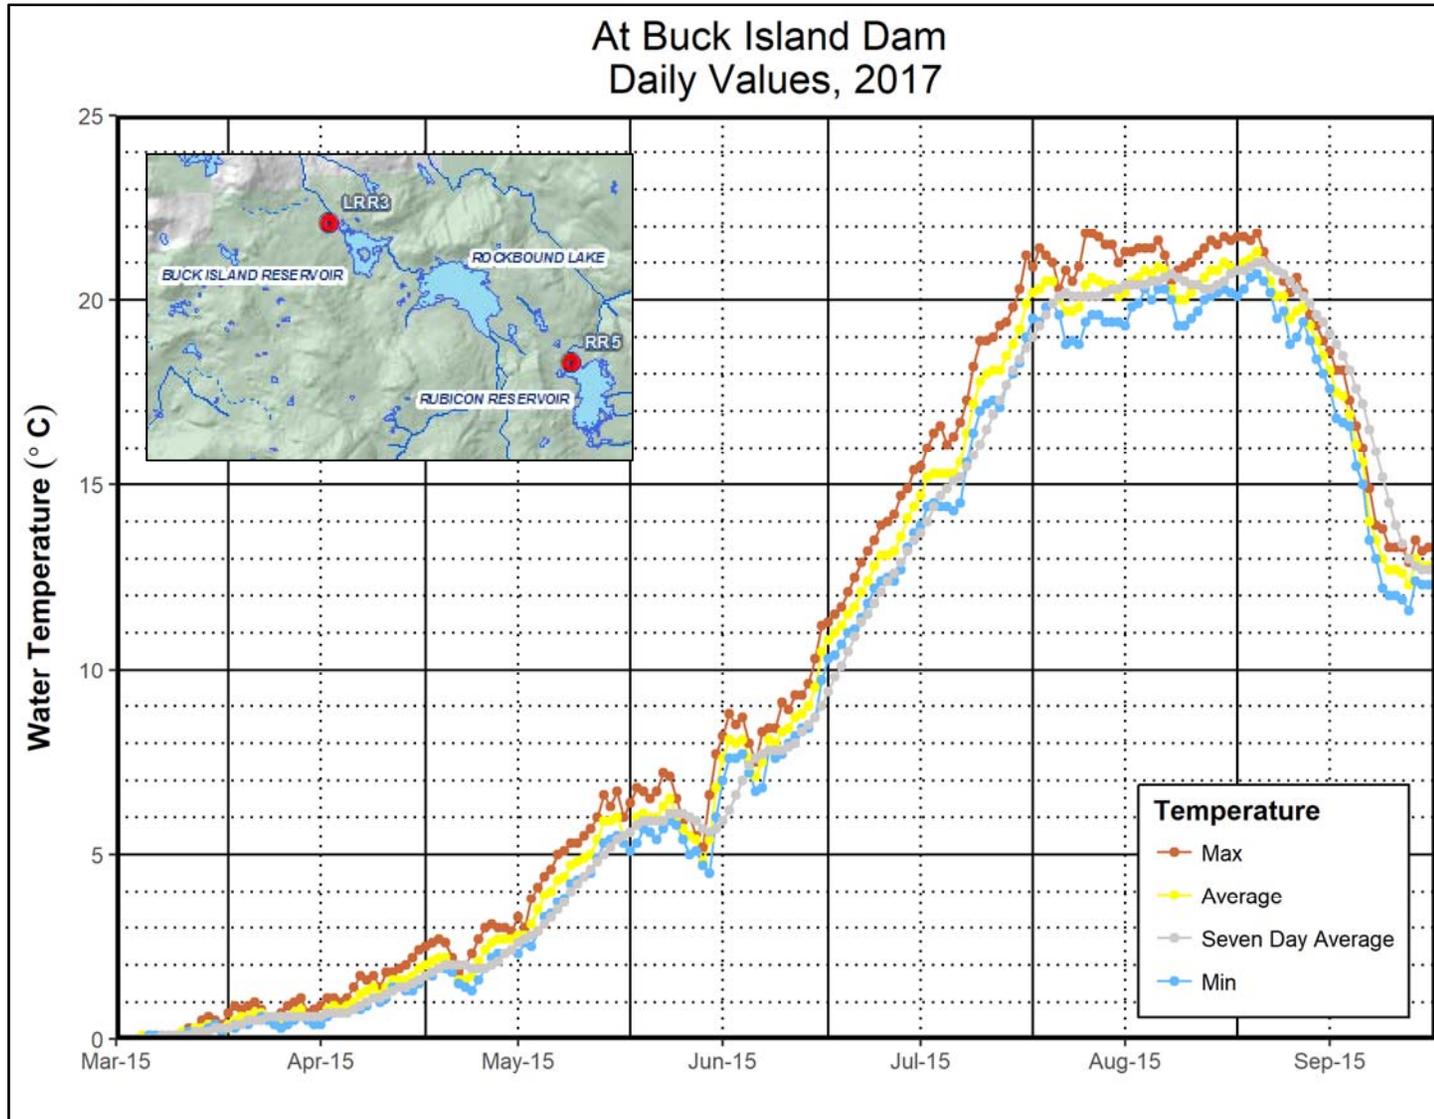
Figure 2 - Little Rubicon River Immediately below Buck Island Reservoir Dam (LRR3)

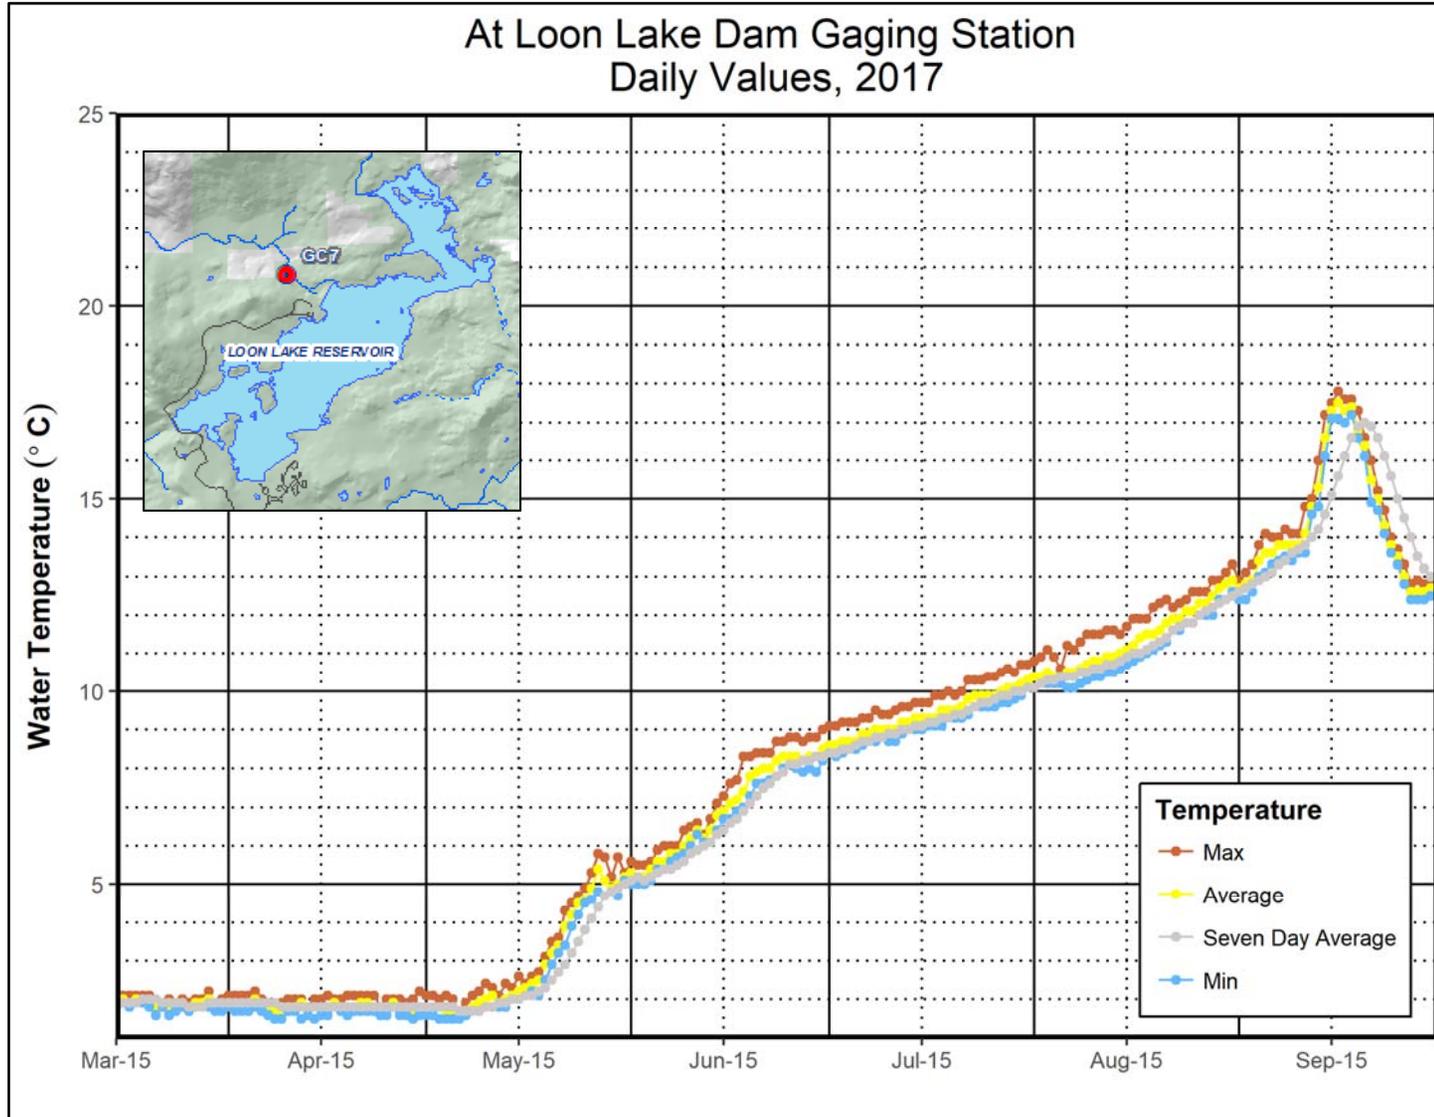
Figure 3 - Gerle Creek Immediately below Loon Lake Reservoir Dam (GC7)

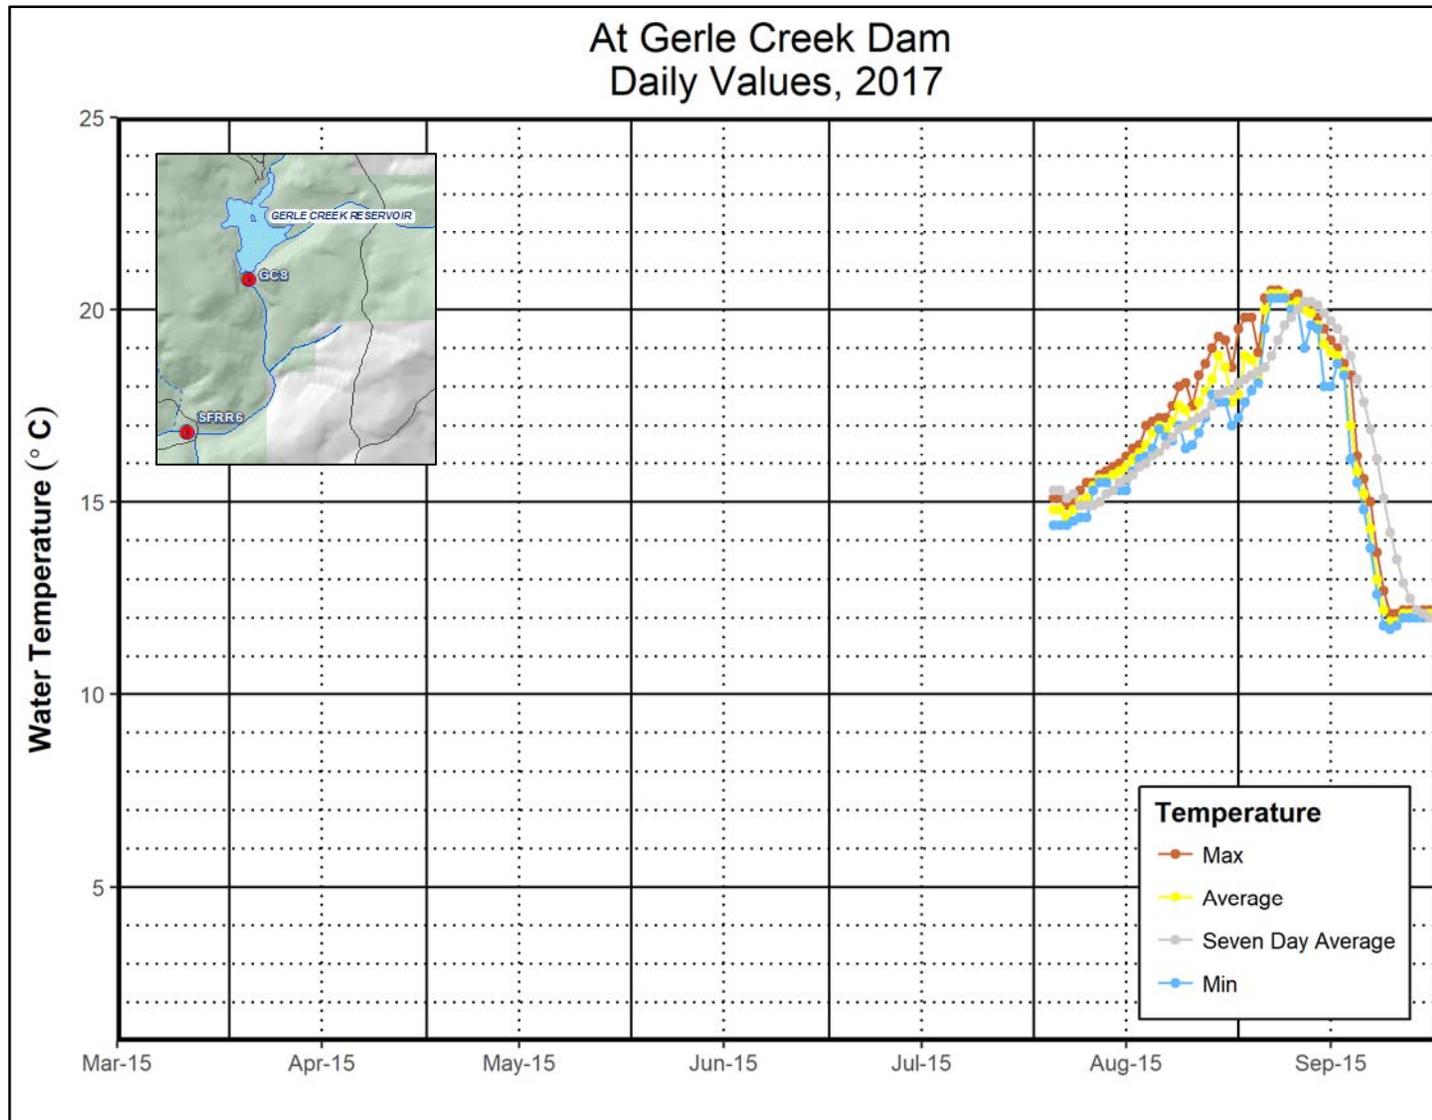
Figure 4 - Gerle Creek immediately below Gerle Creek Reservoir Dam (GC8)

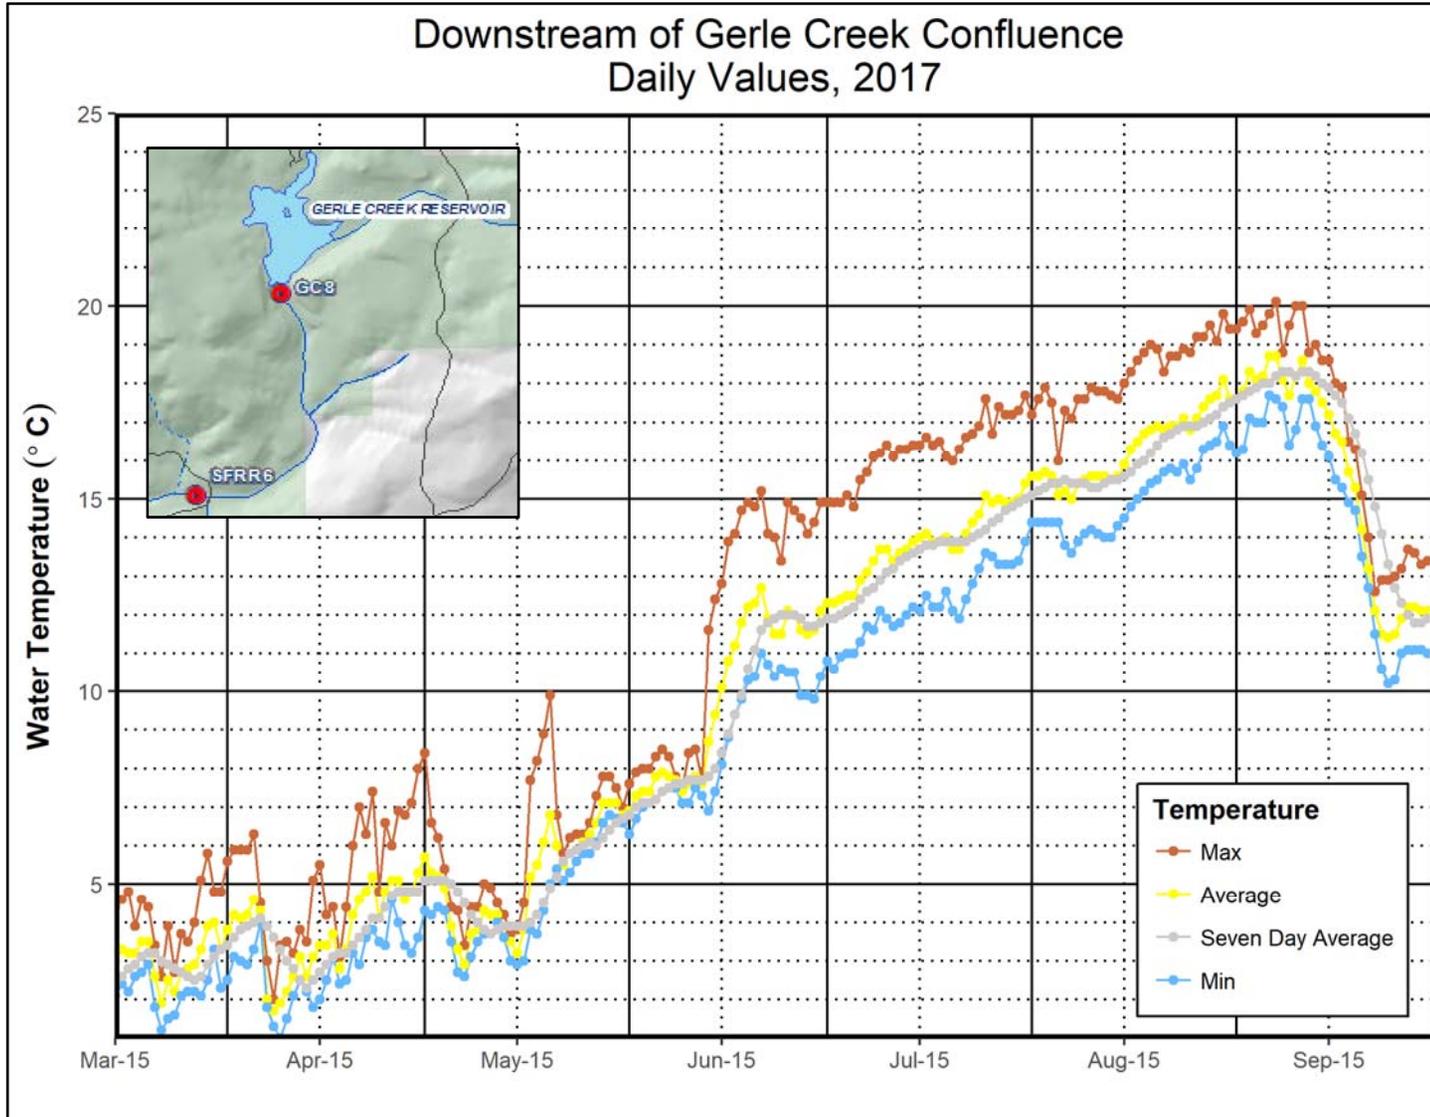
Figure 5 - SF Rubicon River below confluence of Gerle Creek (SFRR6)

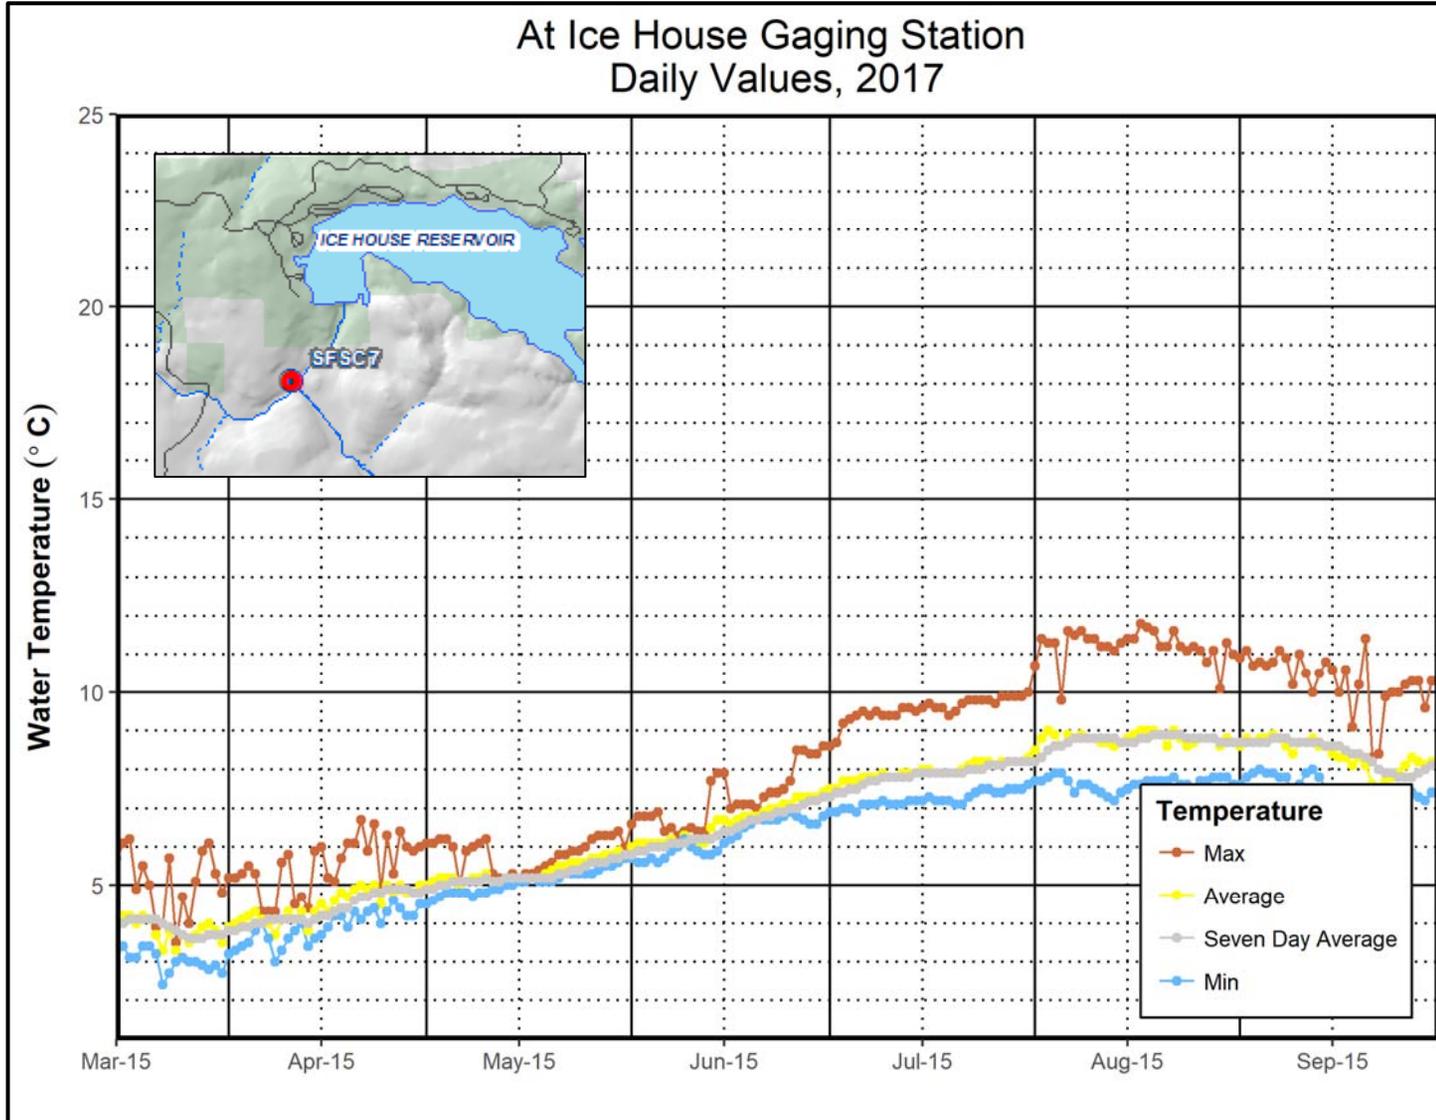
Figure 6 - South Fork Silver Creek immediately below Ice House Reservoir Dam (SFSC7)

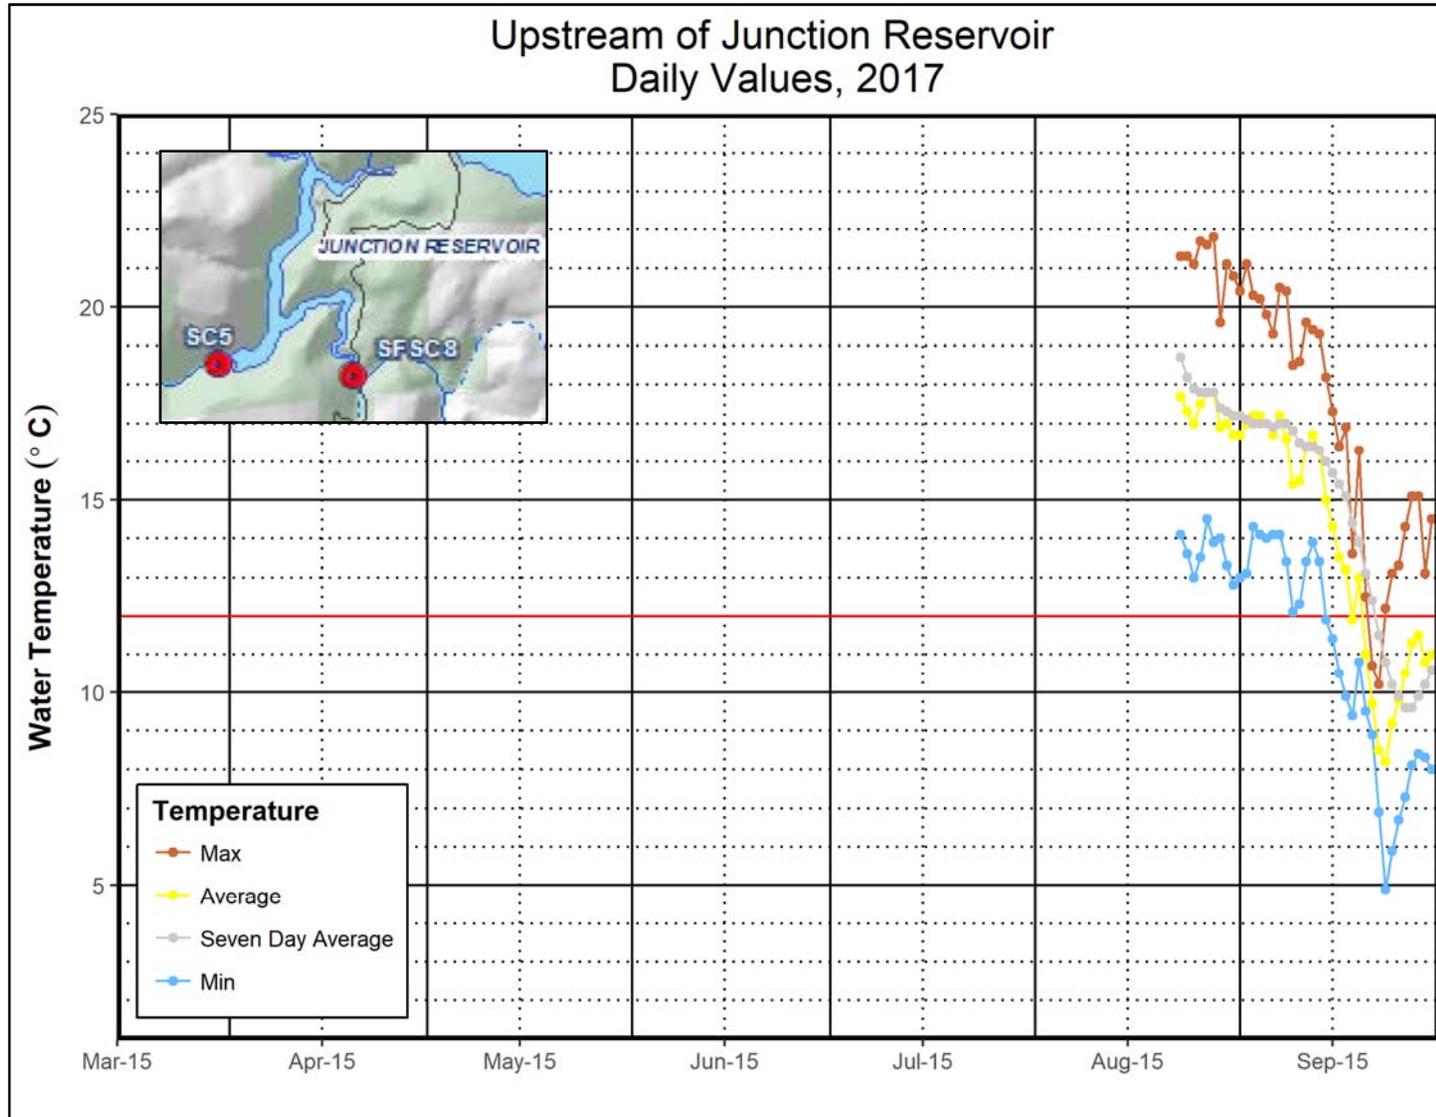
Figure 7 - South Fork Silver Creek immediately upstream of Junction Reservoir (SFSC8)

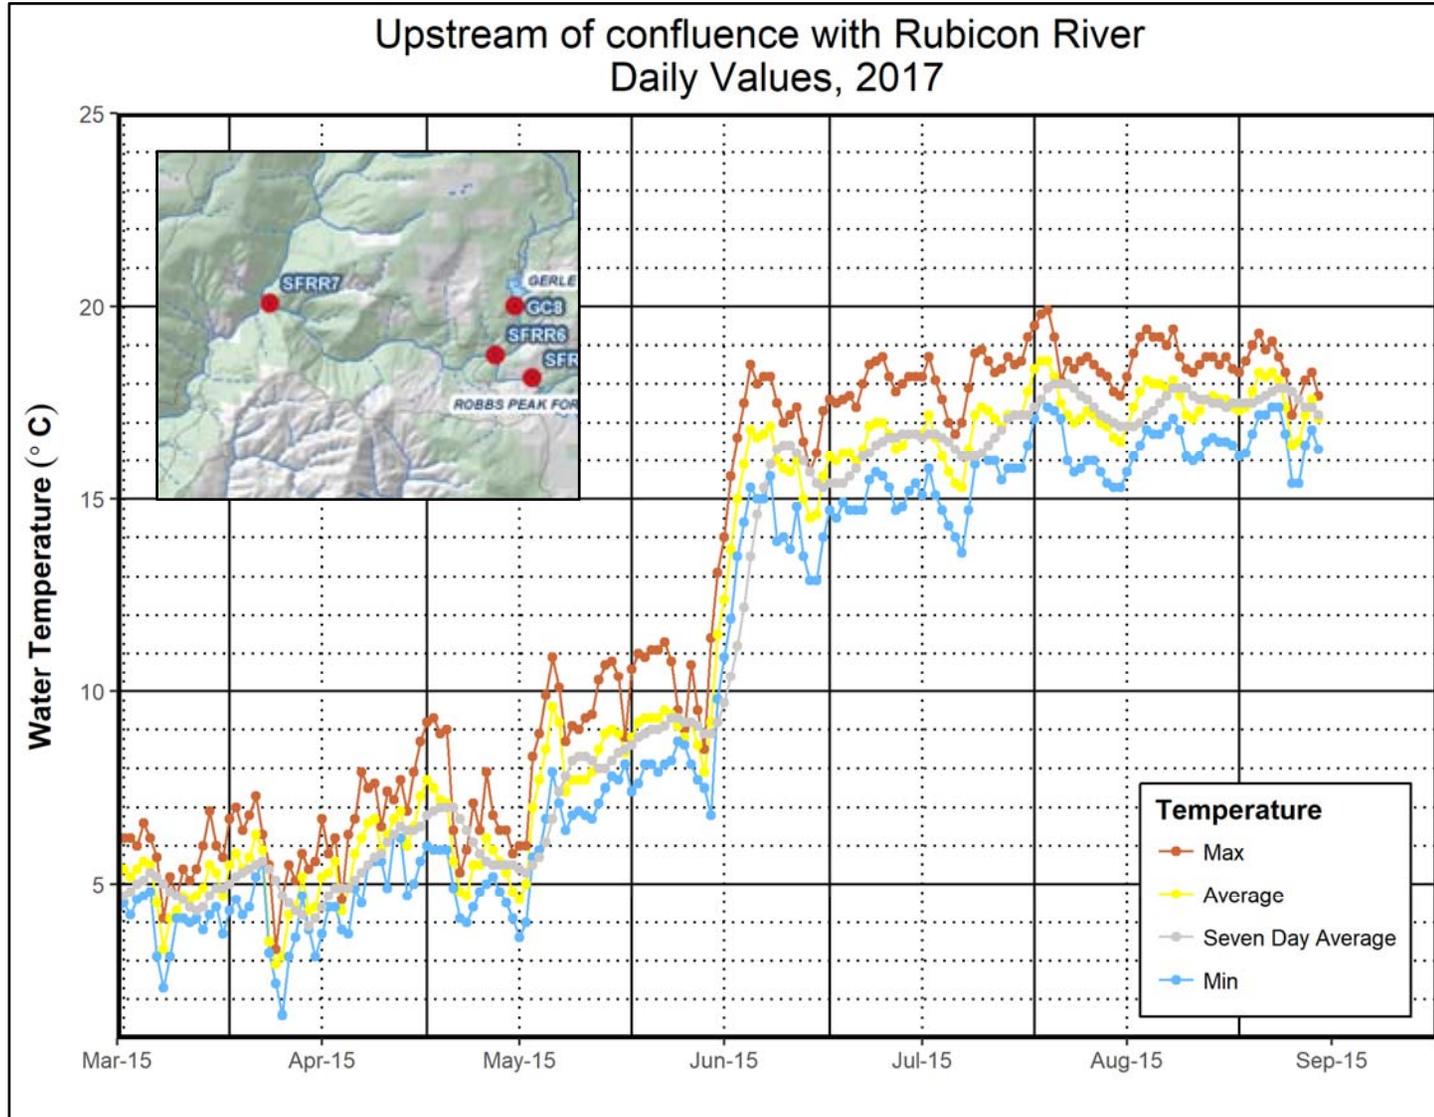
Figure 8 - SF Rubicon River immediately upstream of the confluence with the Rubicon River (SFRR7)

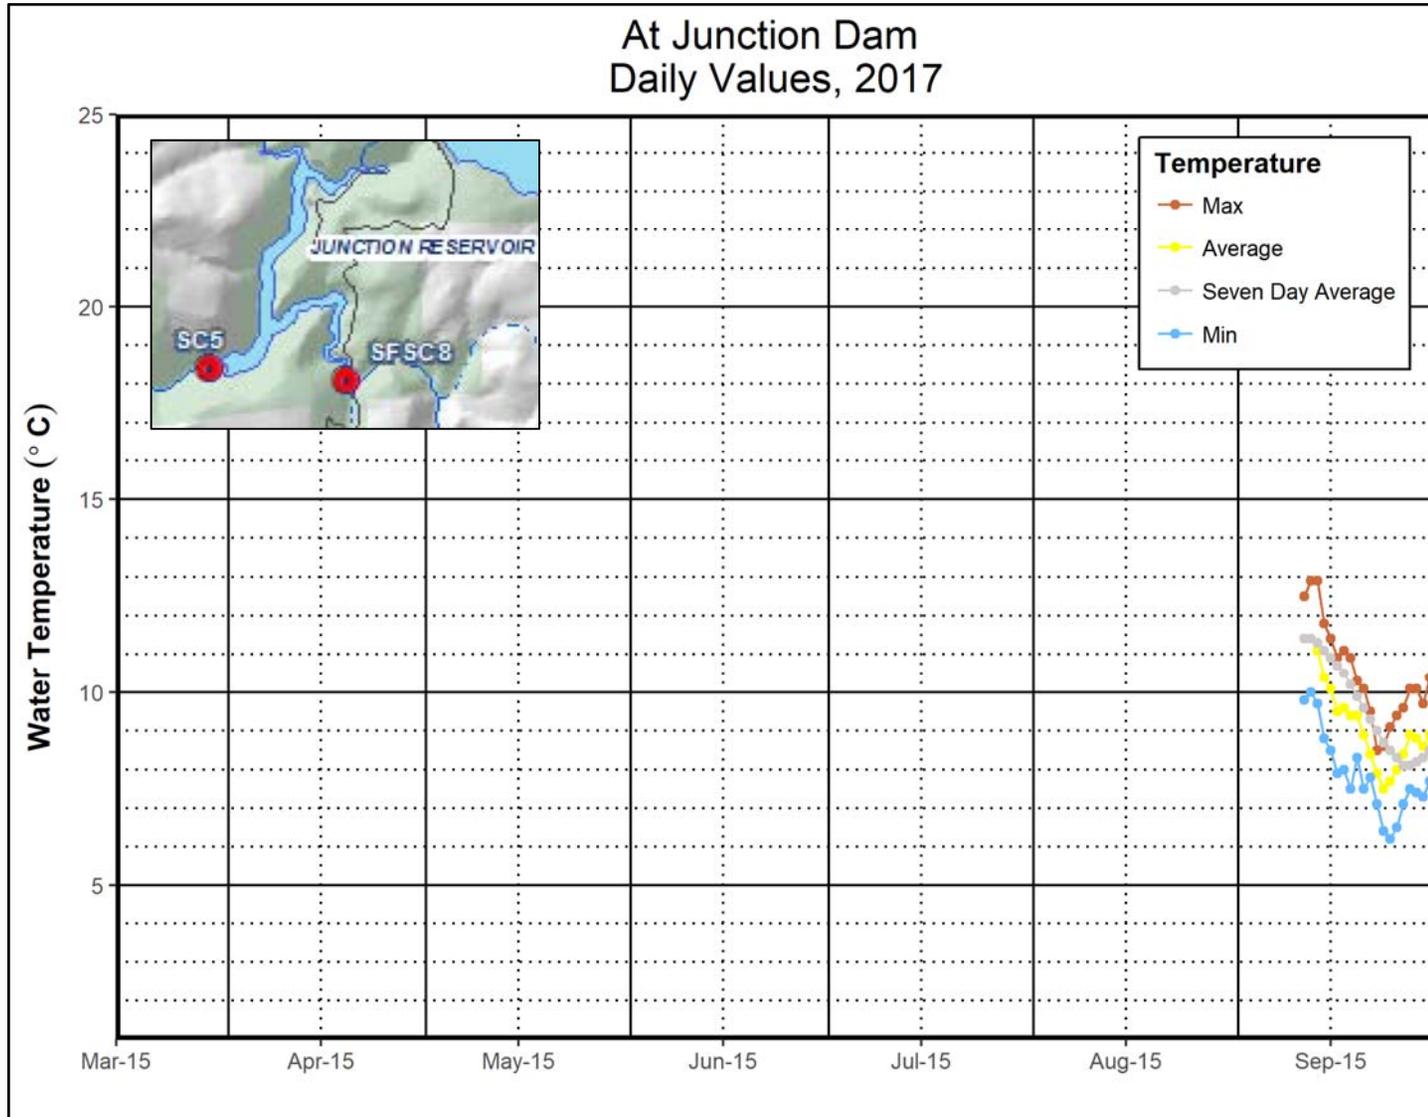
Figure 9 - Silver Creek immediately below Junction Reservoir Dam (SC5)

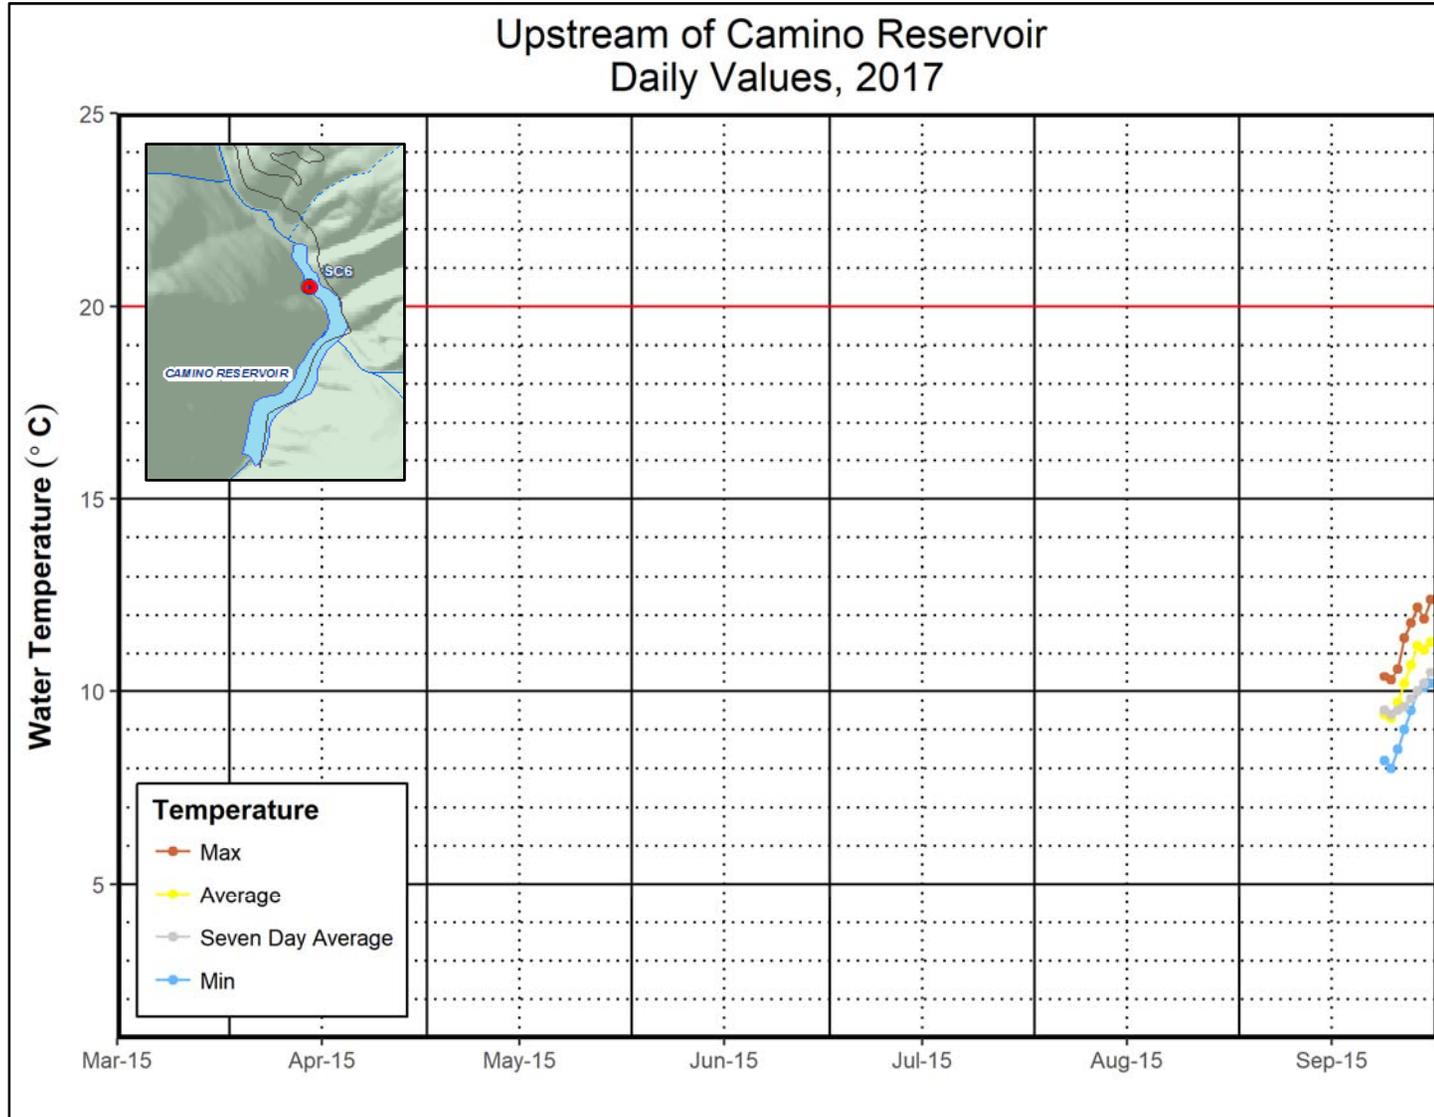
Figure 10 - Silver Creek immediately above Camino Reservoir Dam (SC6)

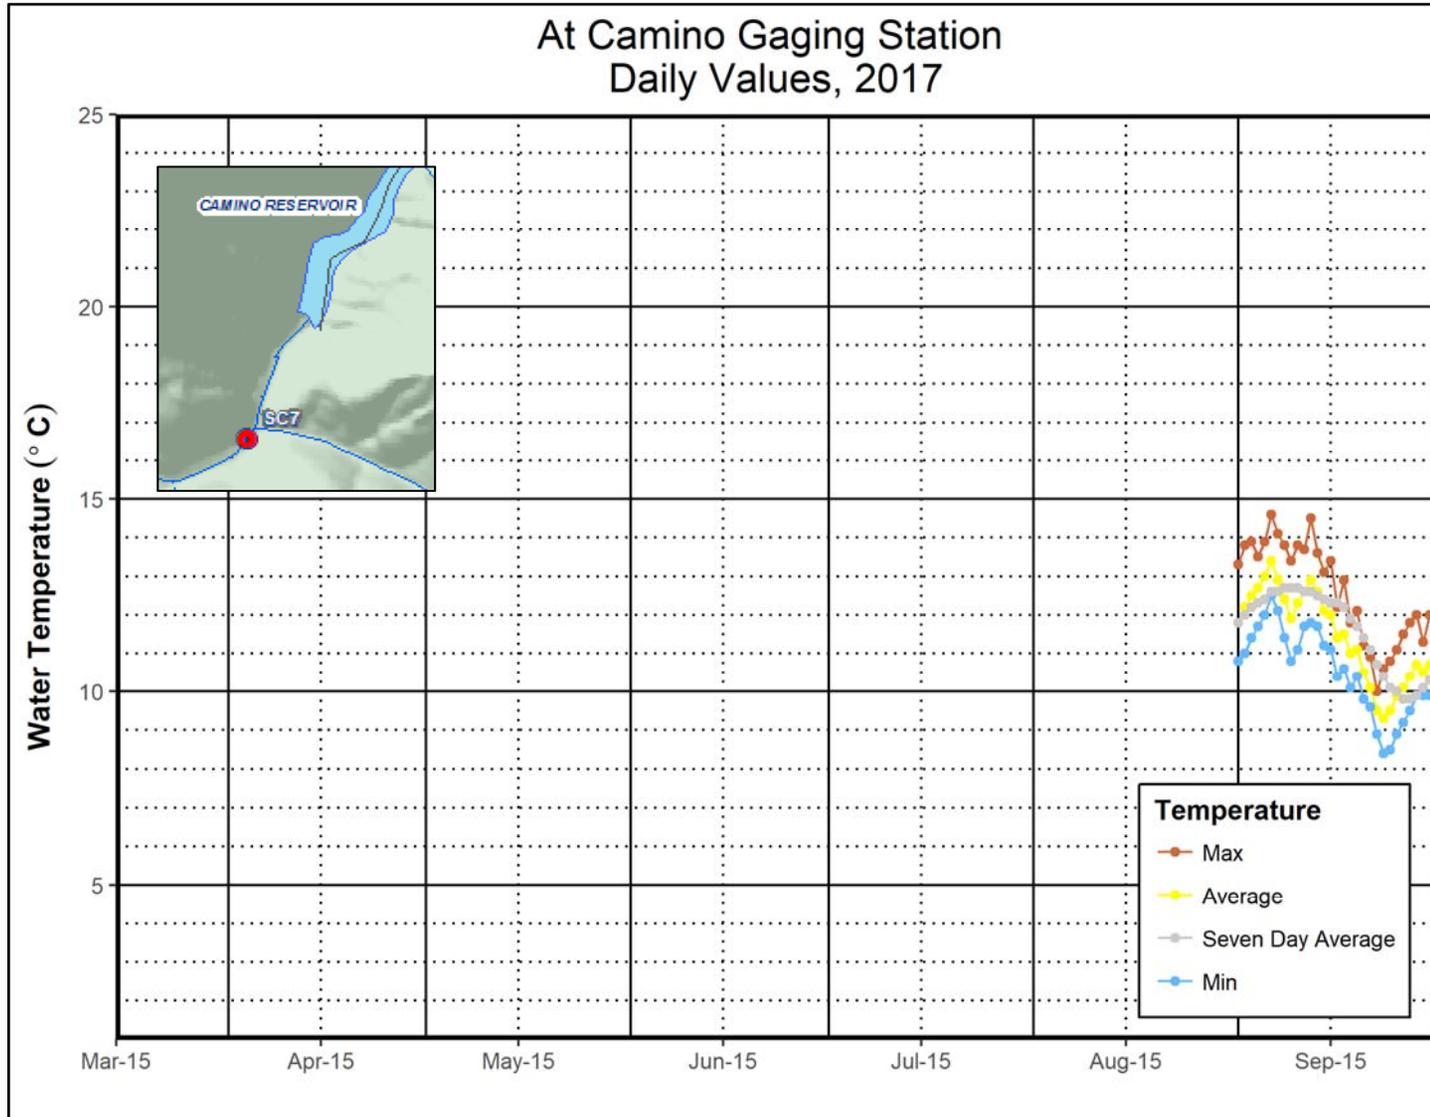
Figure 11 - Silver Creek immediately below Camino Reservoir Dam (SC7)

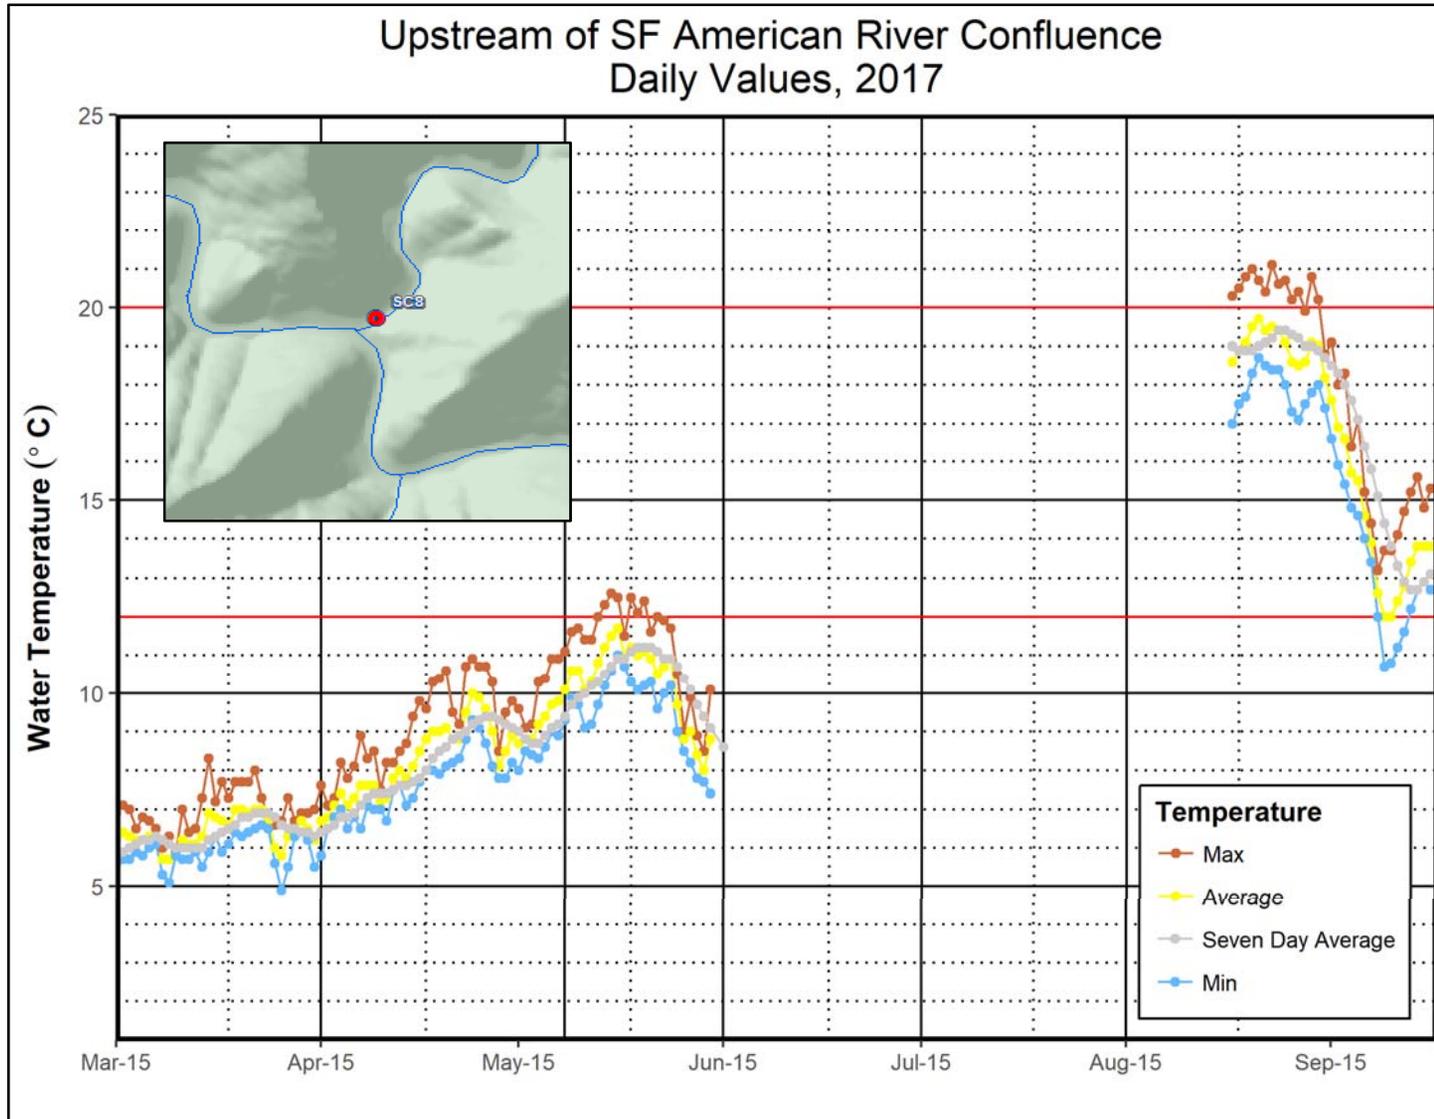
Figure 12 - Silver Creek immediately upstream of SF American River (SC8)

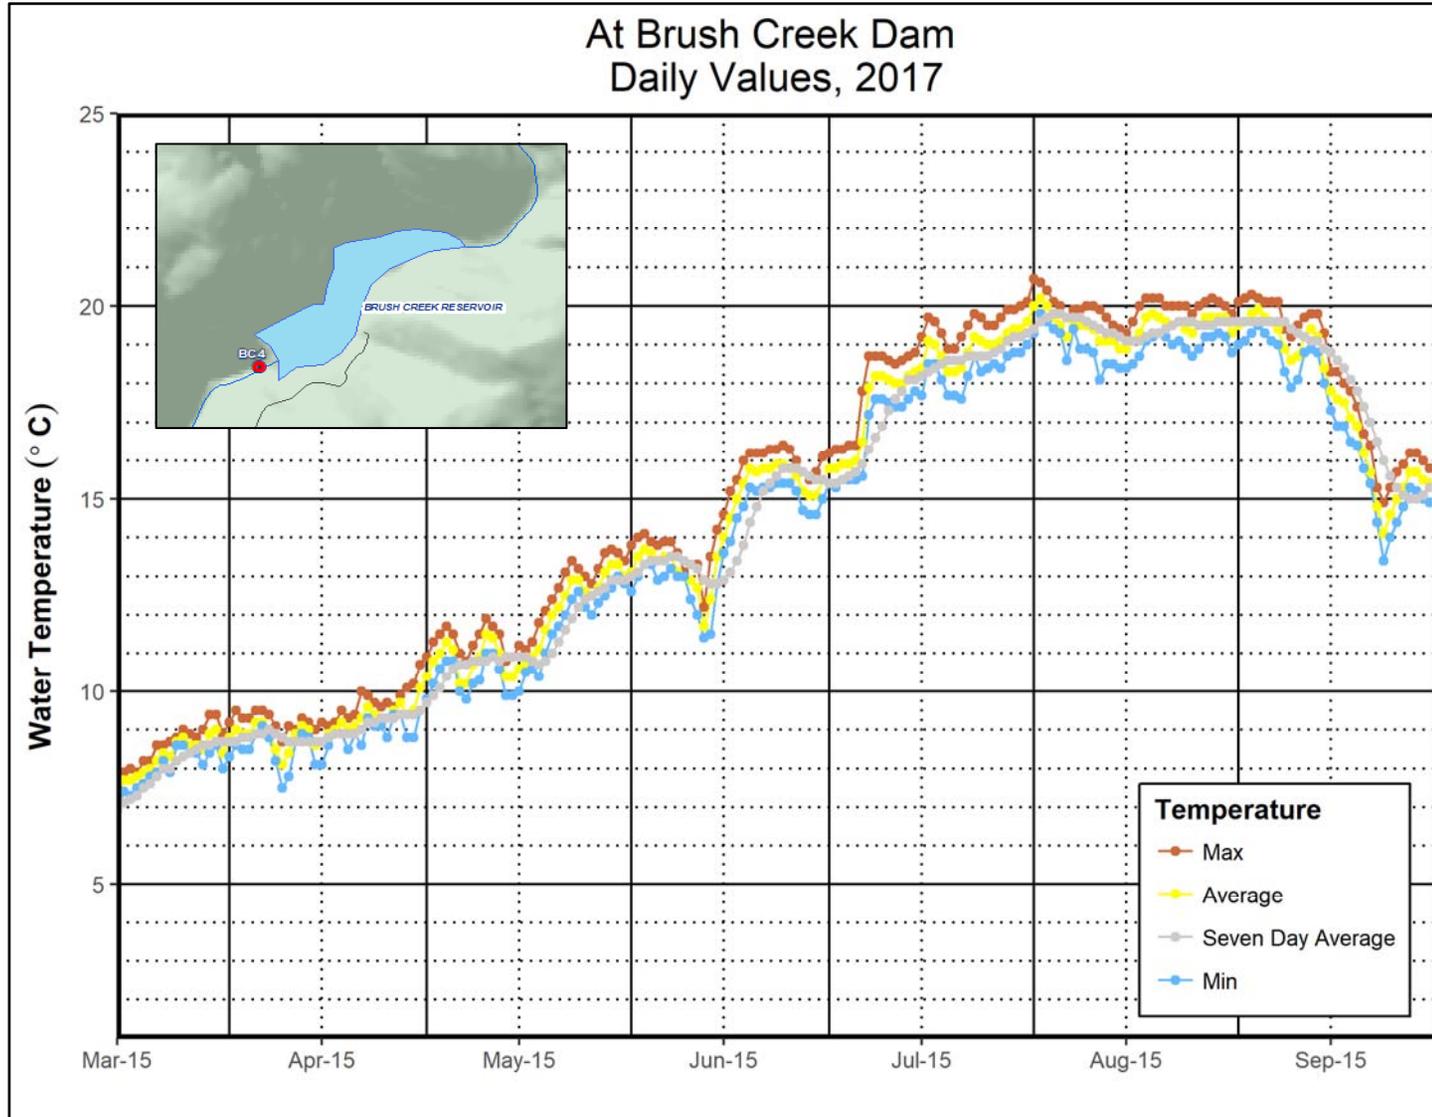
Figure 13 - Brush Creek immediately below Brush Creek Reservoir Dam (BC4)
