Water Temperature Monitoring Report

Sacramento Municipal Utility District

Hydro License Implementation • June 2018

Upper American River Project

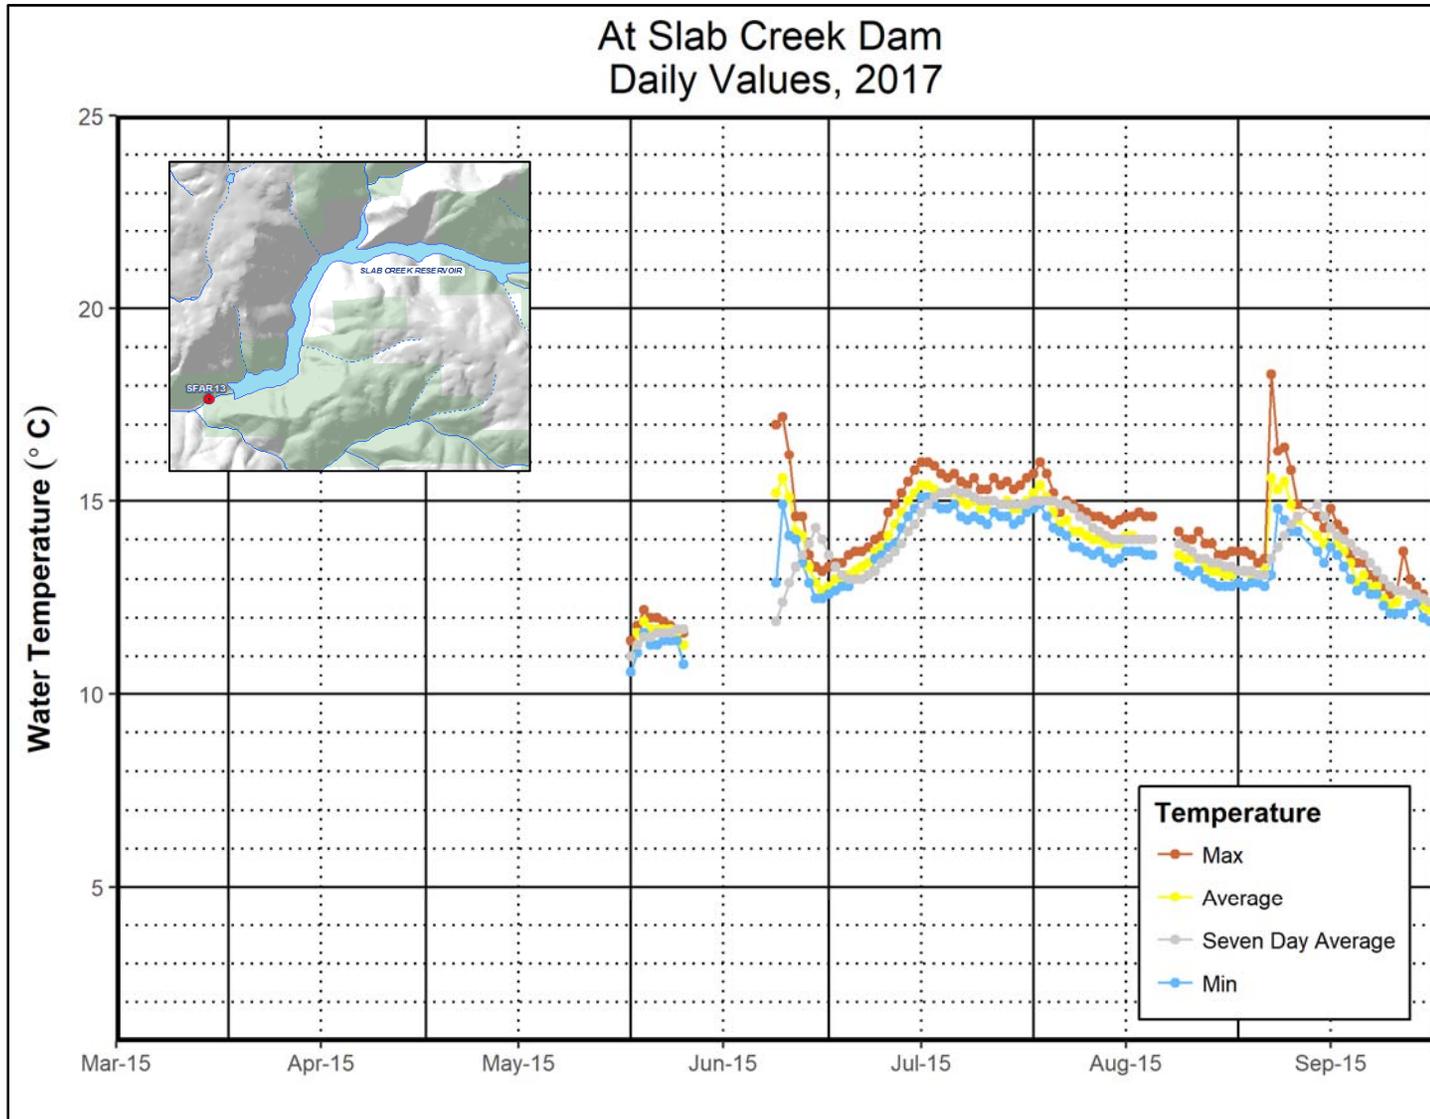
Figure 14 - SF American River immediately below Slab Creek Reservoir Dam (SFAR13)

Water temperature data is presented graphically in figures one through sixteen. It is impractical to place hourly and daily data for all sites into this report, although this data will be made available upon request.

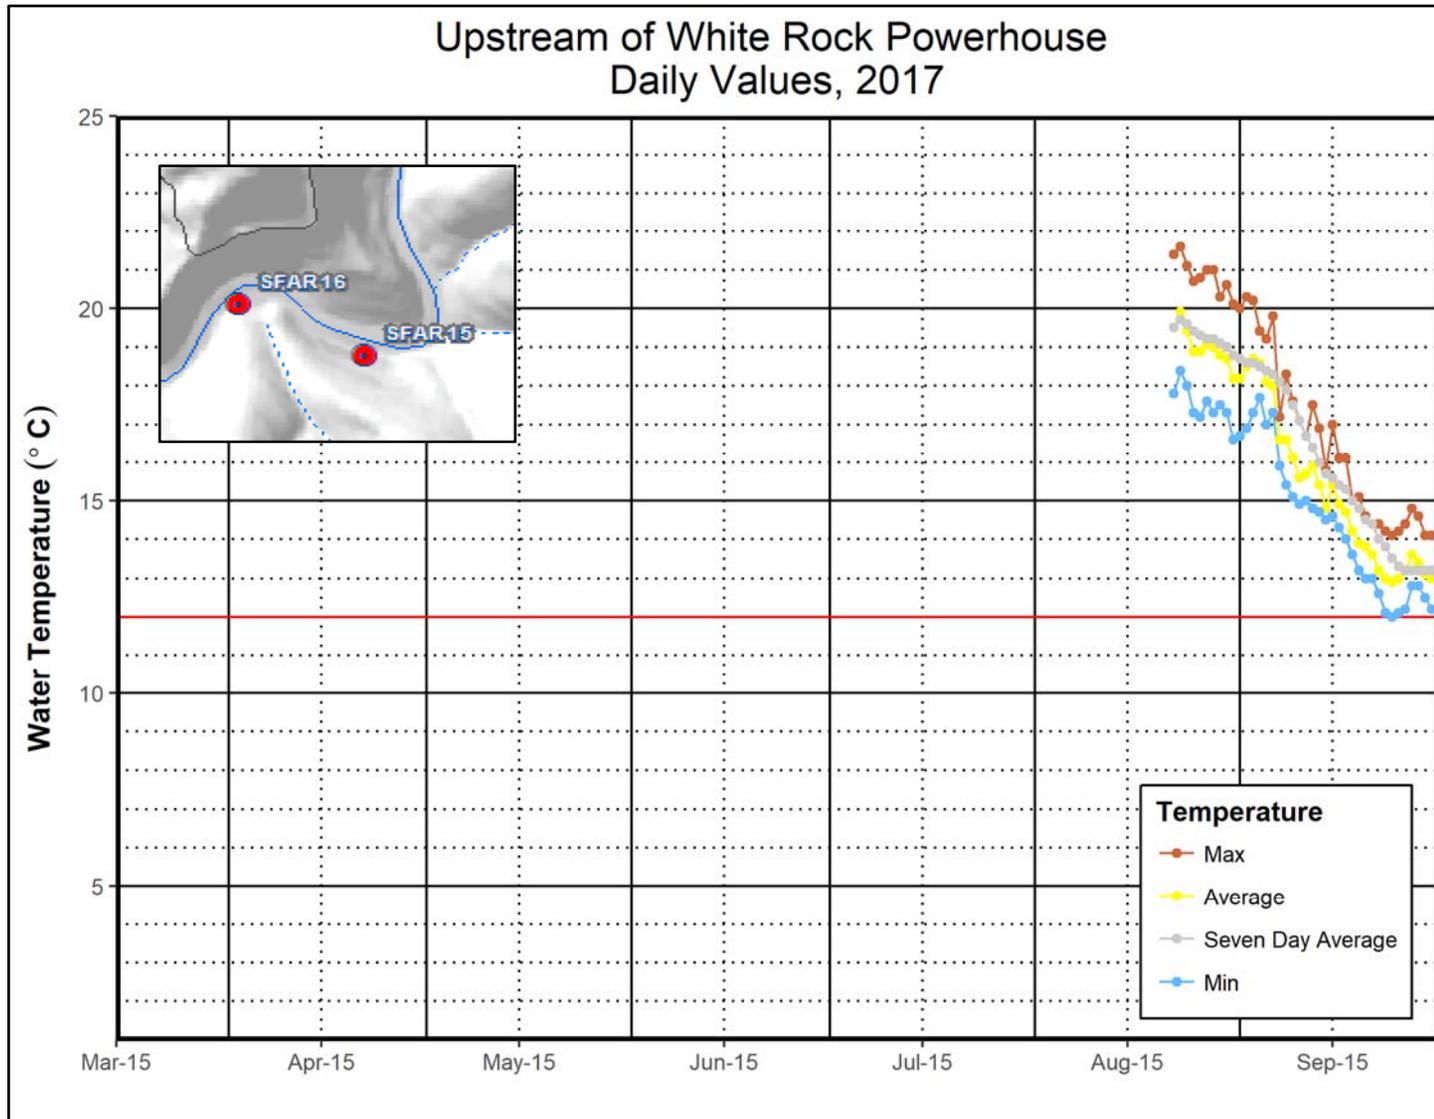
Figure 15 - SF American River approximately ½ mile upstream of White Rock Powerhouse (SFAR15)

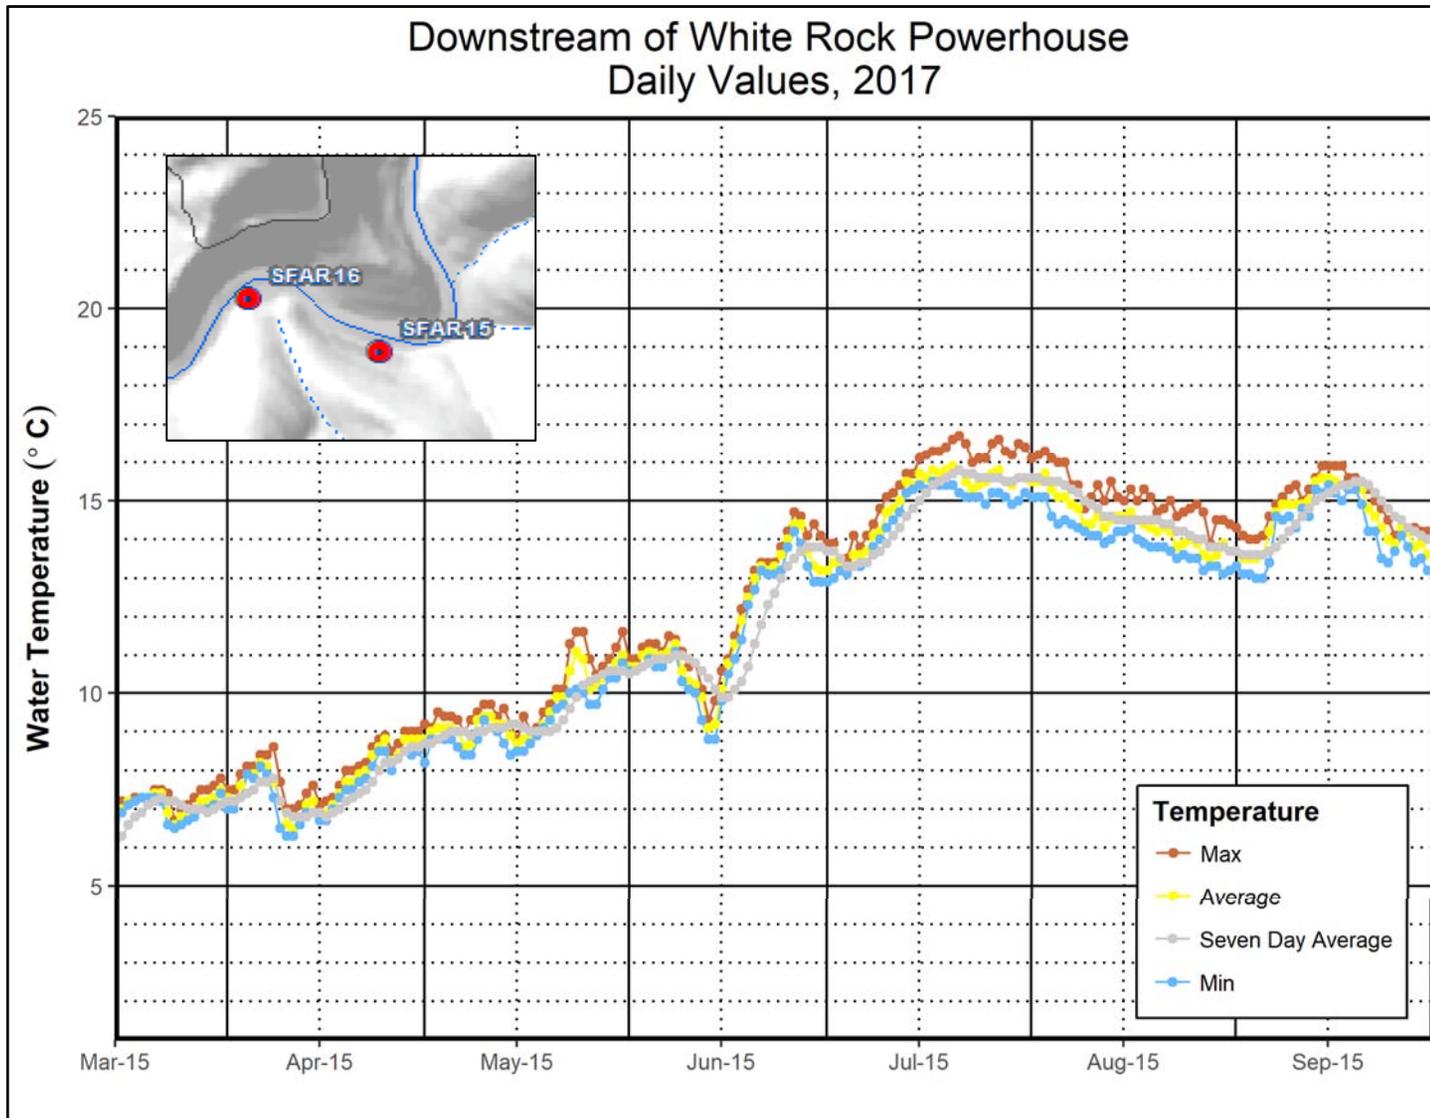
Figure 16 - SF American River to record White Rock Powerhouse discharge temps (SFAR16)
